# Exterior Masonry Condition Assessment

## LaGrande Carnegie Library

**Section 2.0 Building Condition Assessment  
LaGrande Carnegie Library**

# Building Condition Assessment LaGrande Carnegie Library

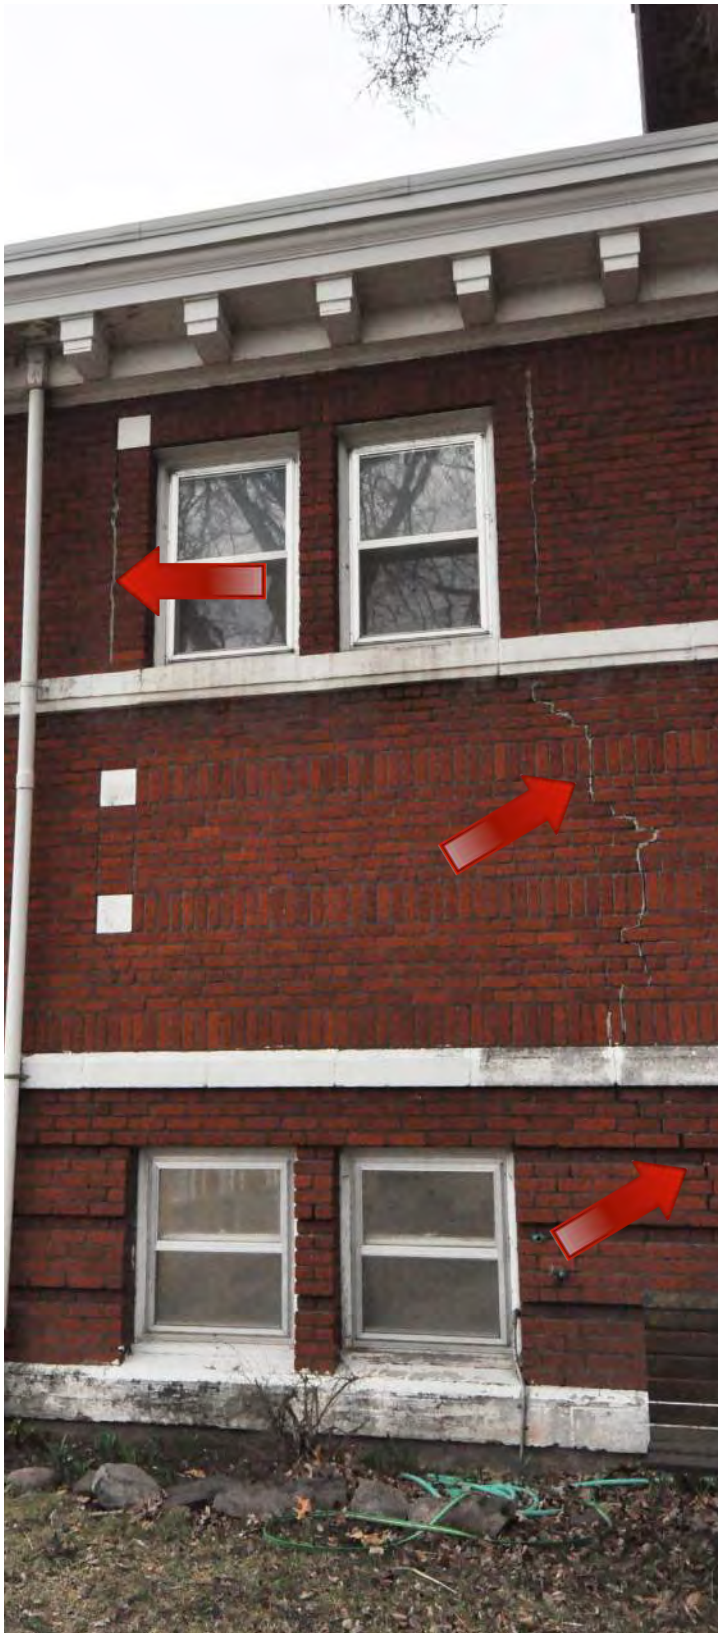
Figure 12: Full height cracks on the north elevation.  
© Richaven Architecture & Preservation, 2020. DSC\_0028.JPG.

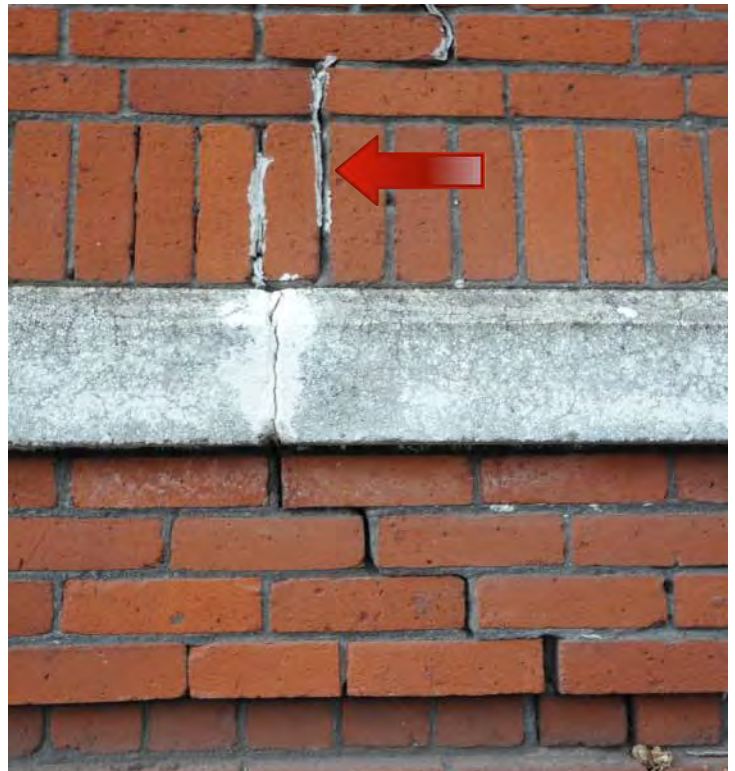
Figure 13: Detail at cracks and failed sealant repairs, north elevation.  
© Richaven Architecture & Preservation, 2020. DSC\_0030.JPG.

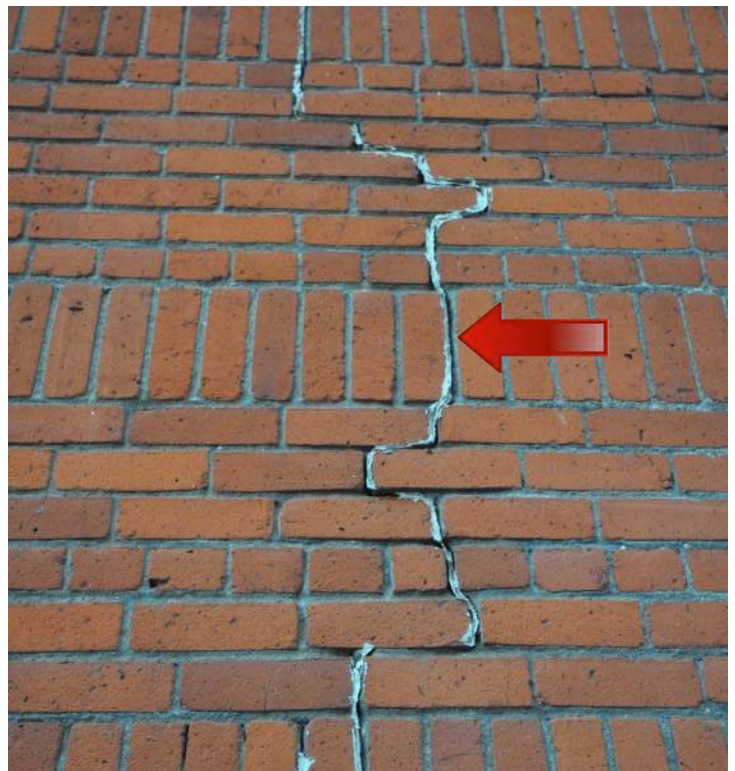
Figure 14: Detail at cracks and failed sealant repairs, north elevation.  
© Richaven Architecture & Preservation, 2020. DSC\_0031.JPG.

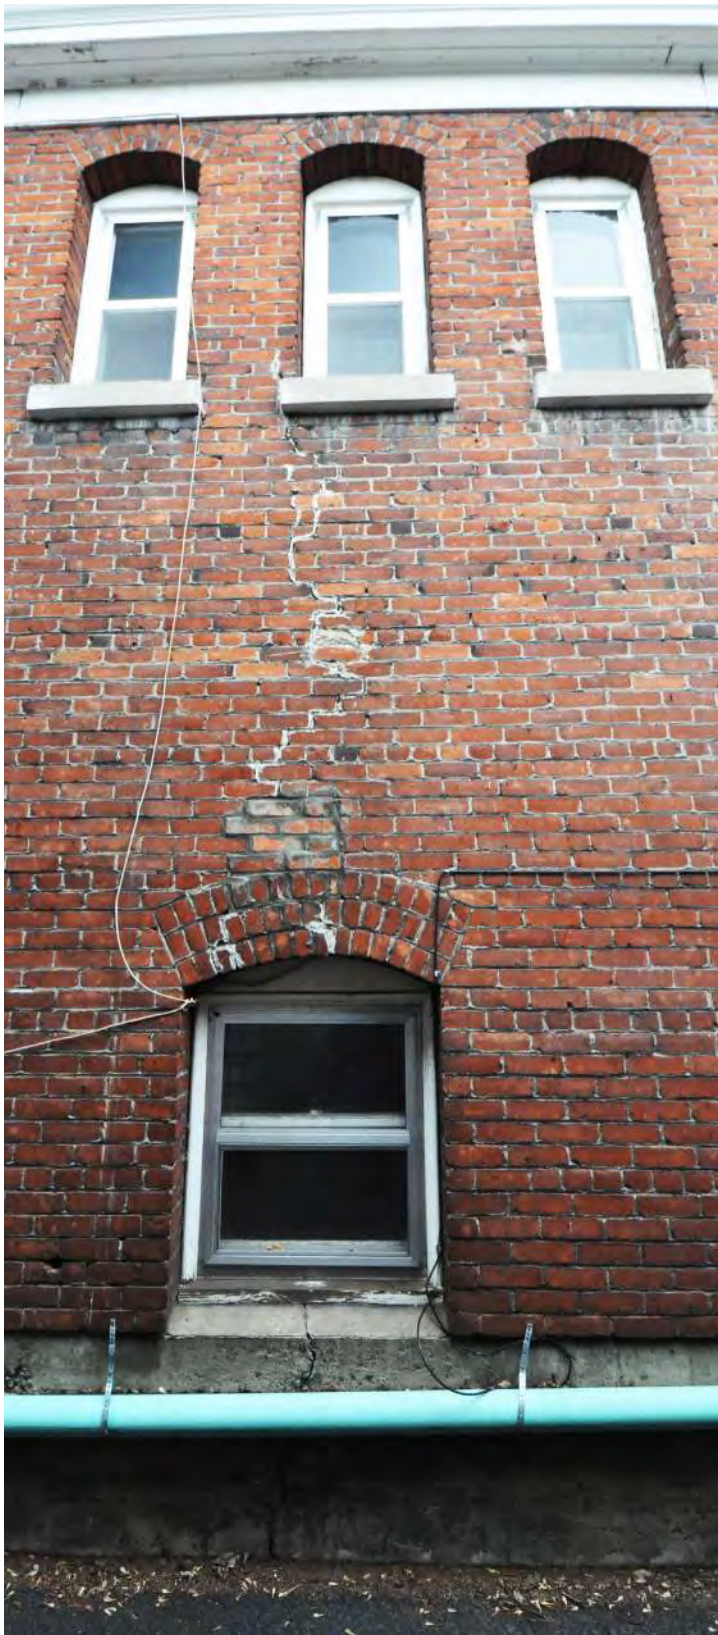
Figure 15: Full height crack in concrete and brick, south elevation.  
© Richaven Architecture & Preservation, 2020. DSC\_0044.JPG.

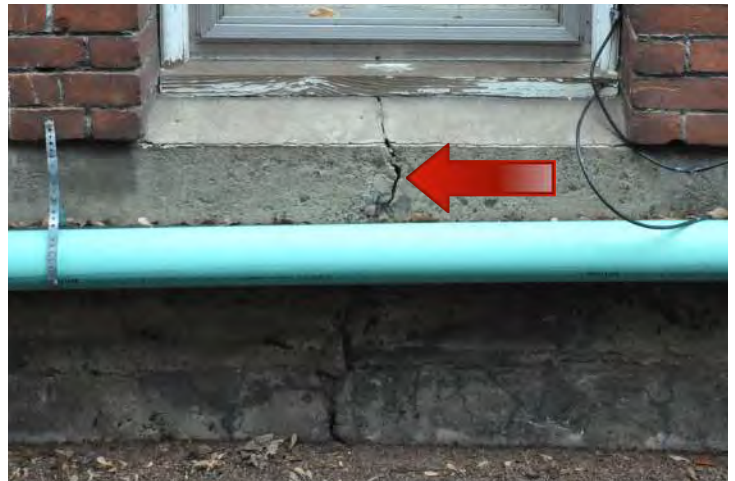
Figure 17: Detail at cracks and failed sealant repairs, south elevation.  
© Richaven Architecture & Preservation, 2020. DSC\_0045.JPG.

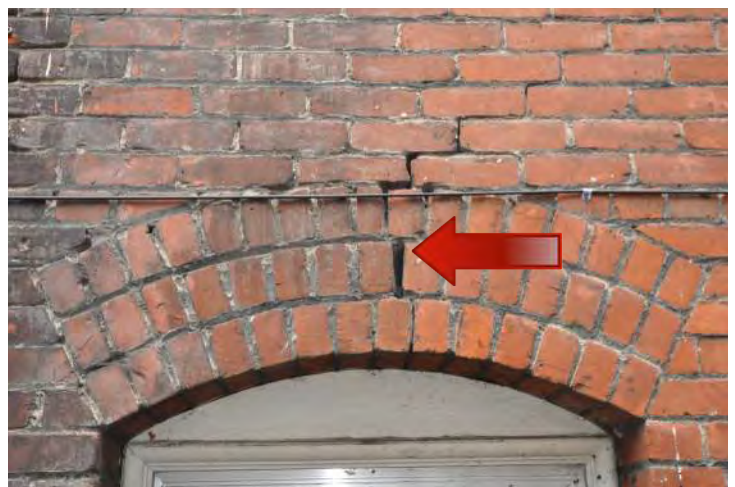
Figure 18: Detail at cracks in brick wall system, south elevation.  
© Richaven Architecture & Preservation, 2020. DSC\_0056.JPG.

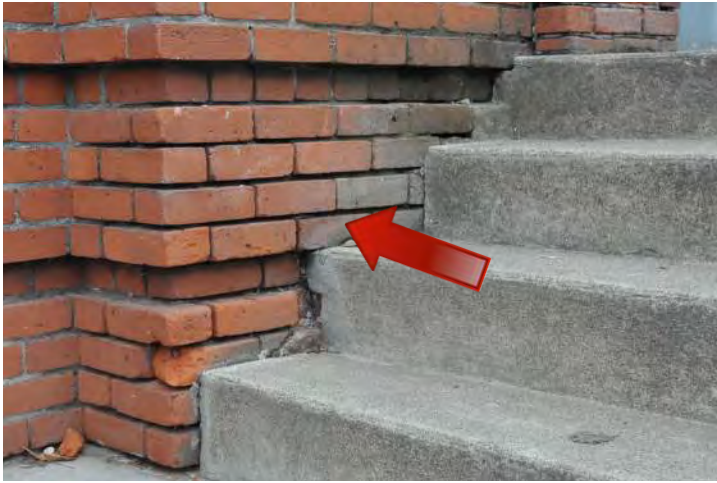
Figure 19: Mortar deterioration adjacent to the main entry stairs on the north elevation is severe and repointing is recommended. Mortar deterioration may have been caused by back splash of rainwater from the steps or application of ice melt products. Repair and protection of the brick and repointing of the mortar joints is highly recommended. In addition, it appears that the concrete stairs may have been installed after the brick walls were constructed due to the tothing of the concrete into the brick. This may result in added stresses on the brick walls and concrete stair structure, as observed in Figure 21.

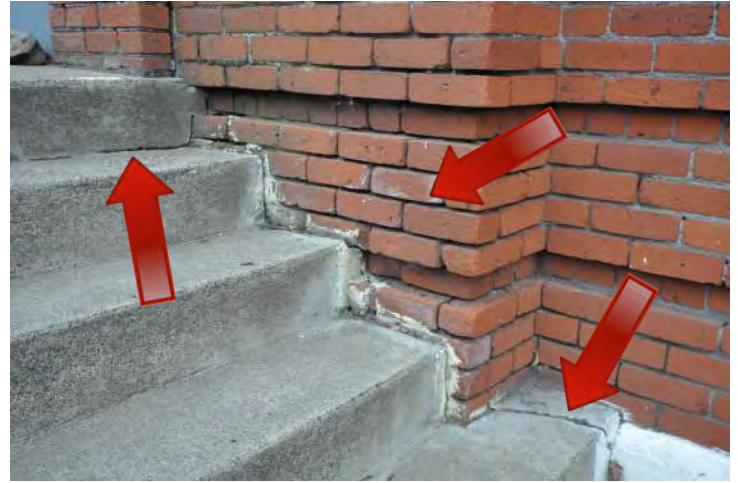
Figure 21: Masonry wall deterioration at the west stairs at the north main entry to the Library. Similar to the east, mortar deterioration is severe and the concrete appears to be tothing into the masonry coursing. It also appears that there may be some settlement of the stair which is causing additional stresses in both the concrete stair and masonry wall system. On this stair that appears to be resulting in a crack in the concrete at the top riser and potentially also excessive loads on the brick at the same level. At the bottom step, the concrete is cracking adjacent to the wall where it overlaps the concrete foundation. It also appears that some parts of the brick at the edge of the stair have become exposed.

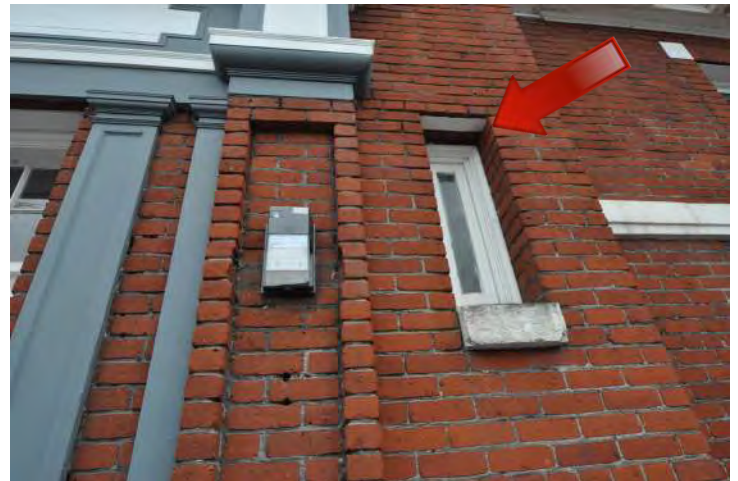
Figure 22: Masonry wall detail on the west side of the main north entry demonstrates deterioration similar to the east side. Additional noteworthy observations include the replacement light fixture which does not appear to be weatherproofed at the junction with the wall and the white-painted steel lintel at the head of the window. Steel lintels are observed at all window openings and appear to be in fair condition with minimal corrosion and rust jacking.

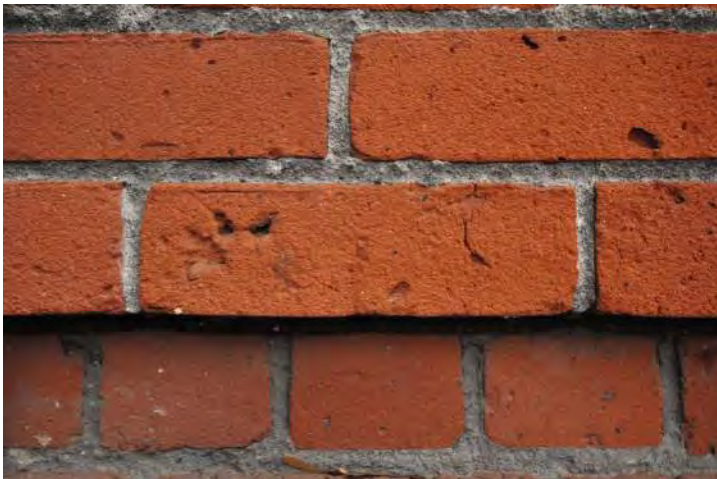
Figure 24: Masonry detail at the east elevation of the Library reveals that the abrasive cleaning of the wall has exposed pockets in the masonry as well as the grog used in the manufacture of the brick. The mortar is also observed to be rough and the tooling of the joint worn away by the cleaning potentially making it subject to more rapid deterioration. Light cleaning, sealing and coating with anti-graffiti coatings should be considered to preserve the masonry wall systems. © Richaven Architecture & Preservation, 2020. DSC\_0076.JPG.

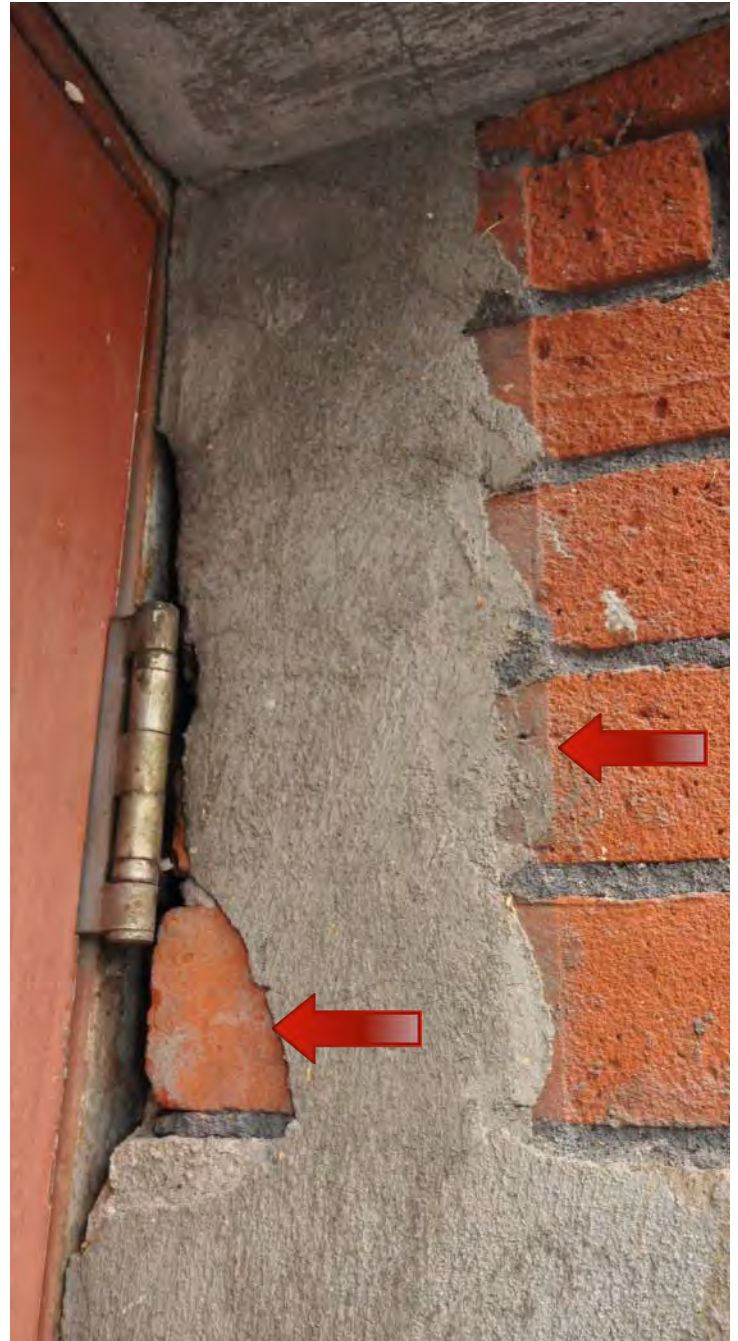
Figure 25: Masonry detail at the north side of the basement door on the east elevation of the Library. The brick masonry appears to have been protected by another material at the time the masonry was cleaned, as indicated by the vertical line between the smooth face of the masonry fire skin at the rough surface of the cleaned masonry. With reference to Figure 23, this detail suggests that the original color of the masonry was a traditional red colored fired brick. The amount of the brick removed in the abrasive cleaning process is also apparent. © Richaven Architecture & Preservation, 2020. DSC\_0073.JPG.

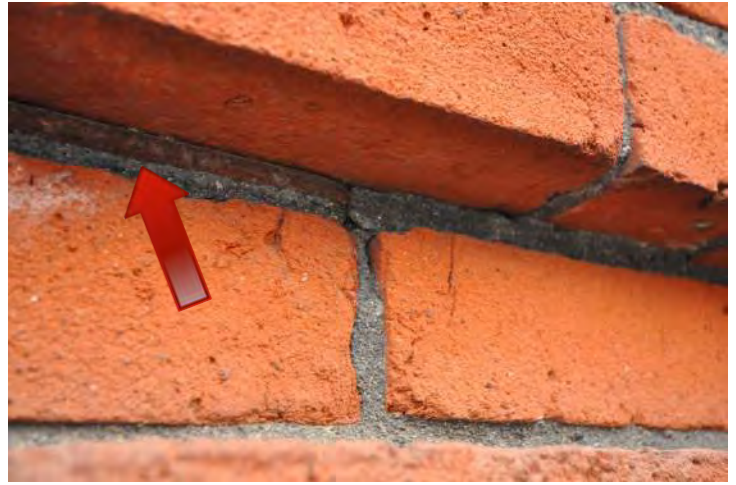
Figure 28: Detail at masonry wall system that was abrasively cleaned. This detail illustrates the porous core of the bricks that are exposed to the weather. Such exposure will likely lead to accelerated deterioration of the brick masonry due to freeze thaw cycling. Long term moisture saturation of the masonry wall system is also possible and may lead to disaggregation of the brick masonry units themselves. This detail also illustrated a steel lintel angle at the top joint in the recessed course. While exhibiting minimal corrosion, it is recommended that all exposed steel is painted to prevent corrosion where possible. However, corrosion due to high levels of moisture in the masonry wall system may also lead to accelerated corrosion of the steel building components.

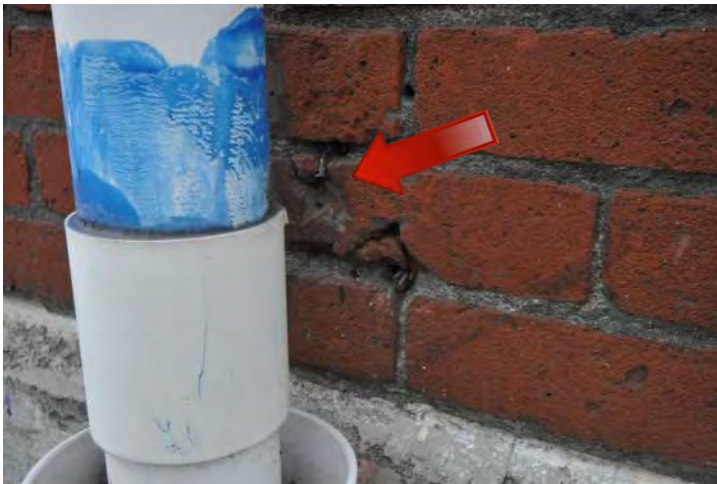
Figure 27: Masonry detail at a downspout on the south elevation of the Library. At this location, previously installed anchors remain in the masonry wall system and should be removed. In addition, it appears that other anchors have been removed and the masonry wall system has been damaged in the process. Repointing of the mortar joints and in-kind replacement of the brick is recommended.

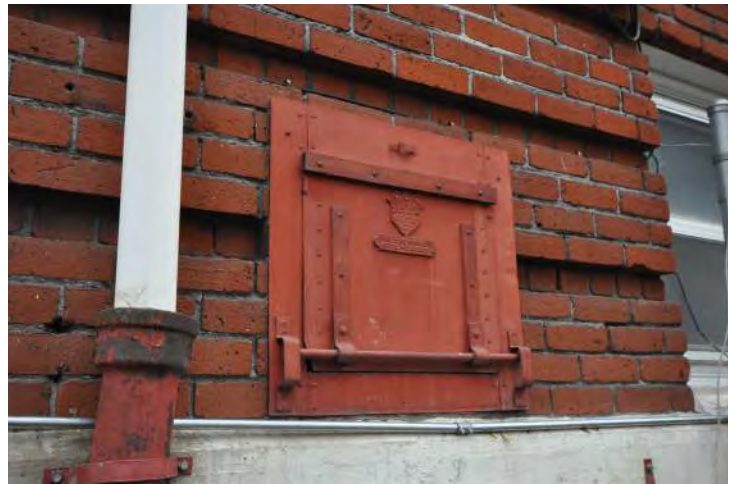
Figure 29: Detail at coal chute and downspout connection at the east elevation of the Library. Further investigation of the brick at the coal chute may help determine the original brick color and finish. The "open hub" connection between the schedule 10 PVC downspout and cast iron drain pipe may lead to areas of ice that can further damage the masonry wall systems due to freeze/thaw cycling.

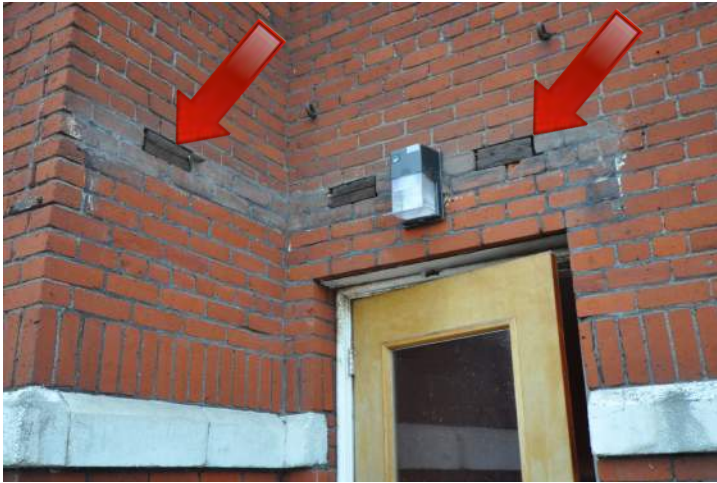
Figure 30: The wood blocking in the masonry wall at the exit door at the southwest corner of the building suggests that there may have been a canopy at this location at one time. The wood blocking may have been anchor points for the canopy framing. The remaining wood can absorb and hold increased moisture that can lead to insect habitation and infestation of the building. In addition, the higher level of moisture in the area can damage the masonry wall system through freeze thaw action. Removal of the wood and infilling the opening with in-kind masonry materials is recommended.

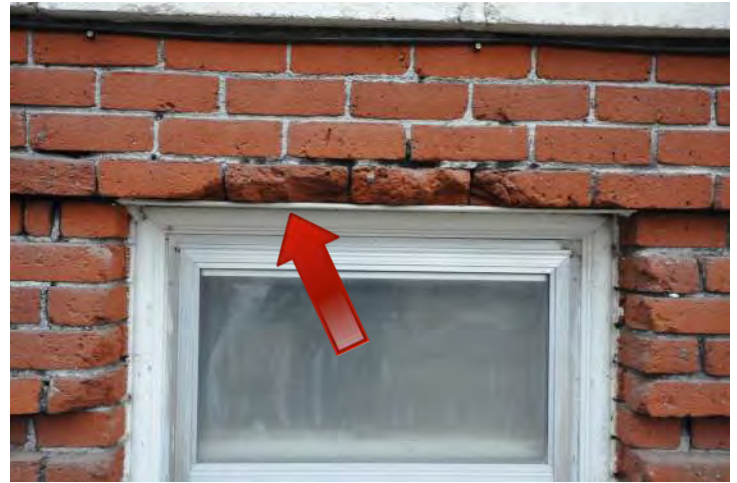
Figure 32: Detail at a basement level window at the east elevation of the Library. Severe damage to the masonry is observed due to the abrasive cleaning and likely mechanical/impact damage as well. The extent of damage at this window location make weatherproofing of the building difficult. Replacement of the damaged brick with matching in-kind materials and repointing of the joints in this area is recommended. In addition, the steel lintel angle at the head of the window is observed and is potentially exposed to the weather. Protection of the steel wall elements is recommended to prevent corrosion and rust jacking.

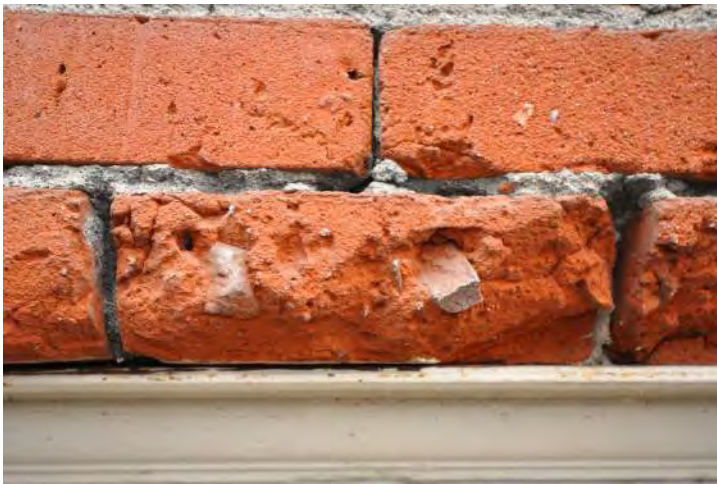
Figure 31: Detail at masonry wall system that was abrasively cleaned. This detail illustrates the porous core of the bricks that are exposed to the weather. Such exposure will likely lead to accelerated deterioration of the brick masonry due to freeze thaw cycling. Long term moisture saturation of the masonry wall system is also possible and may lead to disaggregation of the brick masonry units themselves. This detail also illustrated a steel lintel angle at the top joint in the recessed course. While exhibiting minimal corrosion, it is recommended that all exposed steel is painted to prevent corrosion where possible. However, corrosion due to high levels of moisture in the masonry wall system may also lead to accelerated corrosion of the steel building components.

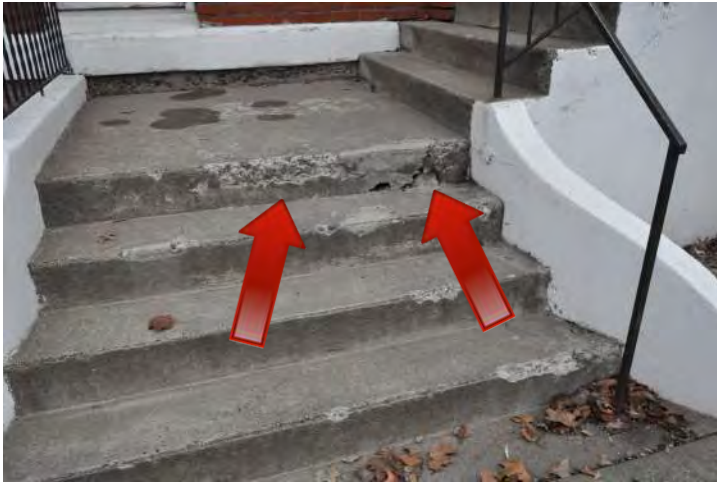
Figure 33: The concrete steps at the north main entry to the Library exhibit severe freeze/thaw damage likely due to ice melt chemicals applied to the steps. Repair of this type of damage may be possible through small localized patches or through removal of sections of the stairs and replacement in-kind. Use of ice melt products is not recommended for this type of area. Consider use of heat melting systems under the stair.

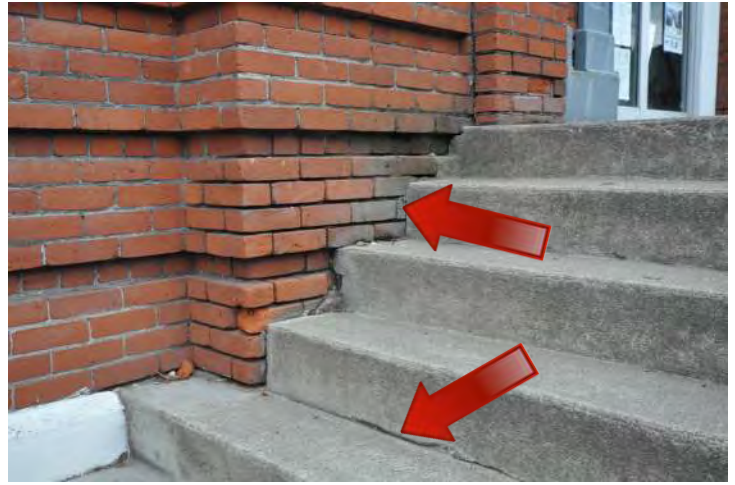
Figure 34: As noted in the caption for Figure 19 & 21, there are significant issues with the masonry wall system at the north main entry stair. In addition, concrete deterioration is observed in the form of cracks at the joint between the riser and tread of the bottom step, which allows entry of water into the system and can lead to accelerated freeze/thaw deterioration.

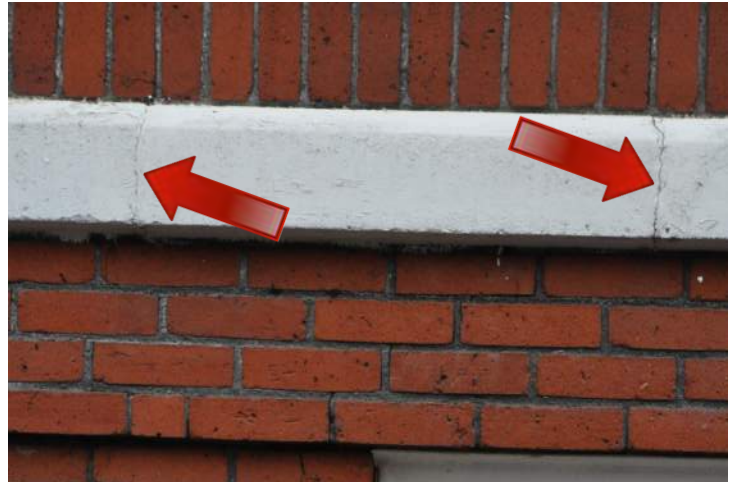
Figure 38: Two cracks in the precast concrete belt course are the result of the vertical cracks telegraphing through this building element. Such cracks should be repaired to prevent water intrusion into the masonry wall system that promotes deterioration.

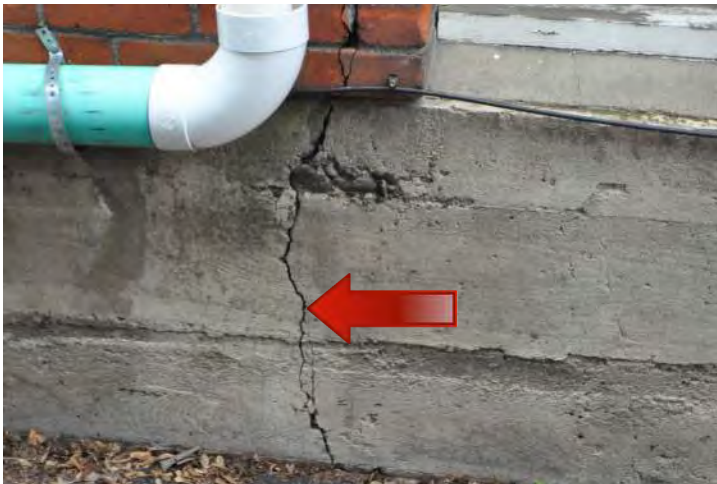
Figure 37: Similar to Figure 36, this crack in the concrete foundation located on the south side of the building, continues up through the brick to the top of the building. The crack is likely due to settlement of the foundation. Also note that the blue drain pipe is held by straps anchored directly into the brick units rather than into mortar joints. Locating anchors in mortar joints is less likely to damage the irreplaceable brick materials and is easier to repair in the future.

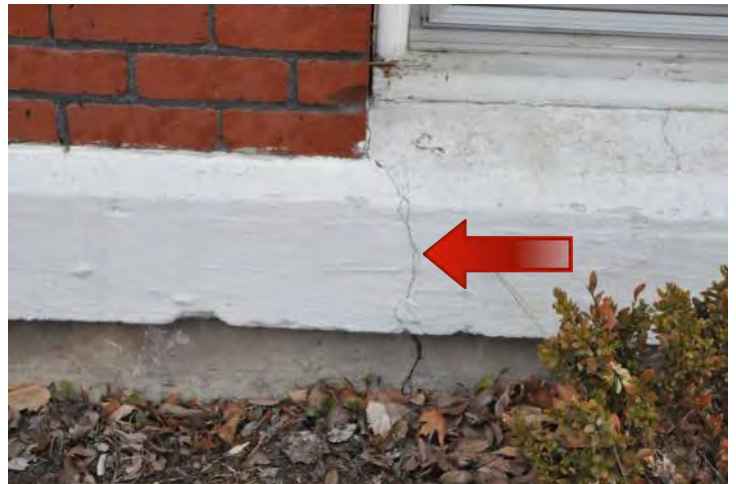
Figure 39: Similar to the two cracks in the precast concrete belt course in Figure 38, the crack through the foundation and the precast concrete course are the result of the vertical cracks telegraphing through this building element. Such cracks should be repaired to prevent water intrusion into the masonry wall system that promotes deterioration.

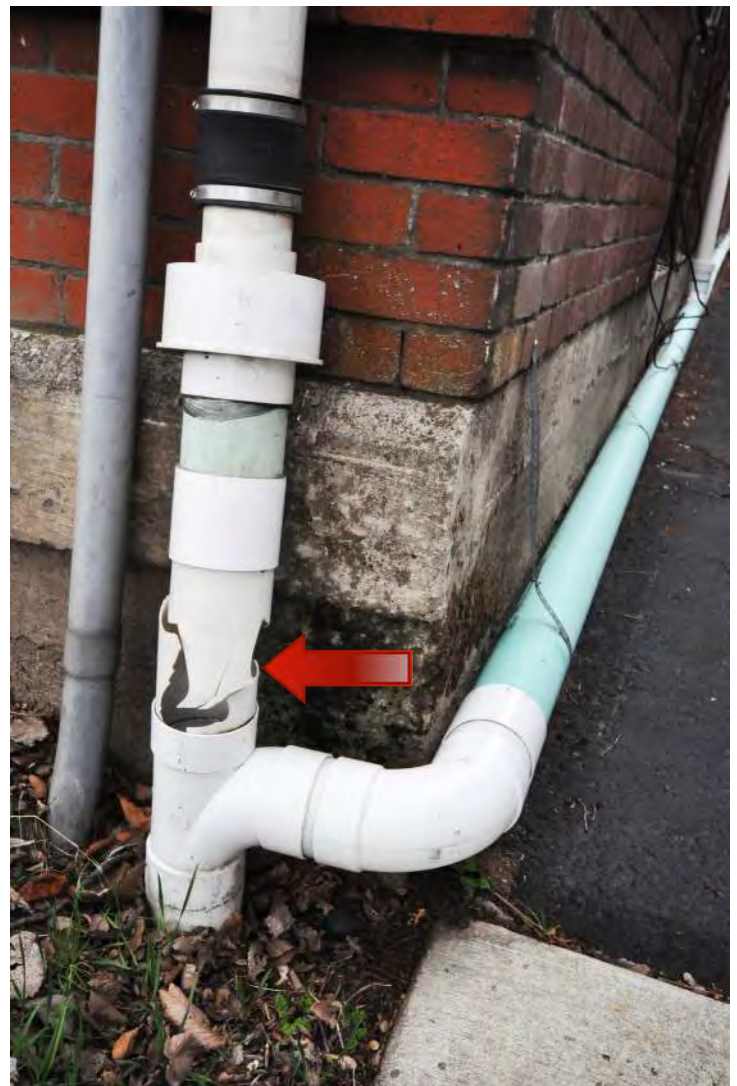
Figure 40: A vertical downspout at the southwest corner of the building is shattered due to freeze/thaw cycling abetted by debris in the pipe.  
© Richaven Architecture & Preservation, 2020. DSC\_0037.JPG.

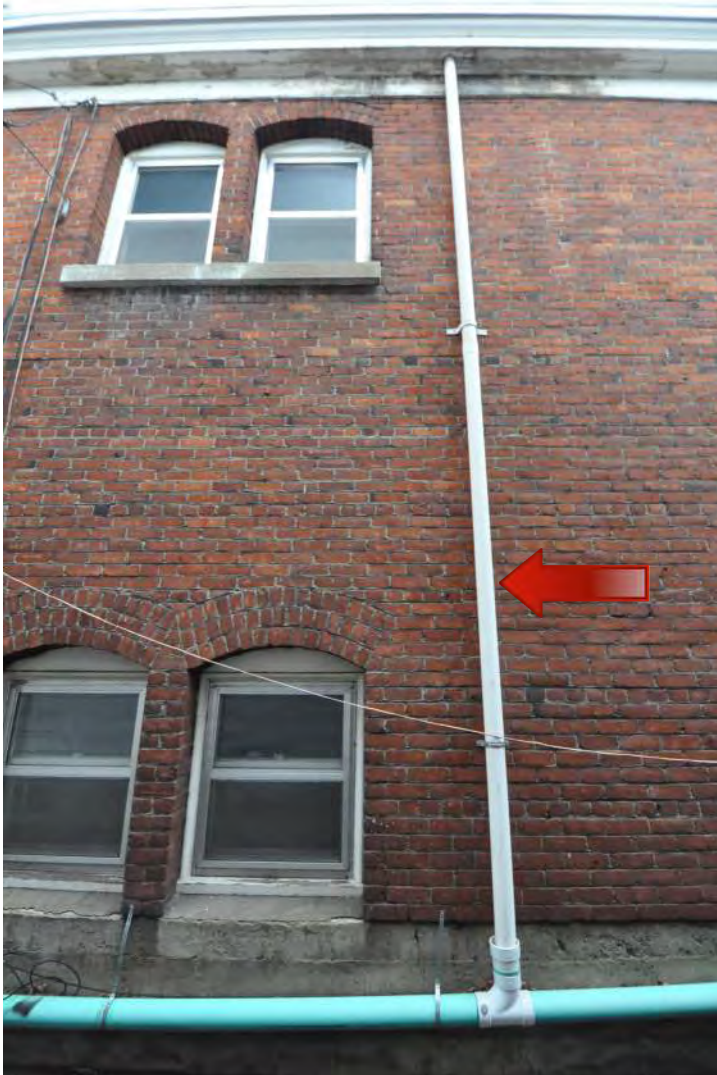
Figure 41: Typical of the drain pipes on the building, this vertical downspout on the south elevation has an "open hub" connection, light weight PVC piping, straps anchored directly into the brick, and there are signs of water related damage at the cornice.

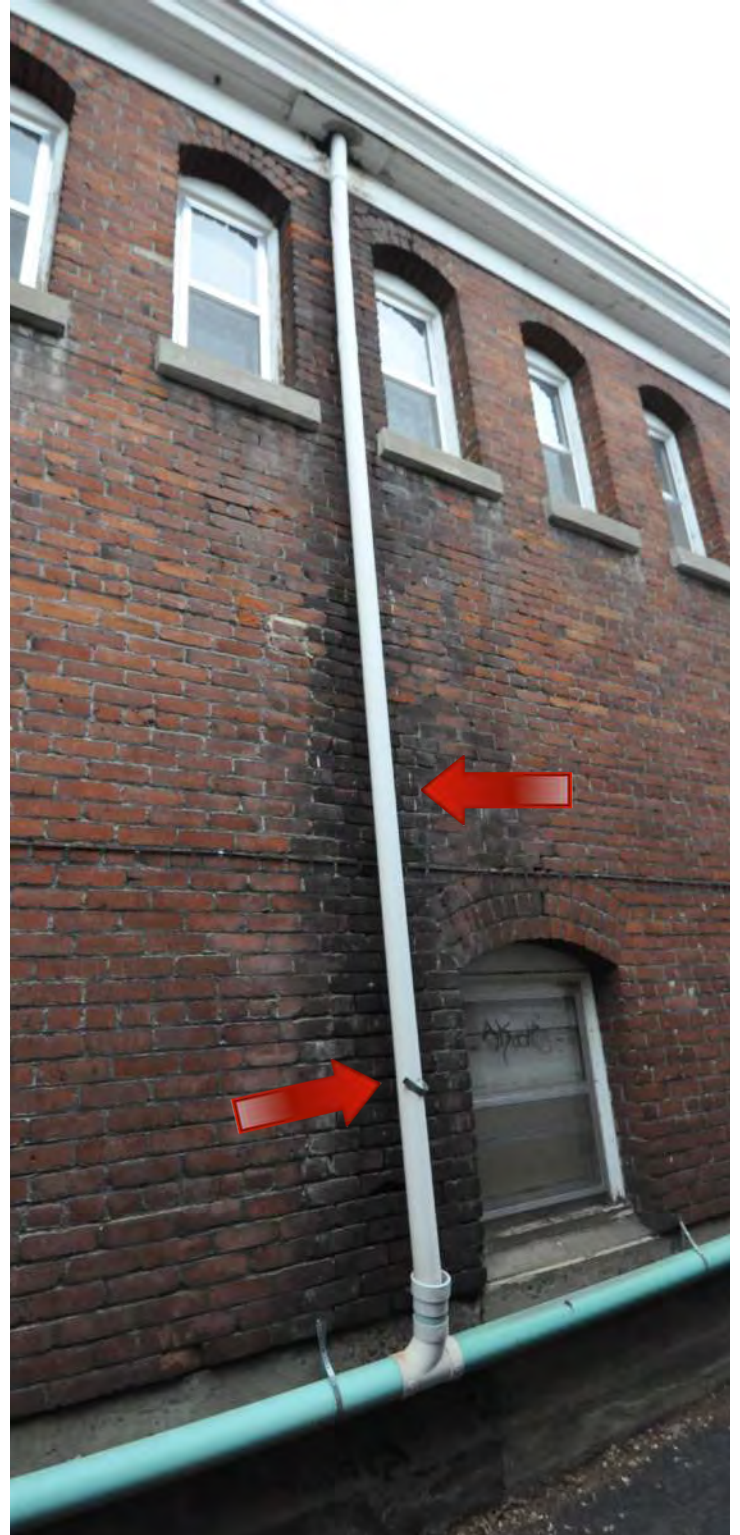
Figure 42: Similar to Figure 41, this downspout pipe also shows significant mortar erosion and brick damage due to the broken downspout leader shown in Figure 43. Also note the broken anchor strap.

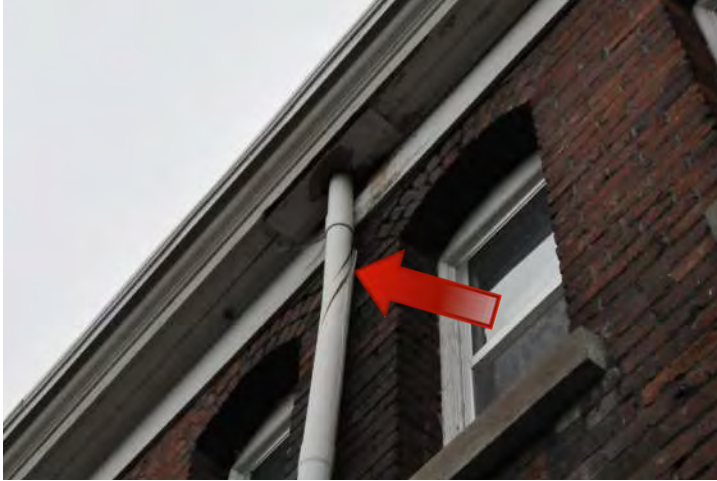
Figure 43: This downspout on the south side of the building shows significant damage, allowing stormwater to flow down the wall and saturate the masonry wall system. Immediate repairs to this downspout are recommended as well as repointing of the brick and wood repairs at the cornice and repair of the integral gutter to prevent leaking water into the building structure.

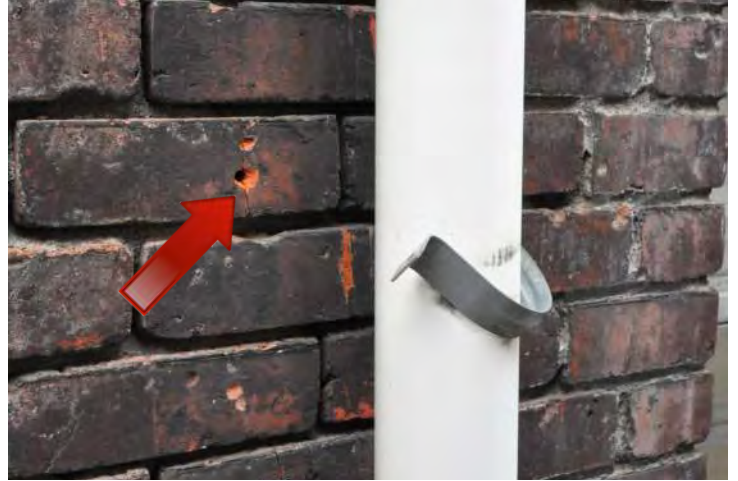
Figure 45: Continuing the pipe shown in Figure 43, this photo shows the erosion of the mortar into the masonry joints, as well as soiling and the missing strap anchor. Note also that the brick is cracked at the location of the anchor, compromising its integrity and reducing the structural integrity of the wall.

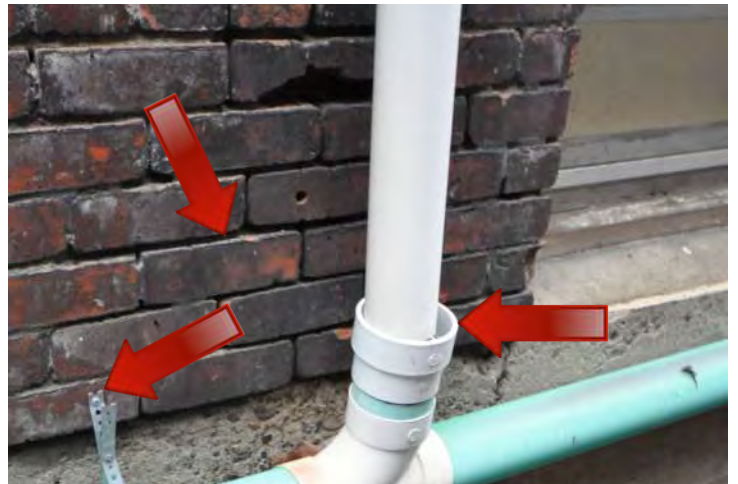
Figure 46: Continuing the downspout shown in Figure 43 and 45, this photo shows the "open hub" connection at the bottom which allows stormwater to splash out of the connection, erosion of the mortar in the brick joints, improper anchoring into the brick units, and significant soiling of the brick masonry (black staining).

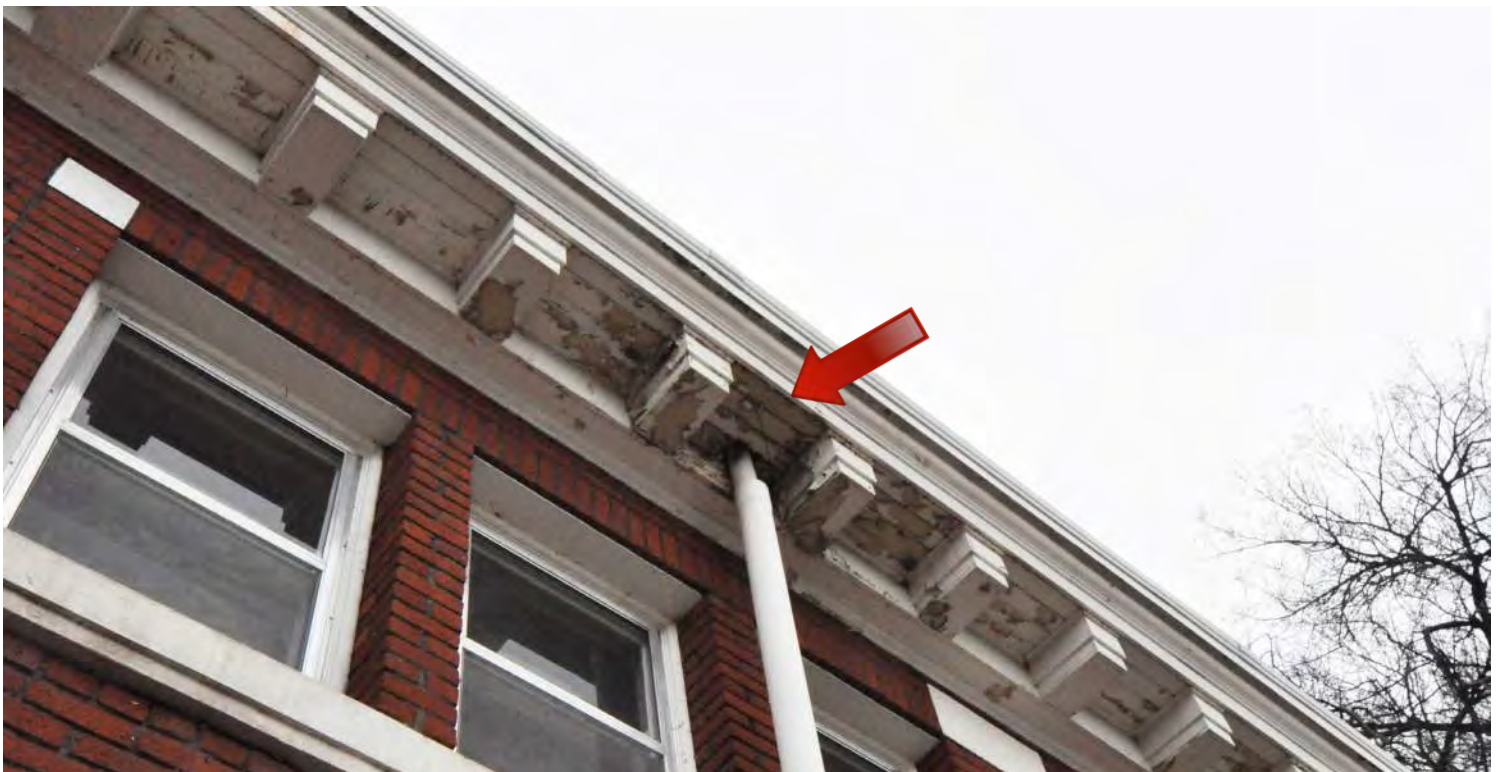
Figure 47: The painted wood cornice is damaged due to water leaking from the downspout connections due to blockage and freeze/thaw cycling.  
© Richaven Architecture & Preservation, 2020. DSC\_0019.JPG.

Additional wood features at the cornice and other openings show significant peeling and deterioration of the paint finish due to excessive moisture. At the underside of the cornice, this appears to be directly related to the downspout connections since the most severe damage is in those areas. It is likely that the integral gutter connections are leaking significant amounts of water and are perhaps damaged by ice dam build-up and debris in the downspouts. Repair of the gutters is immediately recommended to prevent further damage to the wood cornice and roof structure.

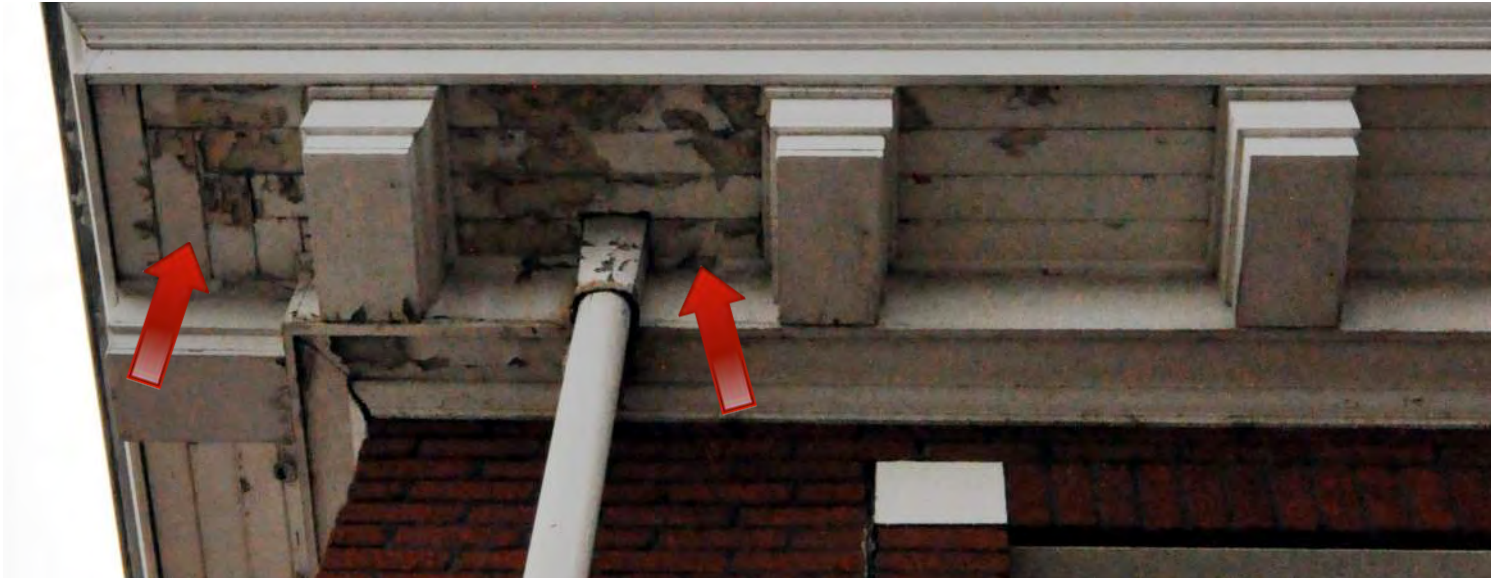
Figure 48: This downspout at the northeast corner of the building shows signs of significant and ongoing water leakage around the downspout. There is a high likelihood of rotting wood in addition to the observed paint damage at all downspouts on the building. The integral gutters and downspout connections should be immediately repaired to prevent further damage to the wood cornice and roof structure.  
© Richaven Architecture & Preservation, 2020. DSC\_0033.JPG.

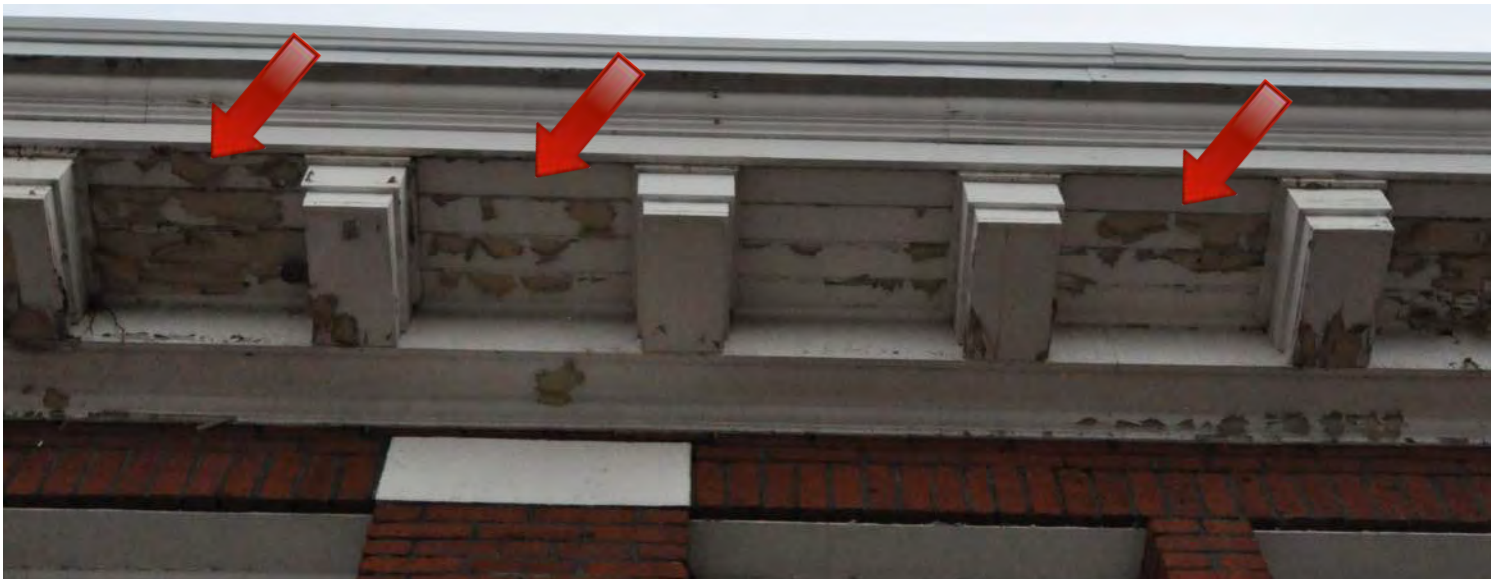
Figure 49: Peeling paint and wood damage at locations of the cornice away from the down spouts indicates that there may be additional leaks in the integral gutters, water traveling horizontally on the top of the soffit boards before soaking through to the paint coatings. Further investigation of the roof system and attic spaces is recommended to ascertain if water damage is more extensive than observed from the exterior.  
© Richaven Architecture & Preservation, 2020. DSC\_0027.JPG.

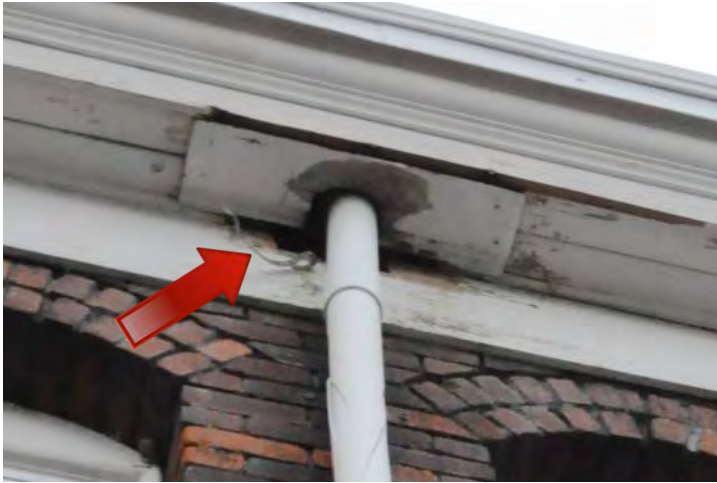
Figure 50: Severe damage to the cornice is observed at the downspout on the south elevation. Damage is so severe that an additional board has been installed to cover the opening. Note that the strap holding the downspout in place is broken and the downspout itself is shattered at this location. Eroded mortar at the brick joints due to the water saturation is also observed at this location.

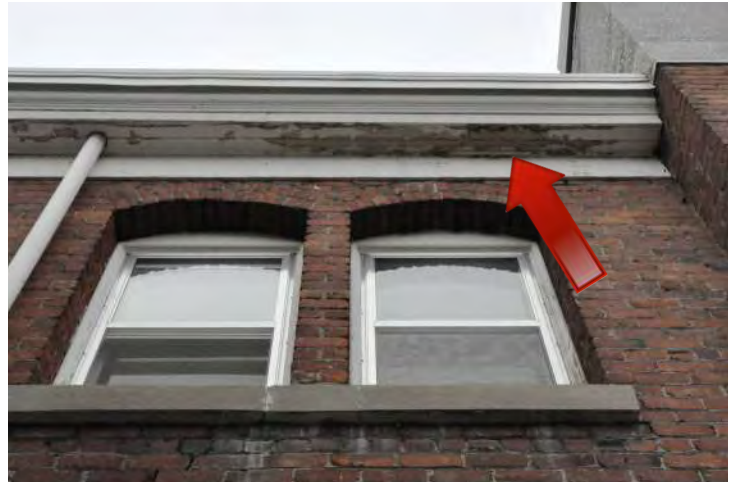
Figure 52: Extensive water damage on the underside of the cornice on the south elevation indicates that there is significant water leakage from the downspout running along the horizontal soffit boards.

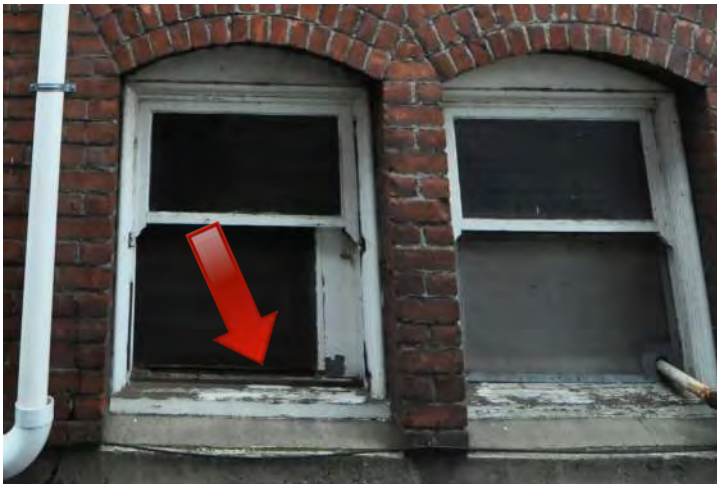
Figure 51: At this basement window on the south elevation of the building, deterioration of the paint finishes and glazing compound is observed. In addition, the bottom sashes of these two windows have been in-filled to allow for pipe and ventilation penetrations. These windows are immediately and fully repairable through consolidation of the wood materials, installing new glazing compound, and repainting of the windows.

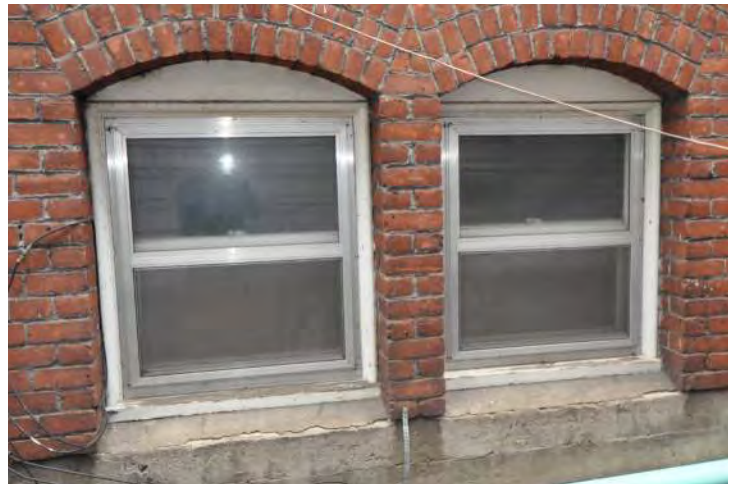
Figure 53: These two basement windows on the south elevation are better preserved because of the storm windows that have been installed on the outside. Storm windows can provide additional thermal protection as well. However, interior storm windows are recommended so as to not impact the historic appearance of the building.
