# Exterior Masonry Condition Assessment

## LaGrande Carnegie Library

**Section 2.0 Building Condition Assessment  
LaGrande Carnegie Library**

# Building Condition Assessment LaGrande Carnegie Library

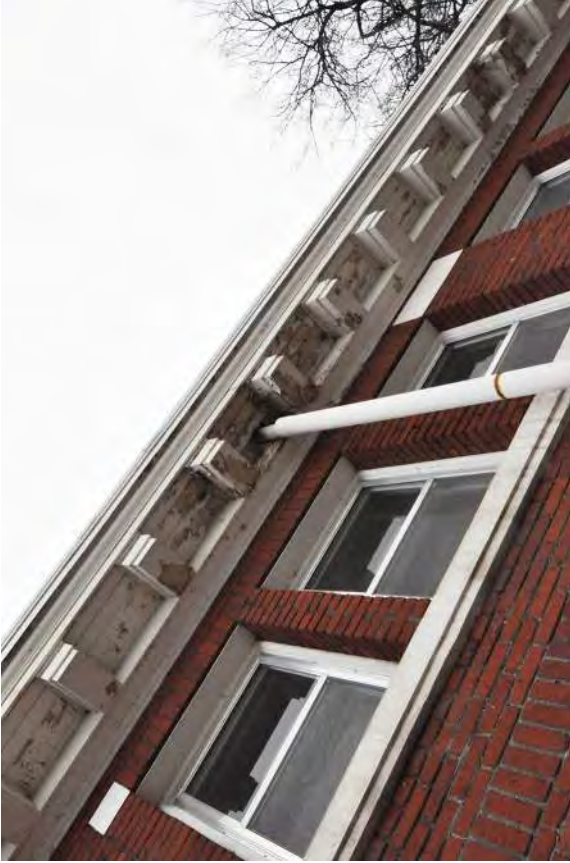
DSC\_0019

Figure 47: The painted wood cornice is damaged due to water leaking from the downspout connections due to blockage and freeze/thaw cycling.  
© Richaven Architecture & Preservation, 2020. DSC\_0019.JPG.
