CITY OF LA GRANDE
Landmarks Commission Regular Session

Thursday, June 8, 2023
6:00 p.m.

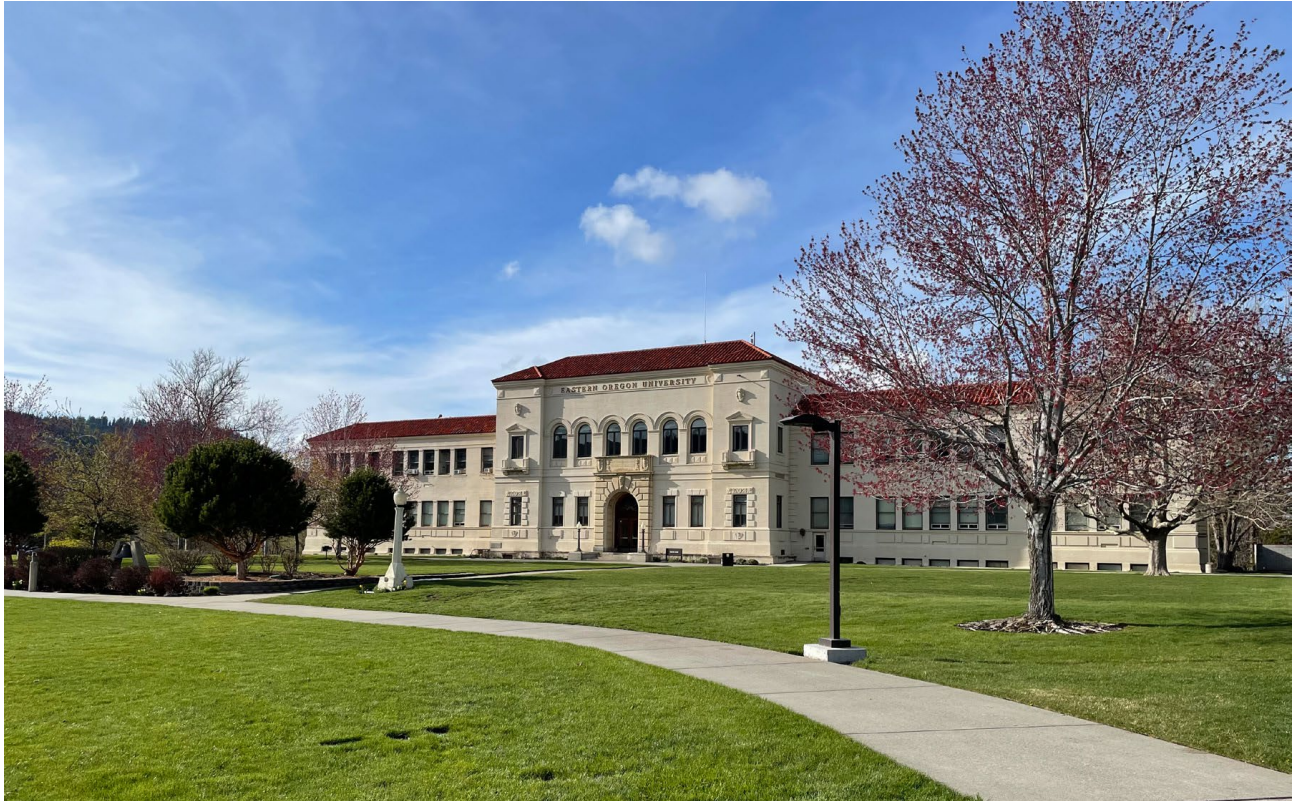
The applicant is requesting a determination of Historic Appropriateness for the Eastern Oregon University, Inlow Hall building restoration project, which includes a full roof replacement, chimney removal, inserting windows in the north elevation concrete archways, replacing all windows, updates to first floor entries and heating elements, reconfiguring the second floor, refinishing the north and south elevation primary entrance doors, repairing Juliet balconies, and limited below grade work for landscaping.

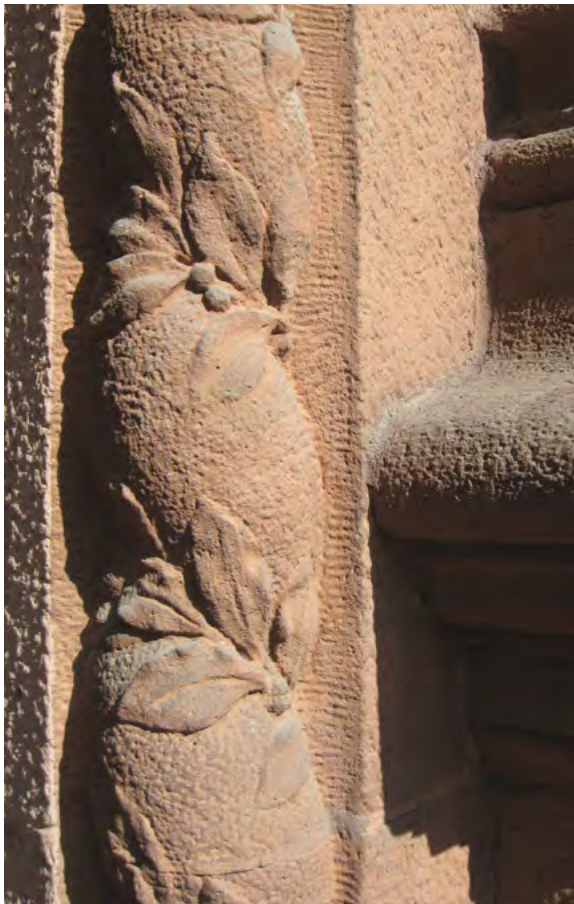
While masonry is one of the most durable historic building materials, it is also very susceptible to damage by exposure, improper maintenance or repairs, abrasive cleaning, or the application of non-permeable coatings.

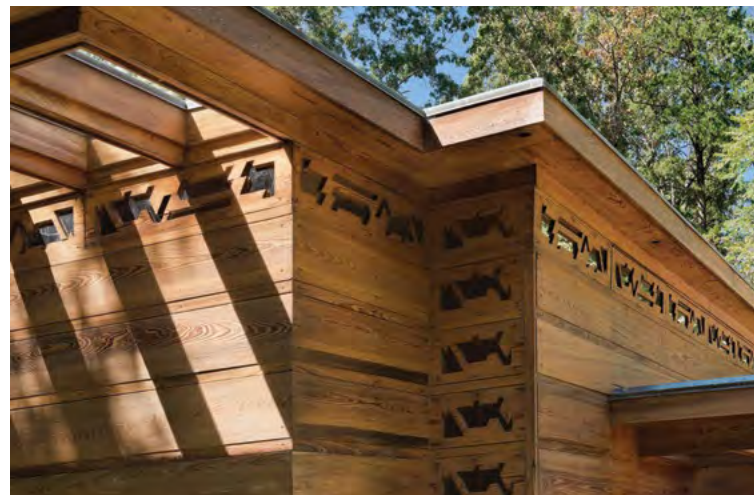
Many historic buildings have wood structural systems and features, such as stairs or columns. The majority of both practical and decorative features, particularly on the interior, are made of wood, such as flooring and paneling.

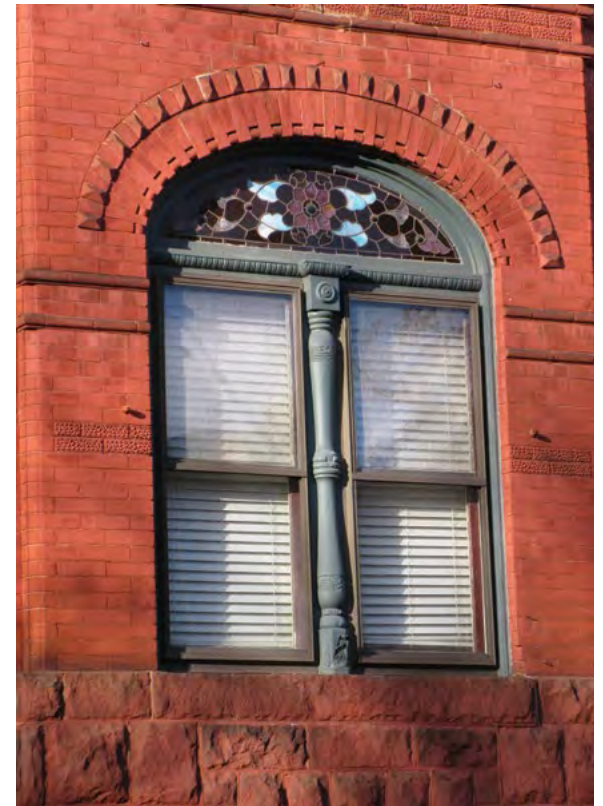
Entrances and Porches

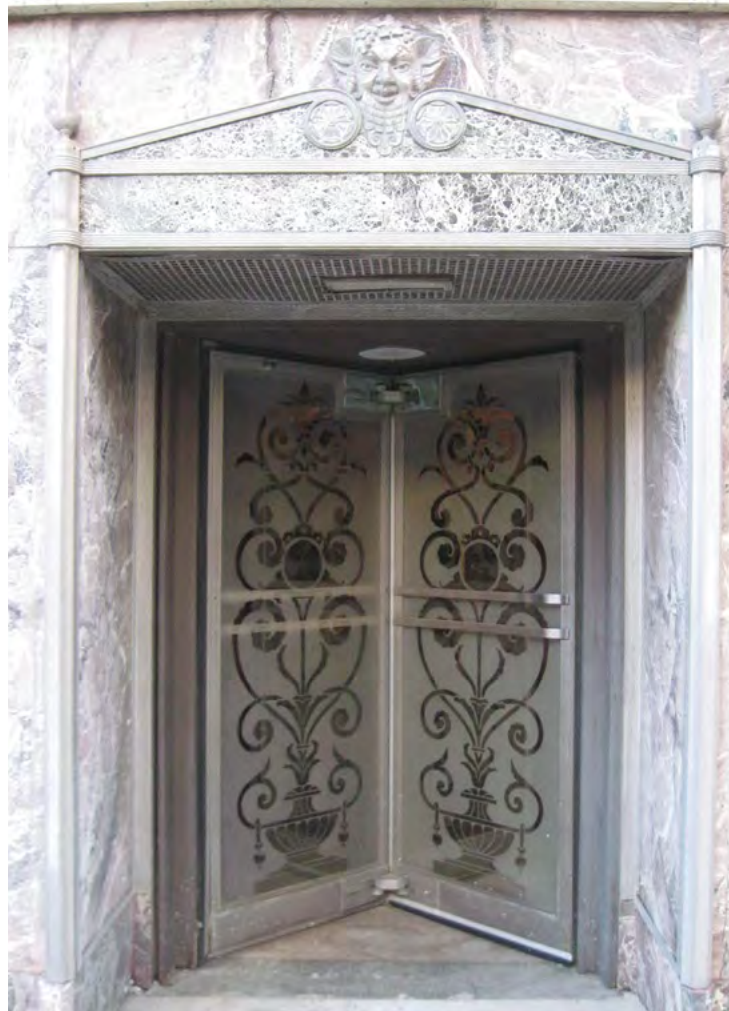
ally, entrances and porches were integral components of a historic building's design; for example, porches on Greek Revival houses, with pediments and Doric or Ionic columns, echoed the architectural elements and features of the building itself. Center, single-bay porches or arcaded porches are evident in Italianate-style buildings of the 1860s. Doors of Renaissance Revival-style buildings frequently featured entablatures or pediments. Porches characterized by lathe-turned porch posts, railings, and balusters were especially prominent and decorative features of Eastlake, Queen Anne, and Stick-style houses. Deep porches on bungalows and Craftsman-style houses of the early 20th century feature tapered posts, exposed posts and beams, rafter tails, and low-pitched roofs with wide overhangs.

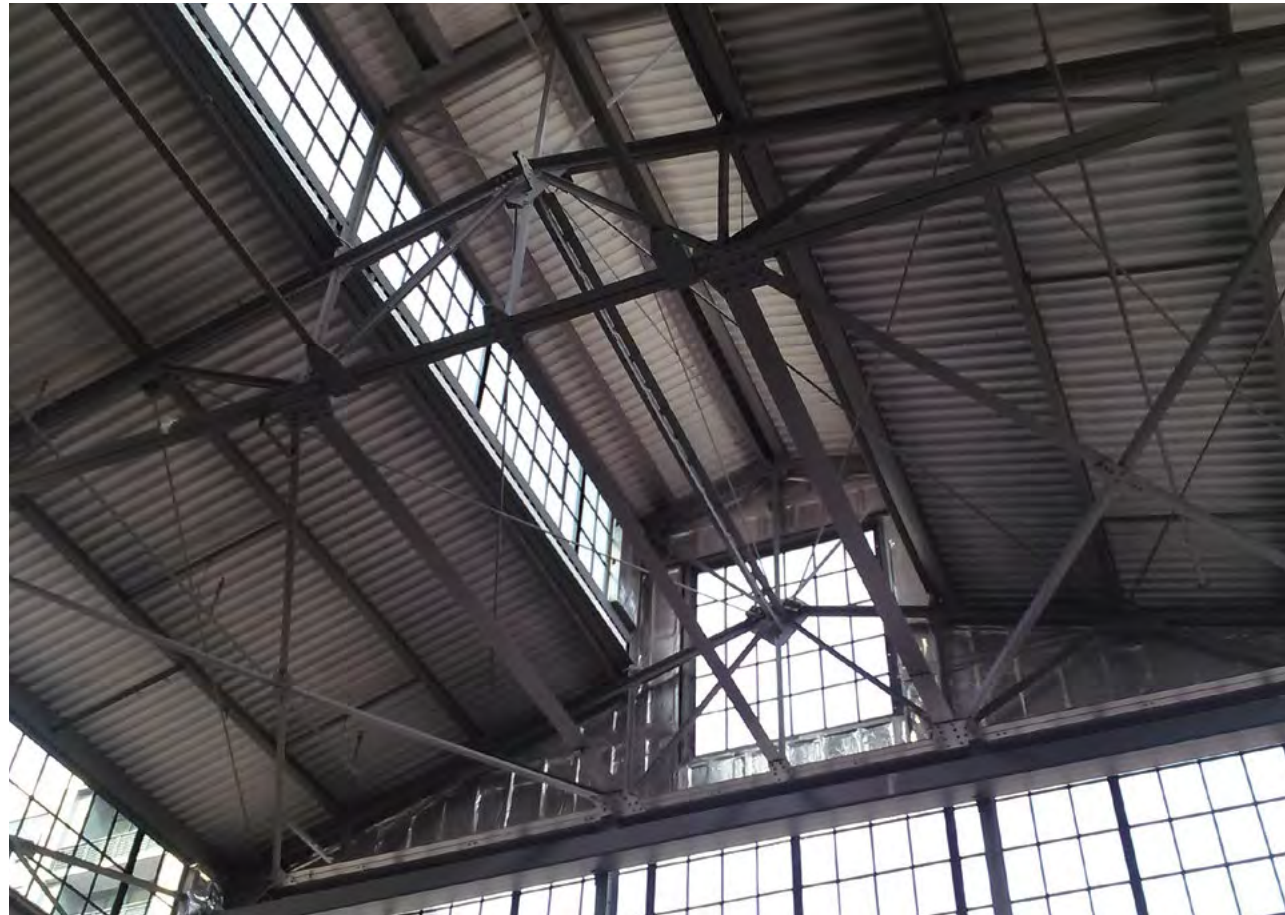
beams, vigas, and outriggers, or masonry foundation walls), they are likely to be important in defining the building's overall historic character. A concealed structural system, although not character defining, may still be significant as an example of historic building technology.

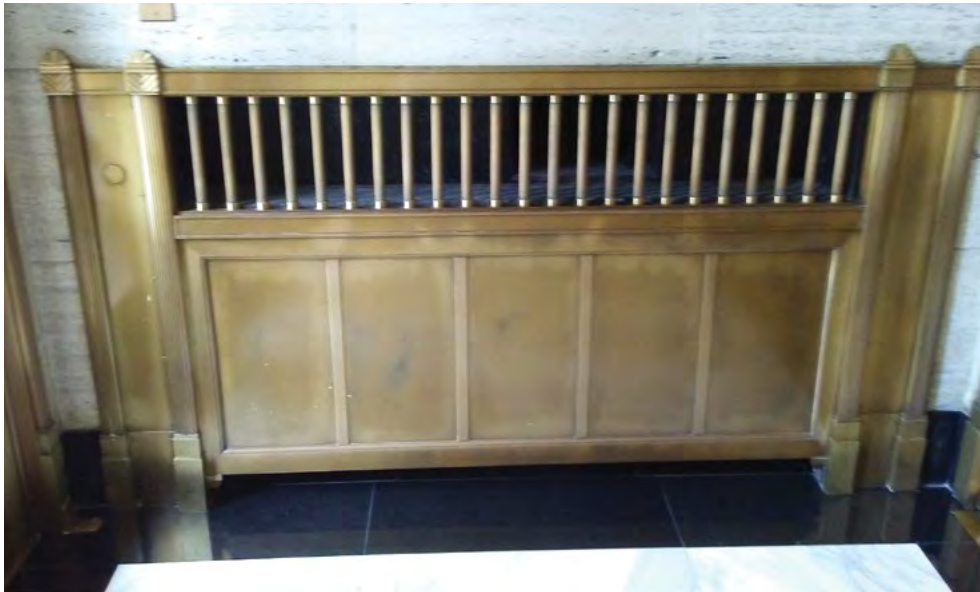
provided both heat and cooling in many buildings. In the late 20th century, as HVAC systems increased in efficiency, they decreased in size, with smaller components, such as split ductless systems with wall-mounted air handlers, cassette ceiling-mounted diffusers, or high-velocity mini duct systems. These systems can be especially useful for retrofitting historic buildings because they are small and unobtrusive. Heat pumps, another late-20th century invention, can help to supplement existing HVAC systems.

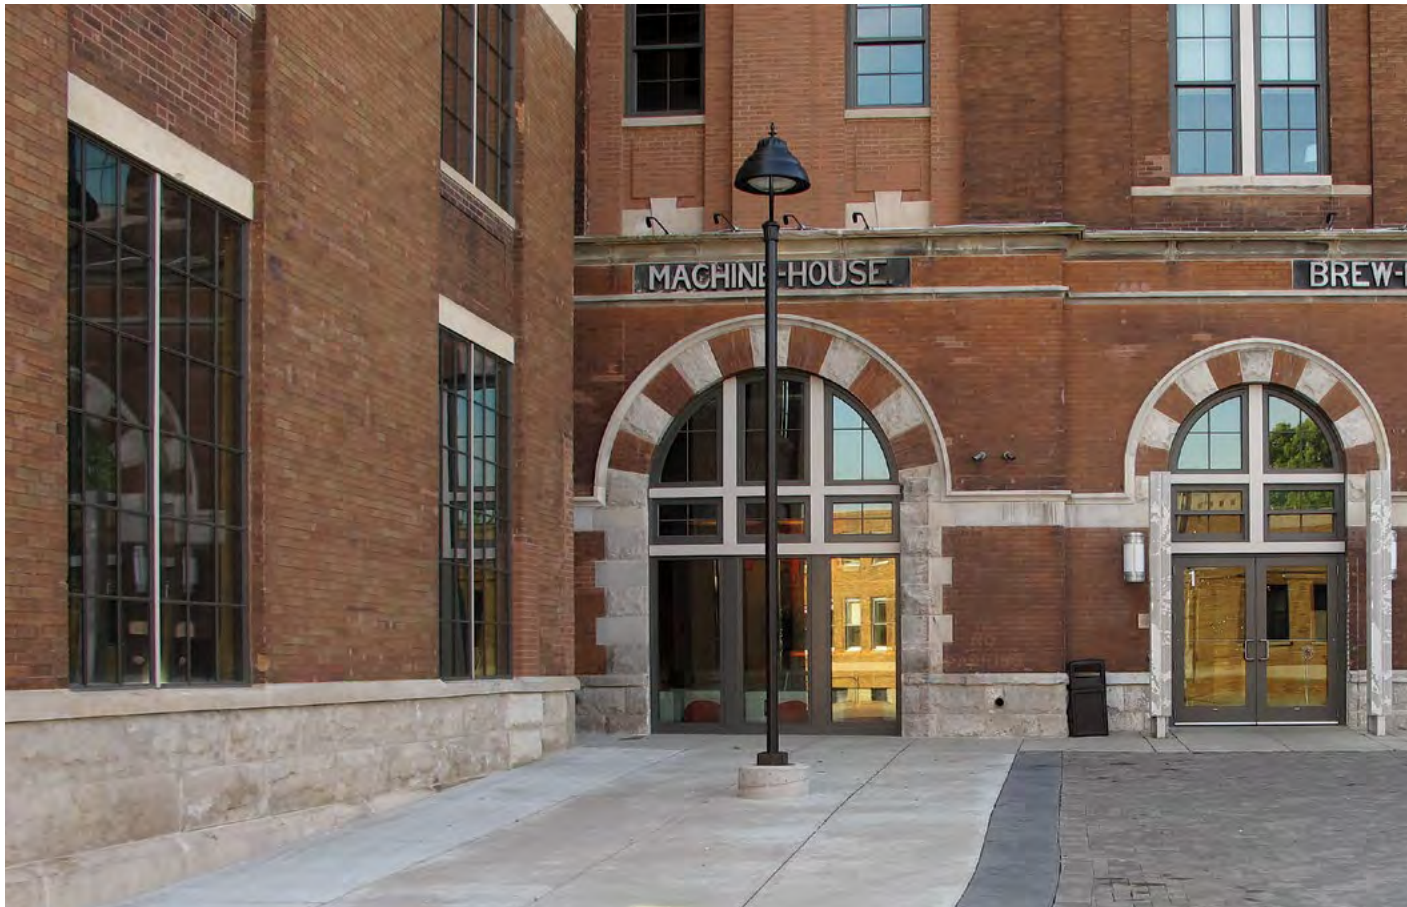
It is often necessary to make modifications to a historic building to make it compliant with accessibility code requirements. Federal rules, regulations, and standards provide guidance on how to make historic buildings accessible. Work must be carefully planned and undertaken in a manner that results in minimal or no loss of historic exterior and interior character-defining spaces, features, or finishes. The goal should be to provide the highest level of access with the least impact to the historic building.

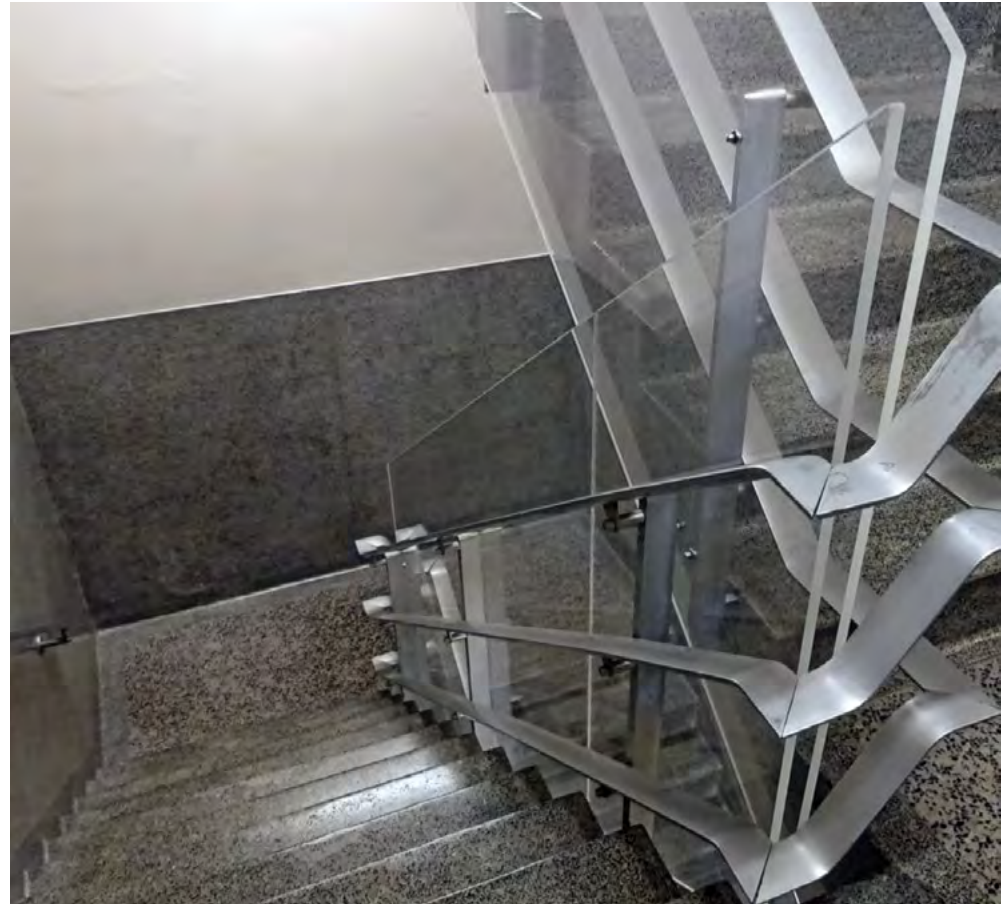
Resilience to Natural Hazards

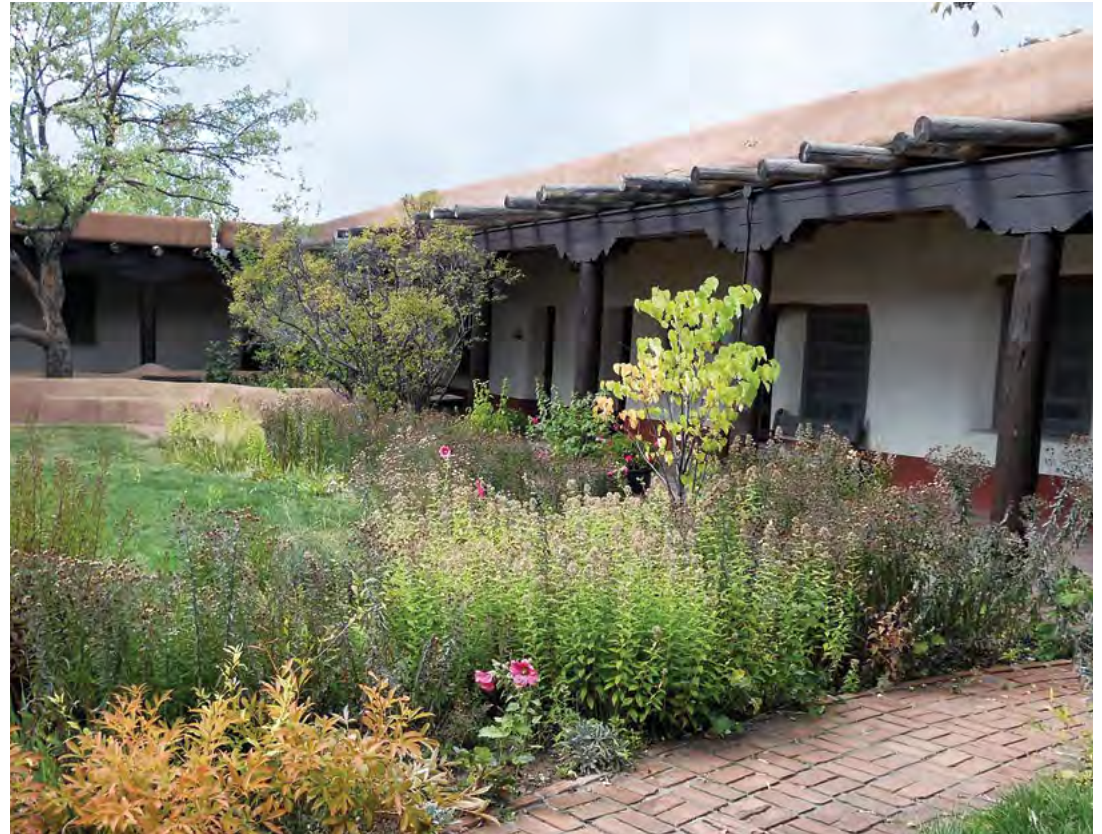
Standards for Preservation

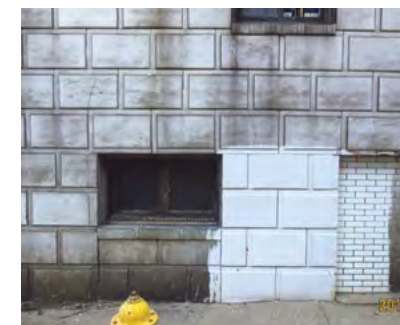
[1] A test patch should always be done before using a chemical cleaner to ensure that it will not damage historic masonry, as in this instance, terra cotta.

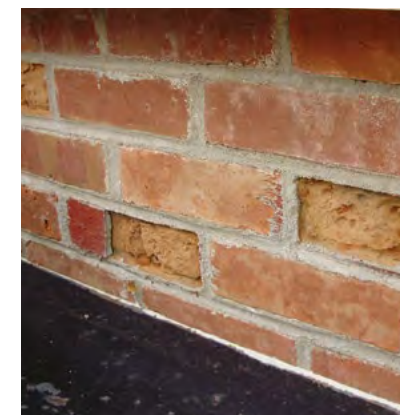
[2] **Not Recommended:** The use of inappropriate Portland cement mortar to repoint these soft 19th-century bricks has caused some of them to spall. *Photo: Courtesy Nebraska State Historic Preservation Office.*

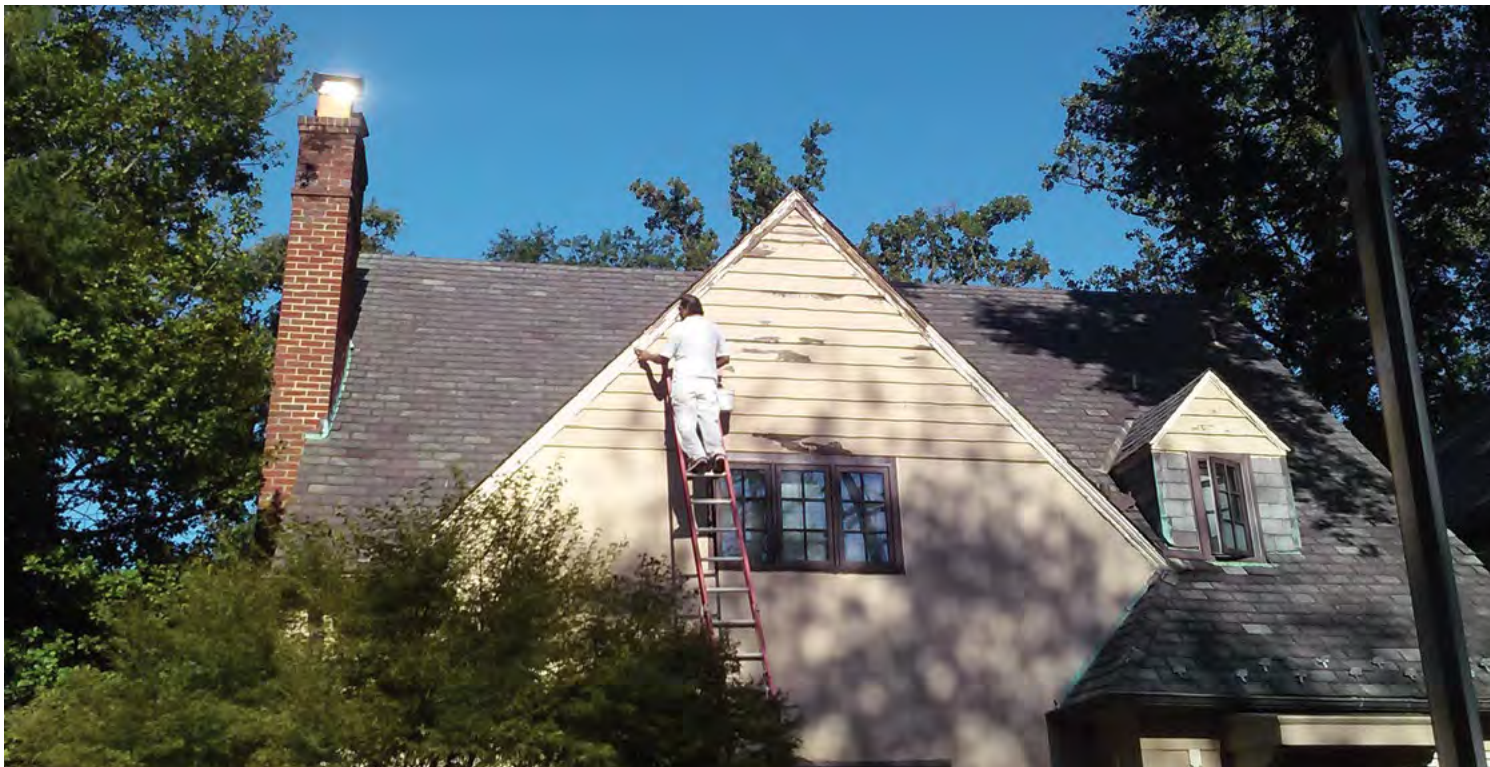
[4] Hand scraping to remove peeling paint from wood siding in preparation for repainting is an important part of regularly-scheduled maintenance.

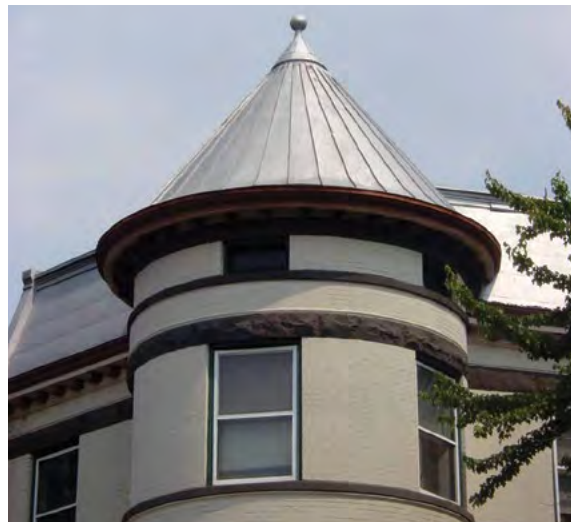
METALS: WROUGHT AND CAST IRON, STEEL, PRESSED METAL, TERNEPLATE, COPPER, ALUMINUM, AND ZINC

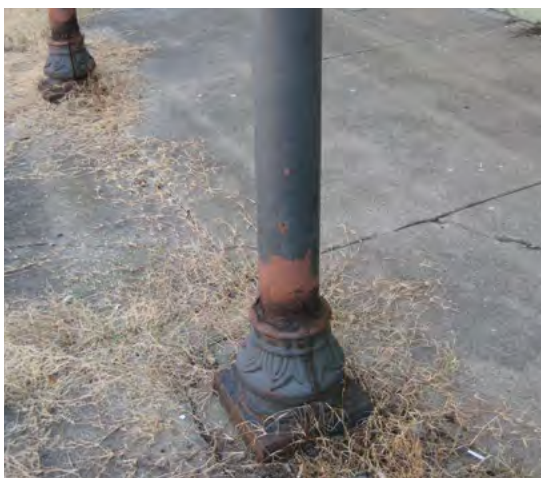
[7] (a) After the damaged portions of the base were repaired, (b) the cast-iron columns were cleaned and repainted to protect the metal from rusting.

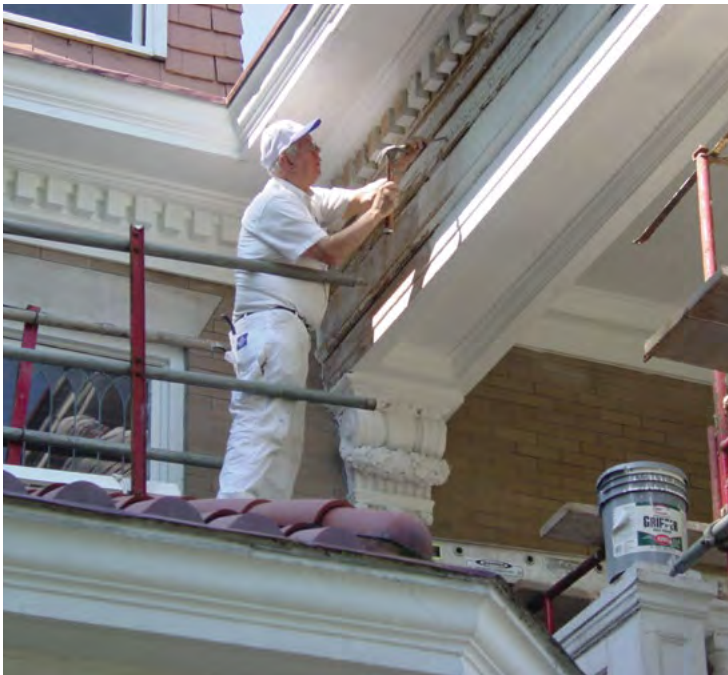
[12] Repair and limited replacement in kind to match deteriorated wood porch features is always a recommended preservation treatment.

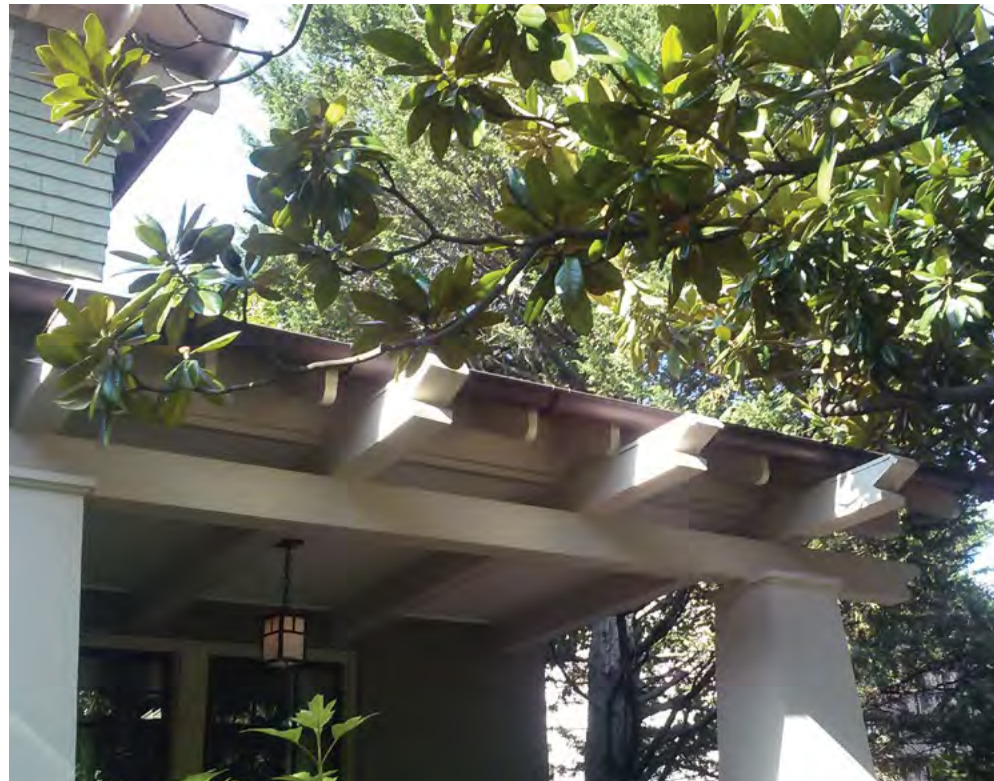
ENTRANCES AND PORCHES

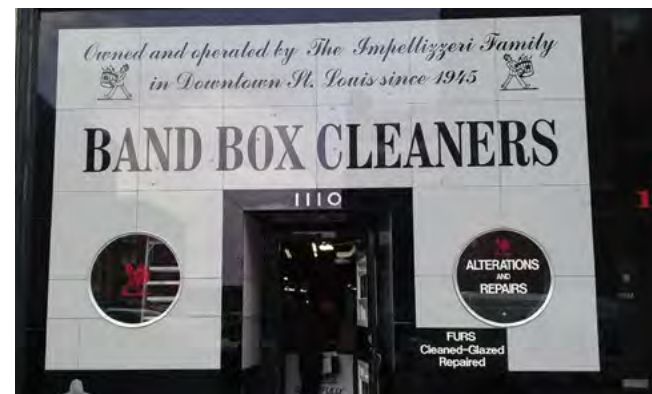
[14] The signage is an original and integral part of this historic Carrara glass storefront.

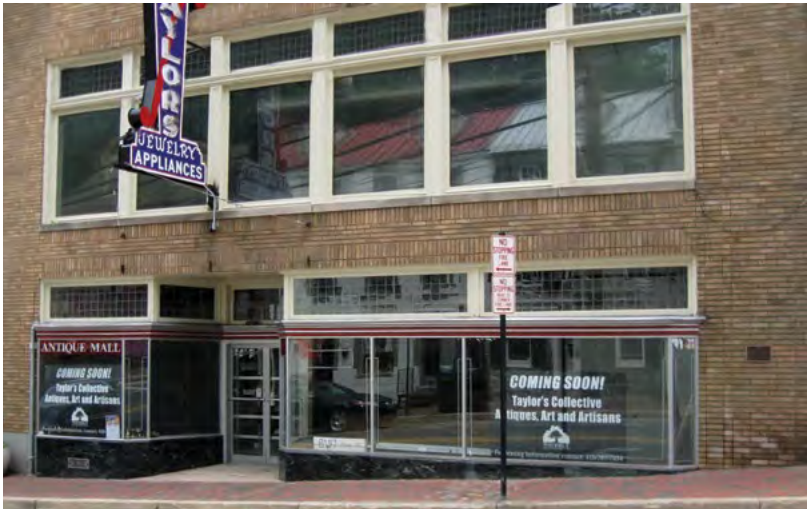
[15] Regular maintenance has helped to preserve this historic storefront, which retains all of its character-defining features, including the granite bulkhead, multi-paned transom glazing, and recessed entrance.

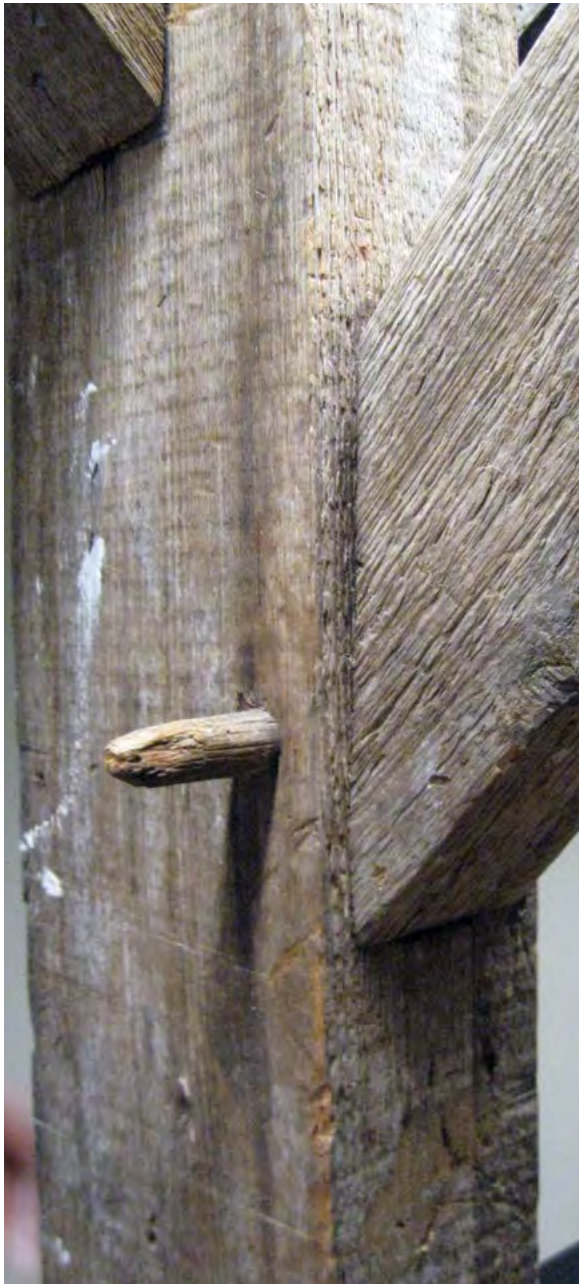
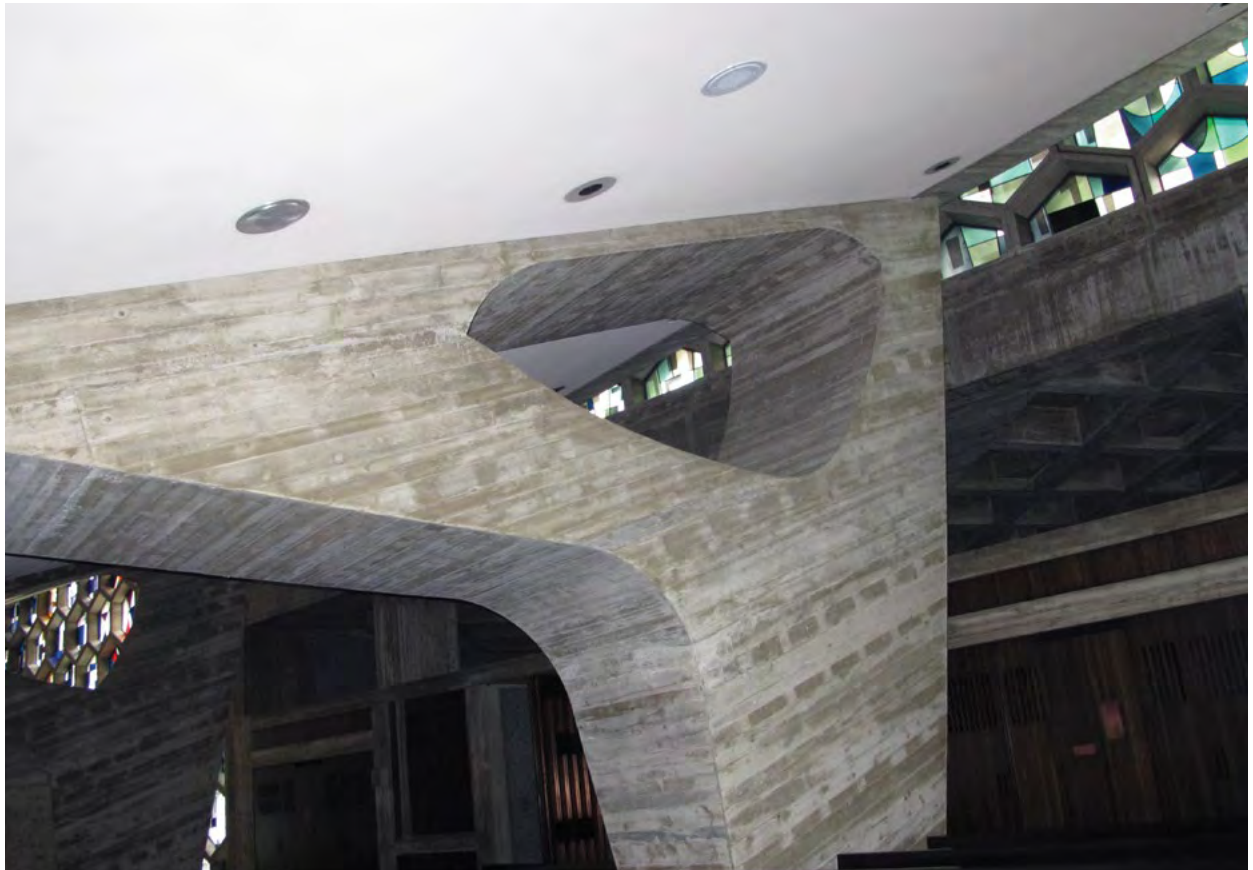
[17] Distinctive examples of traditional construction techniques should be preserved, such as this wooden peg, which is part of the structural system of this late-19th-century warehouse.

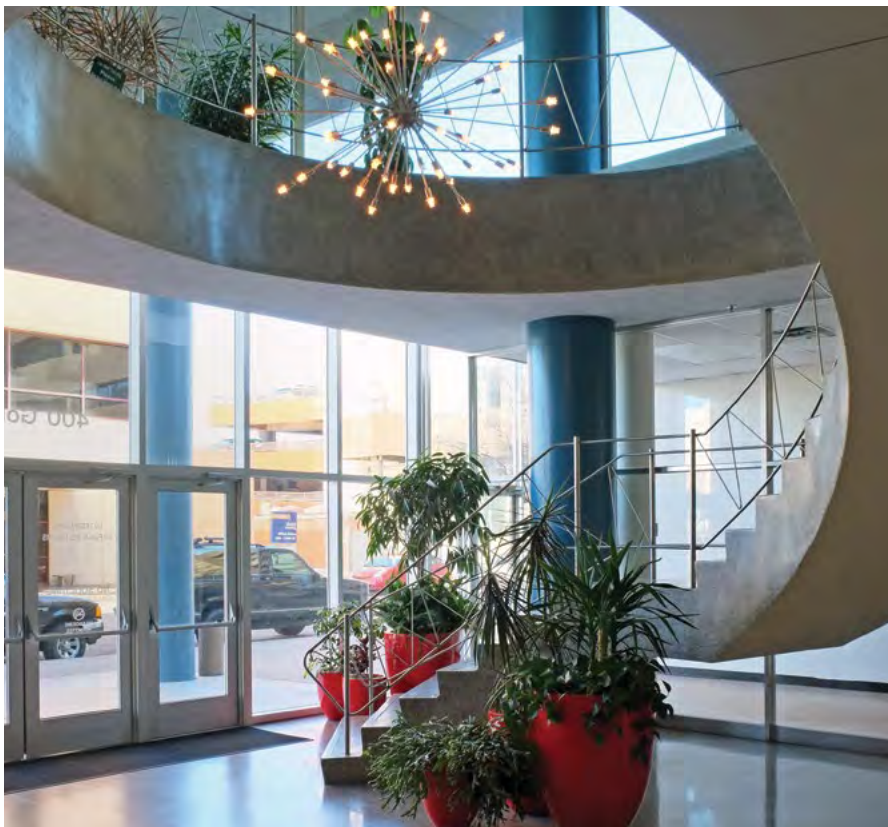
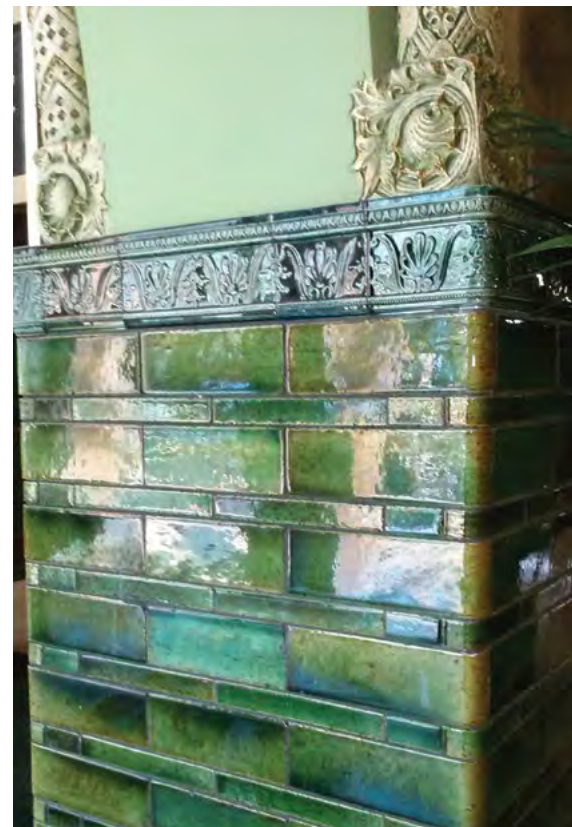
[19] The sweeping staircase with its metal railing, chandelier, and terrazzo floor in the lobby of the 1954 Simms Building, Albuquerque, NM, are character-defining features. *Photo: Harvey M. Kaplan.*

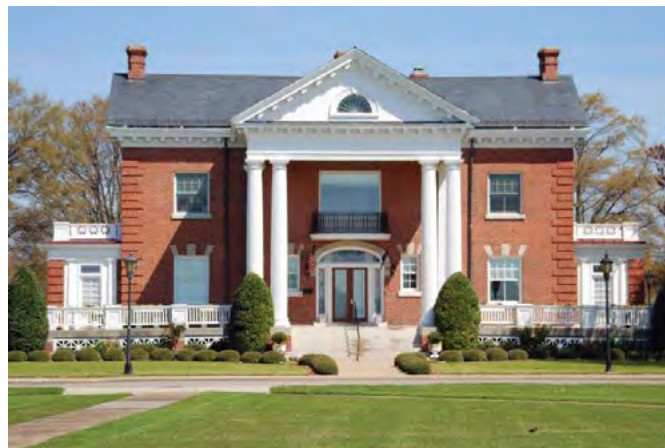
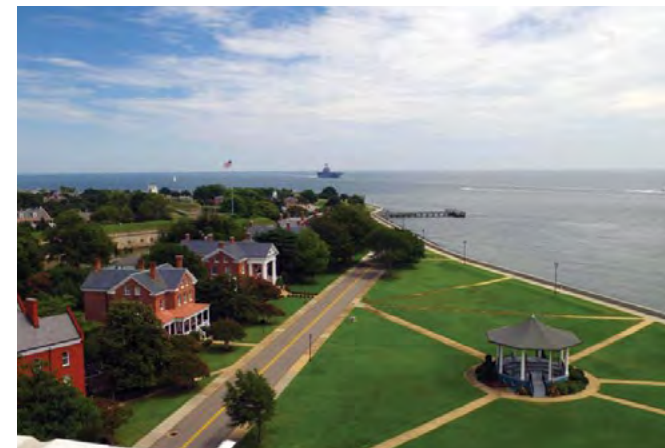
SETTING (DISTRICT / NEIGHBORHOOD)

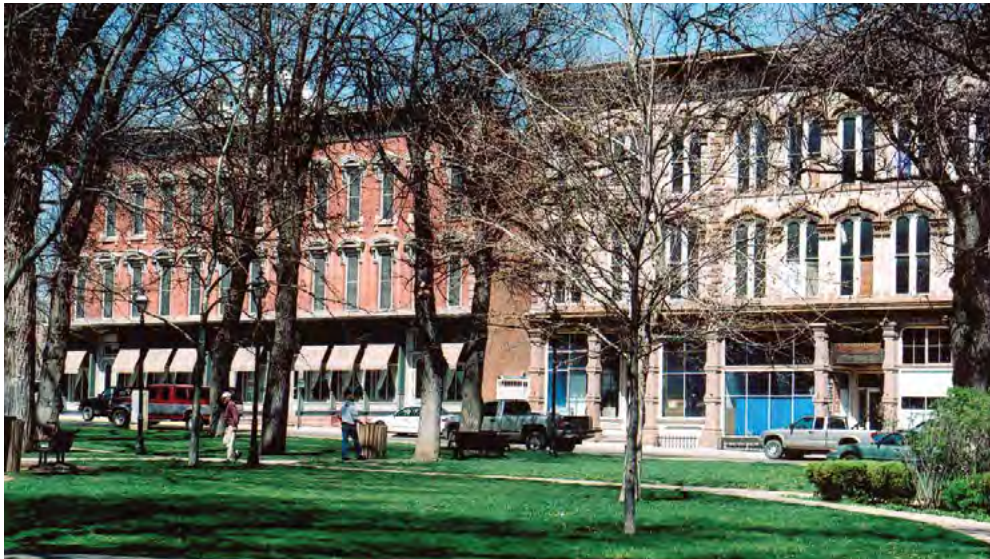
[23] The city square is important in defining the character of the historic setting in this small town.

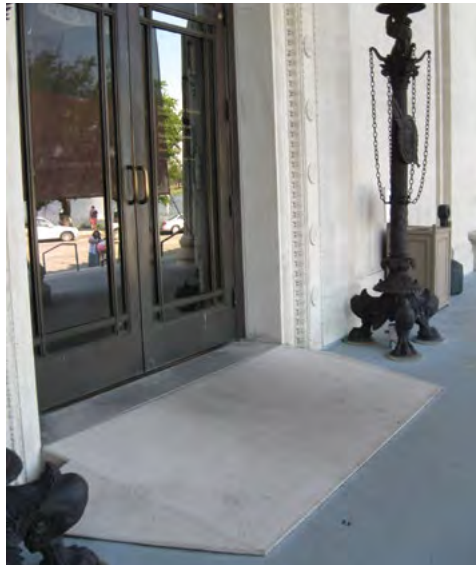
[27] The access ramp at the left of the entrance is concealed by a hedge which minimizes its visibility and impact on the character of the historic apartment building.

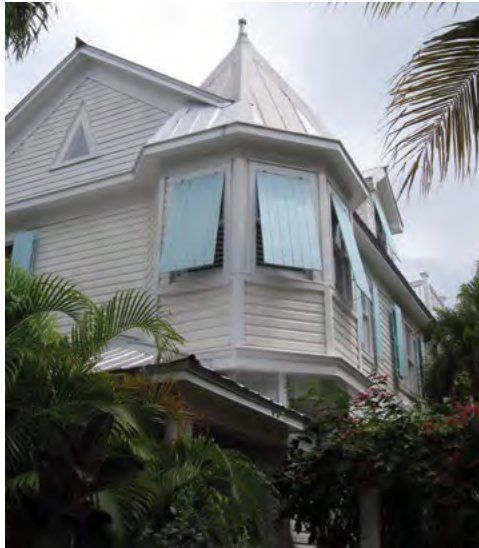
[30] Historic window shutters still serve their original function as protection in hurricane-prone areas.

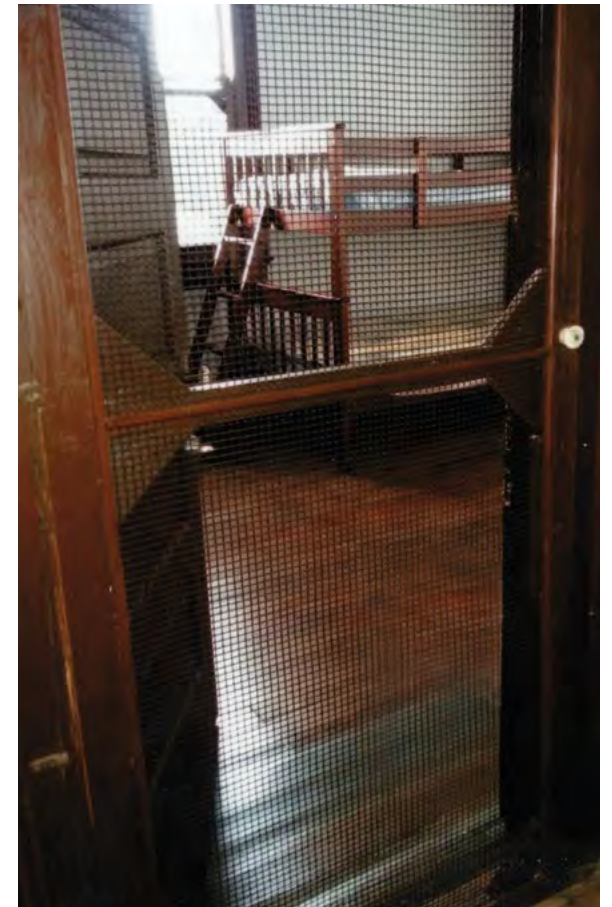
[31] An interior screen door at the entrance to individual apartments is a historic feature traditionally used to help circulate air throughout the building.

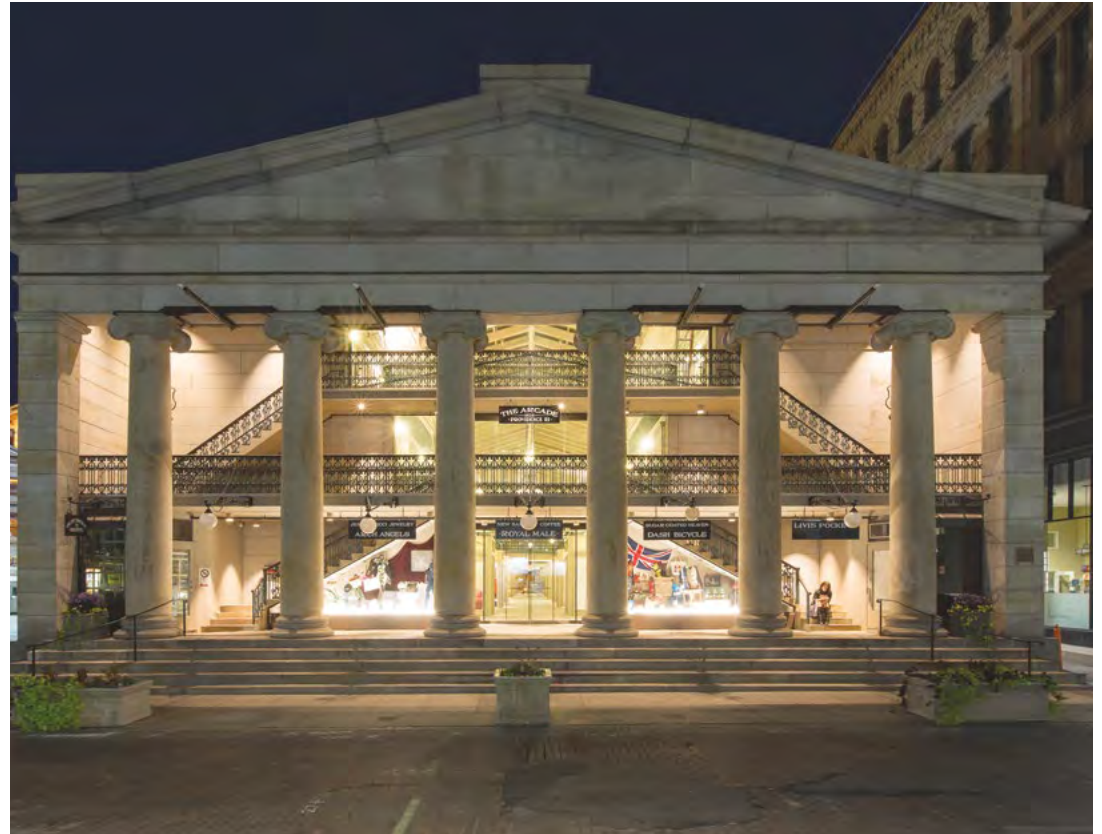
Standards for Rehabilitation

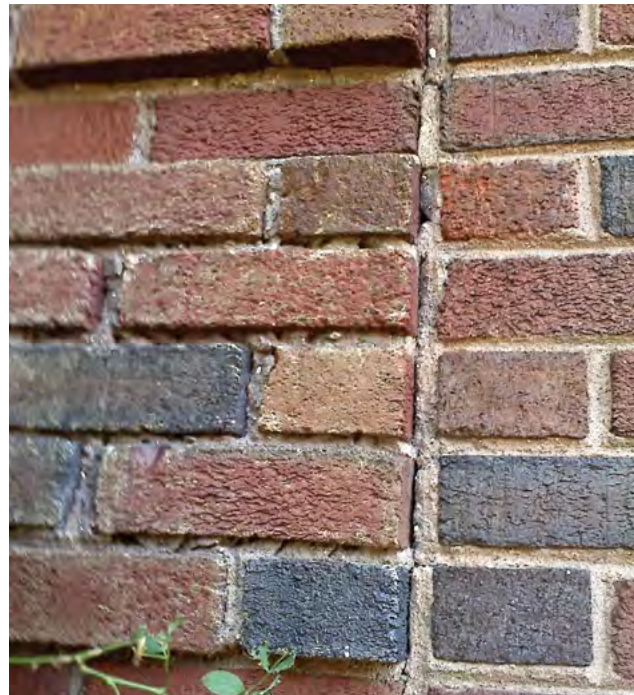
[4] Not Recommended:
The quoins on the left side of the photo show that high-pressure abrasive blasting used to remove paint can damage even early 20th-century, hard-baked, textured brick and erode the mortar, whereas the same brick on the right, which was not abrasively cleaned, is undamaged.

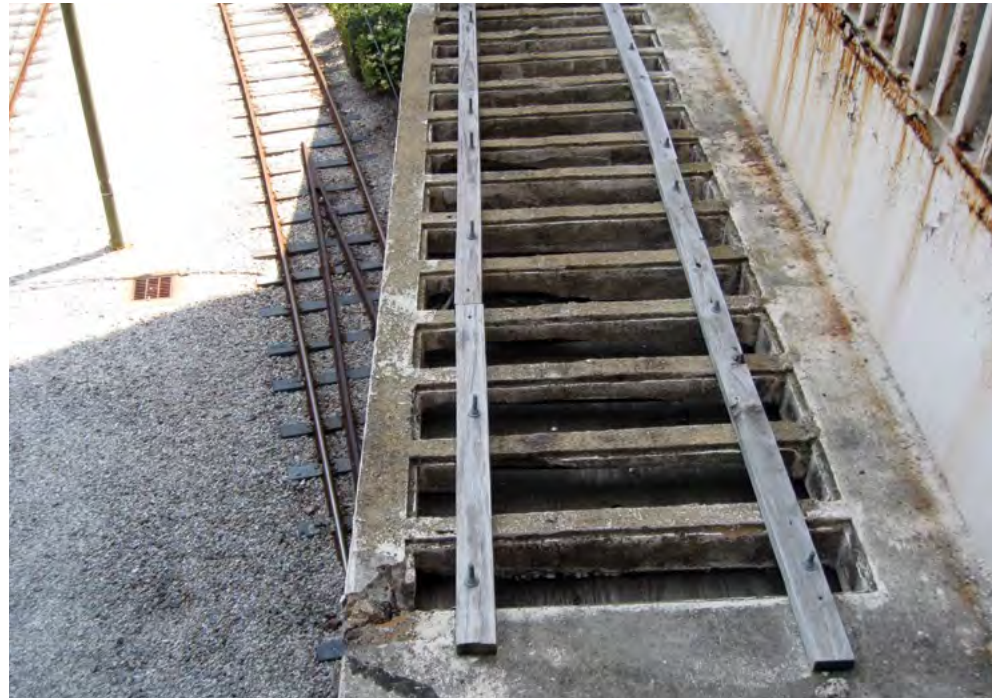
[6] Some areas of the concrete brise soleil screen on this building constructed in 1967 are badly deteriorated. If the screen cannot be repaired, it may be replaced in kind or with a composite substitute material with the same appearance as the concrete.

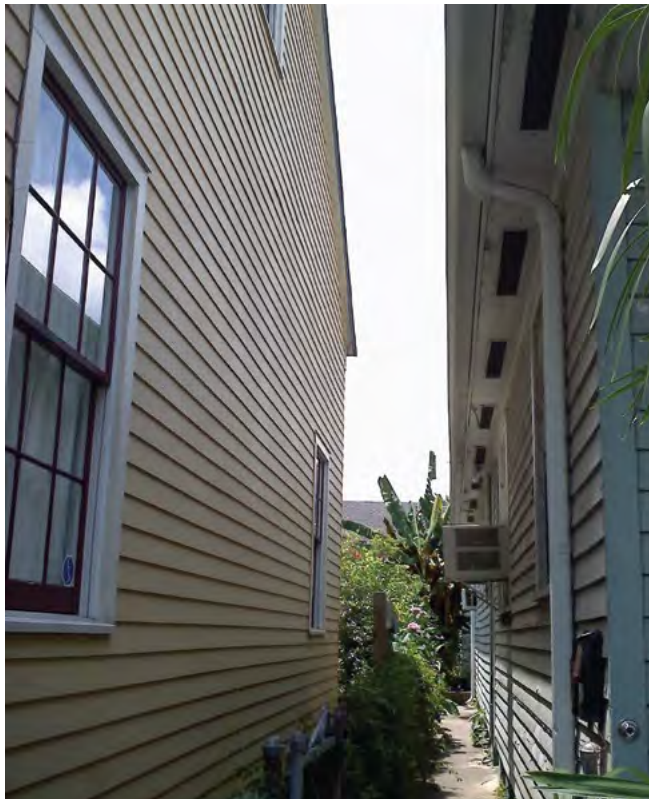
[9] Smooth-surfaced cementitious siding (left) may be used to replace deteriorated wood siding only on secondary elevations that have minimal visibility.

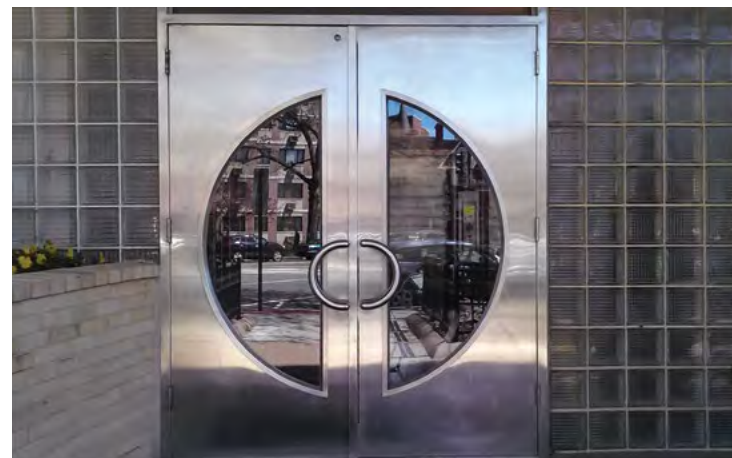
METALS: WROUGHT AND CAST IRON, STEEL, PRESSED METAL, TERNEPLATE, COPPER, ALUMINUM, AND ZINC

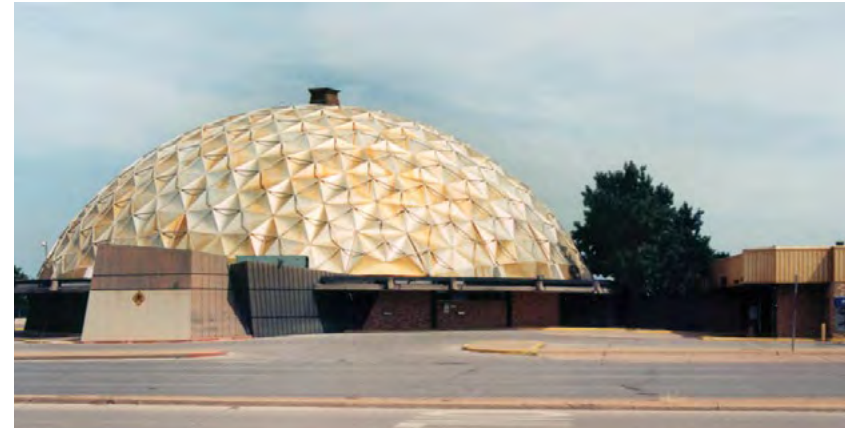
[13] The gold-colored, anodized aluminum geodesic dome of the former Citizen's State Bank in Oklahoma City, OK, built in 1958 and designed by Robert Roloff, makes this a distinctive mid-20th century building.

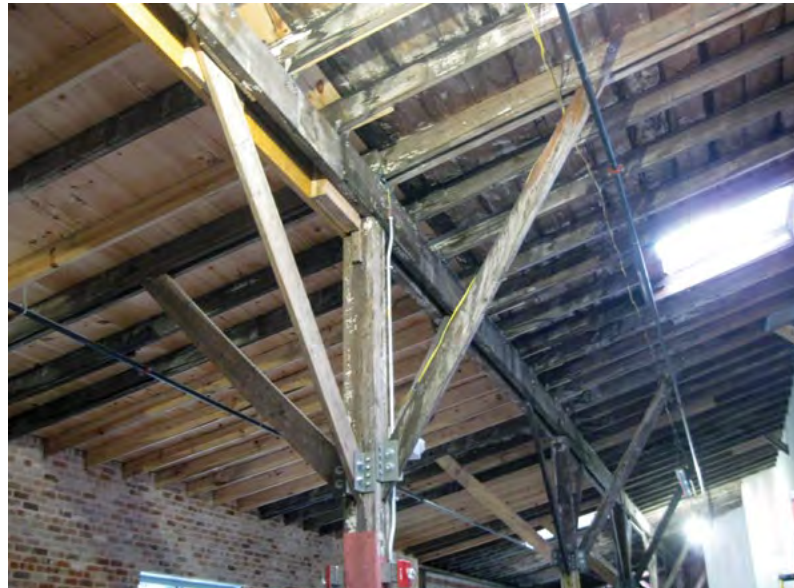
[17] New wood elements have been used selectively to replace rotted wood on the underside of the roof in this historic warehouse.
