CITY OF LA GRANDE
Landmarks Commission Regular Session

Thursday, June 8, 2023
6:00 p.m.

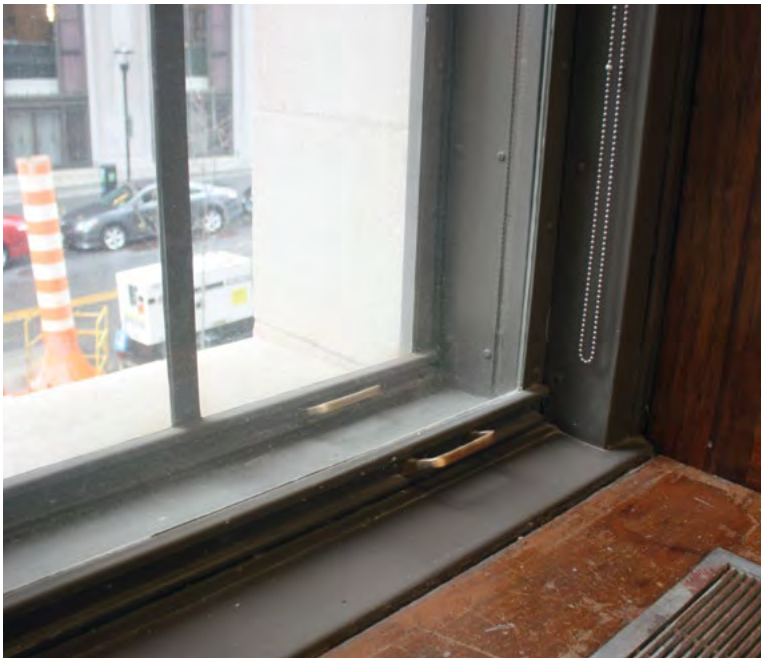
[18] The historic metal storm windows in this 1920s office building were retained and repaired during the rehabilitation project.

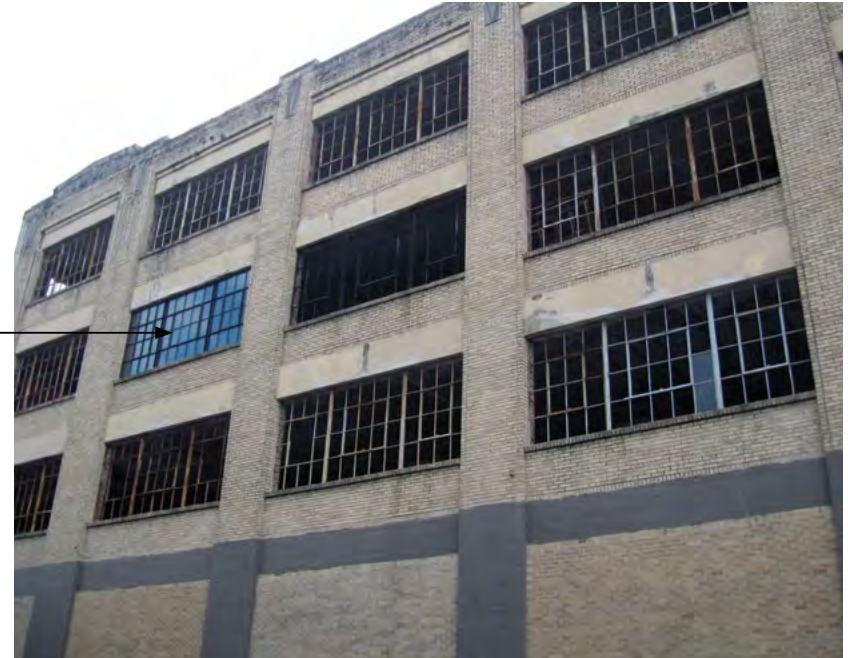
[19] Installing a mockup of a proposed replacement window can be helpful to evaluate how well the new windows will match the historic windows that are missing or too deteriorated to repair.

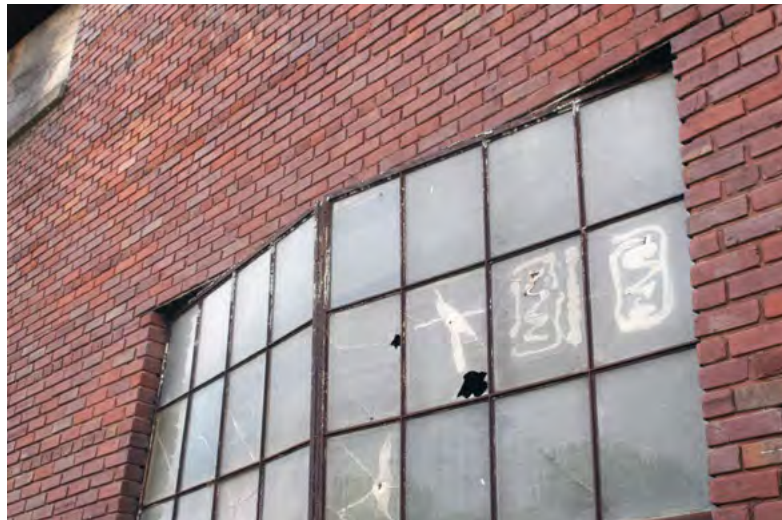
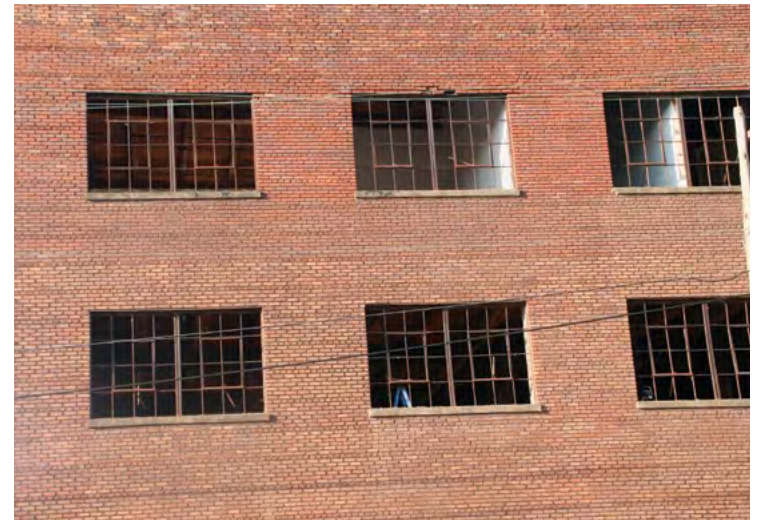
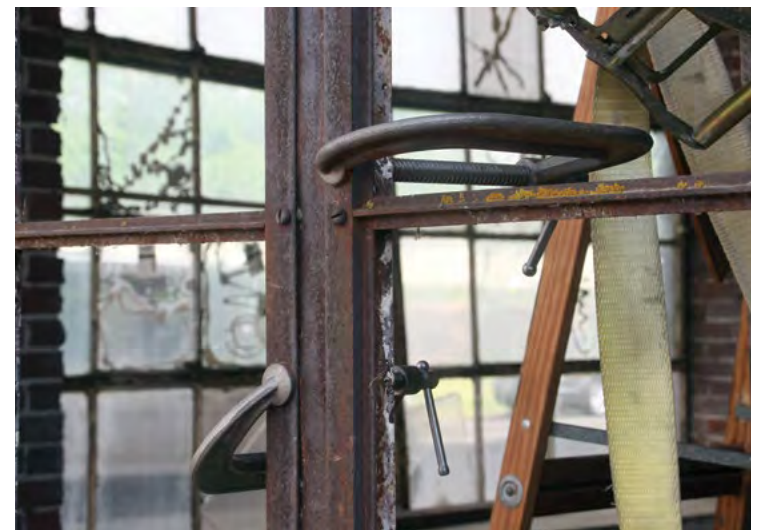
[20 a-d] The original steel windows in this industrial building were successfully repaired as part of the rehabilitation project (left).

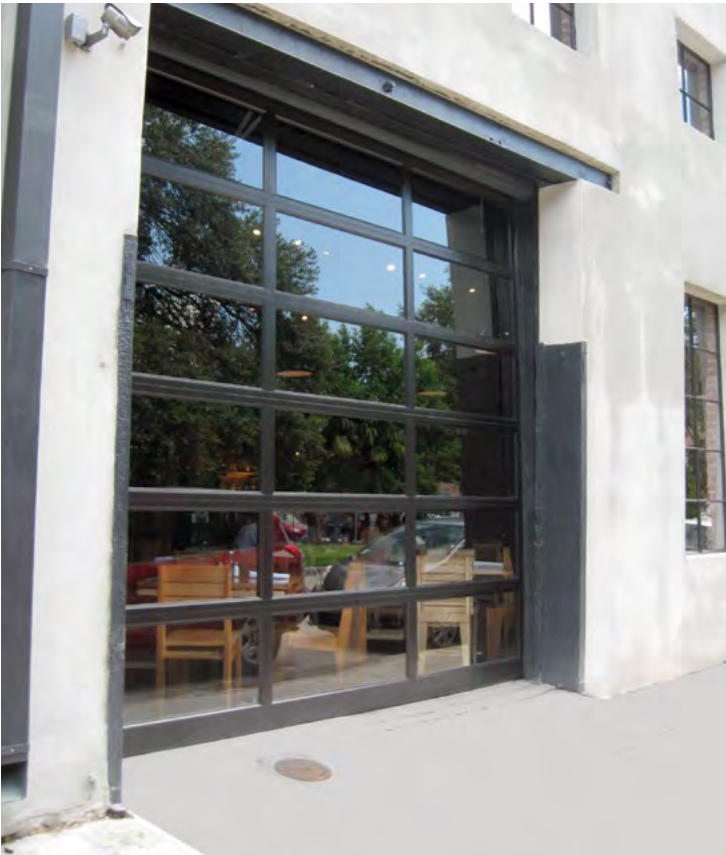
[25] The new infill designs for the garage door openings in this commercial building (a) converted for restaurant use and in this mill building (b) rehabilitated for residential use are compatible with the historic character of the buildings.

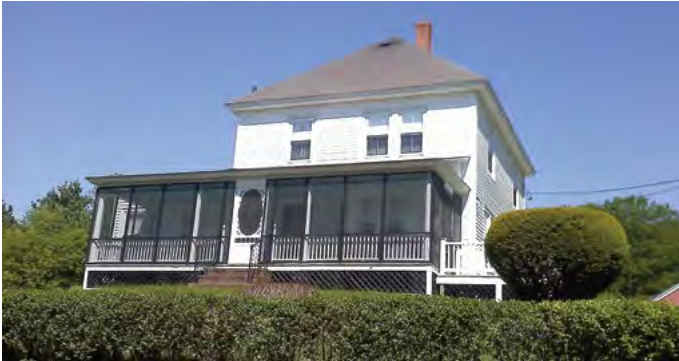
[26] **Not Recommended:** Installing a screened enclosure is never recommended on a front or otherwise prominent historic porch. In limited instances, it may be possible to add screening on a porch at the rear or on a secondary façade; however, the enclosure should match the color of the porch and be placed behind columns and railings so that it does not obscure these features.

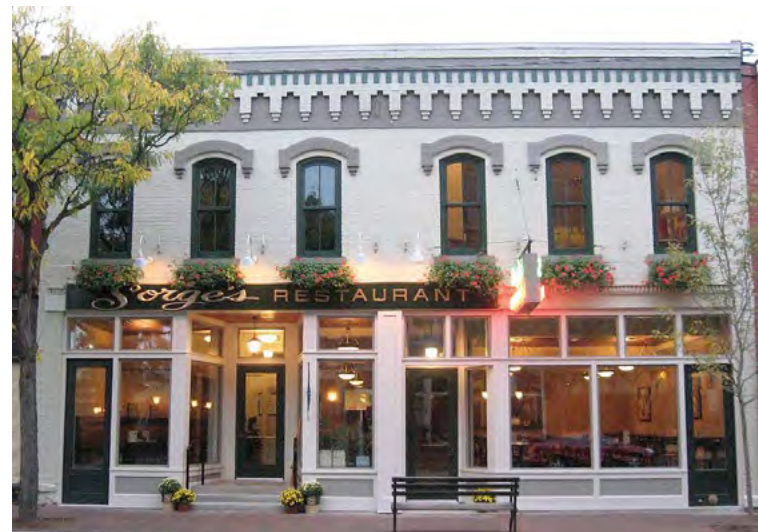
[28] This new storefront, which replaced one that was missing, is compatible with the historic character of the building.

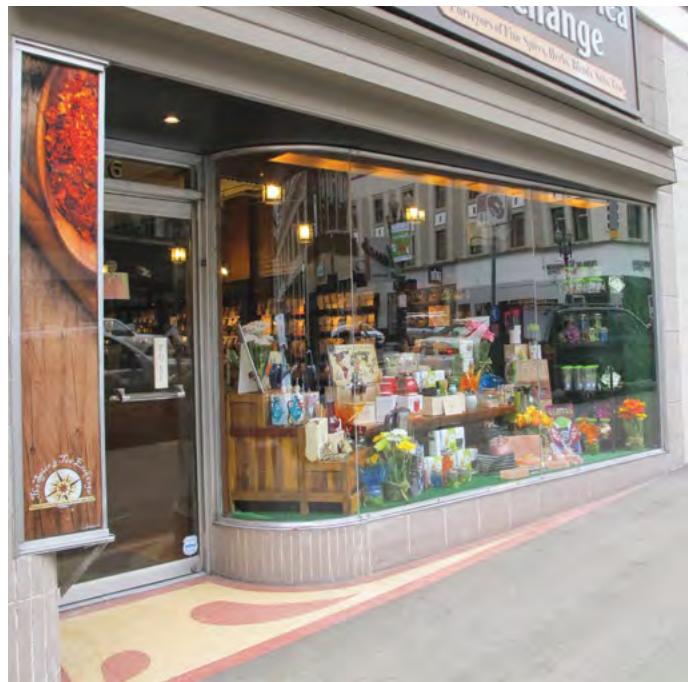
[27] This original c. 1940s storefront, with its character-defining angled and curved glass display window and recessed entrance with a decorative terrazzo paving, is in good condition and should be retained in a rehabilitation project.

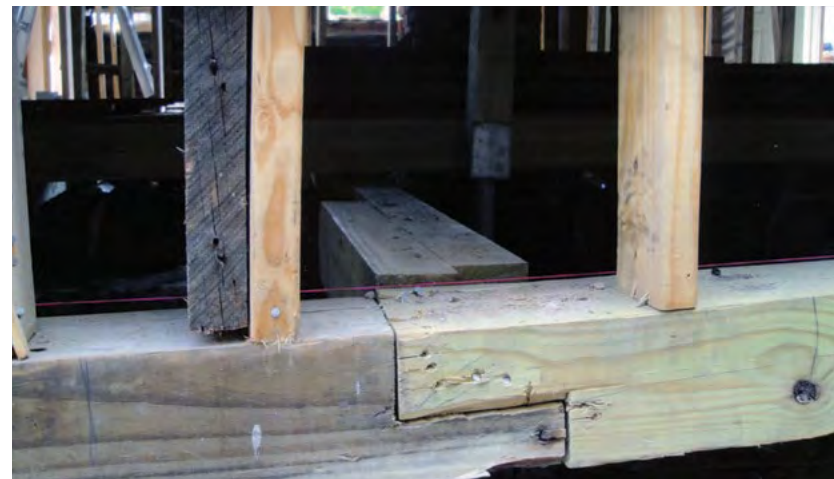
[33] Retaining as much as possible of the historic wood sill plate and replacing only the termite-damaged wood is always the preferred and recommended treatment.

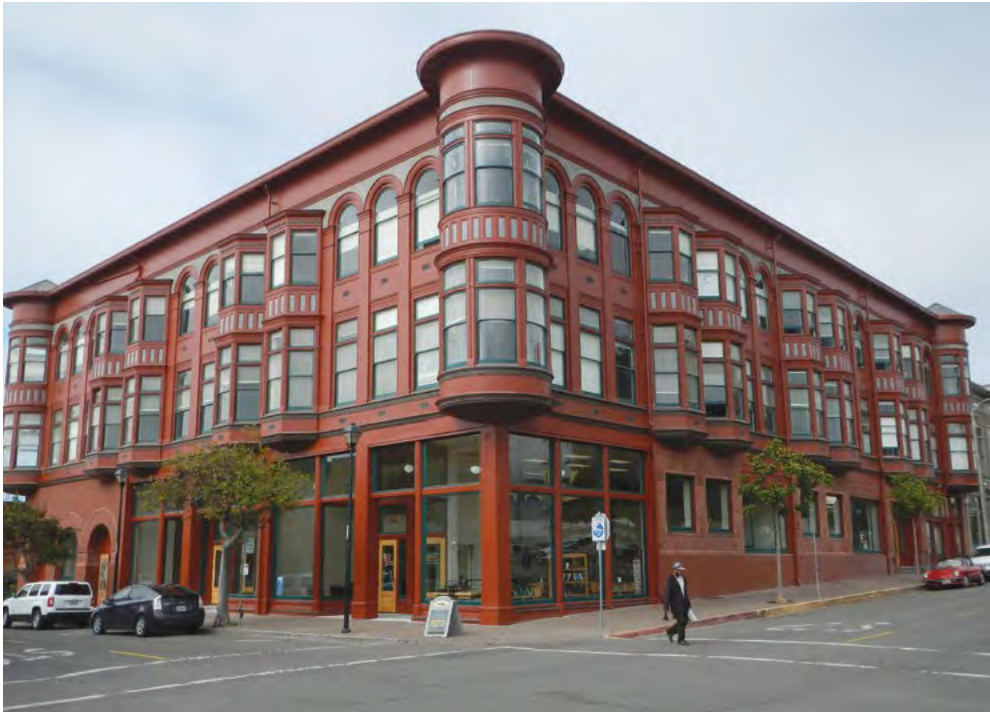
[32] (a-b) The rehabilitation of the 1892 Carson Block Building in Eureka, CA, for its owner, the Northern California Indian Development Council, included recreating the missing corner turret and sensitively introducing seismic reinforcement (c) shown here (opposite page) in a secondary upper floor office space. Photos: Page & Turnbull.

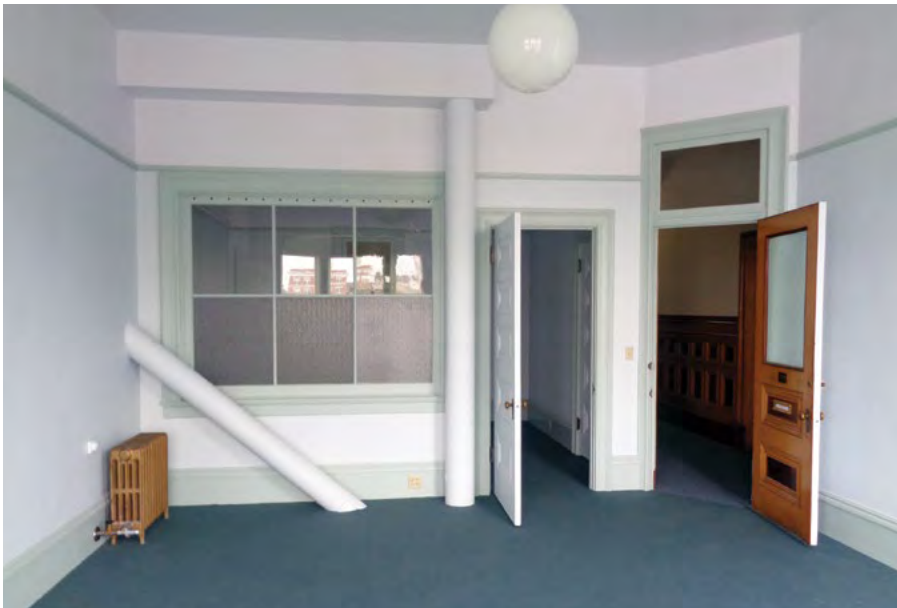
Replacing to match any interior features or finishes that may have to be removed to gain access to make structural repairs, and reusing salvageable material.

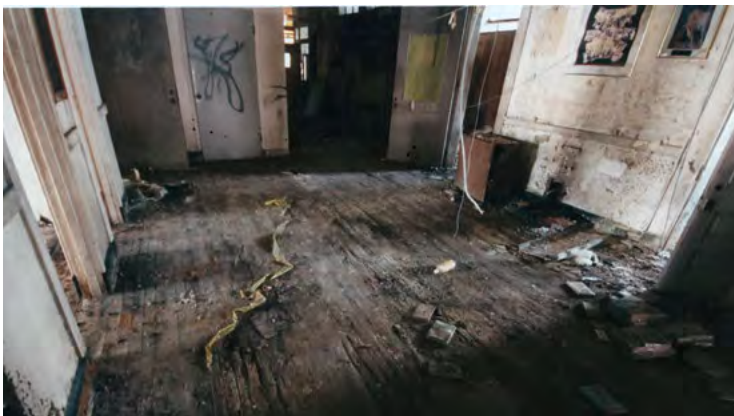
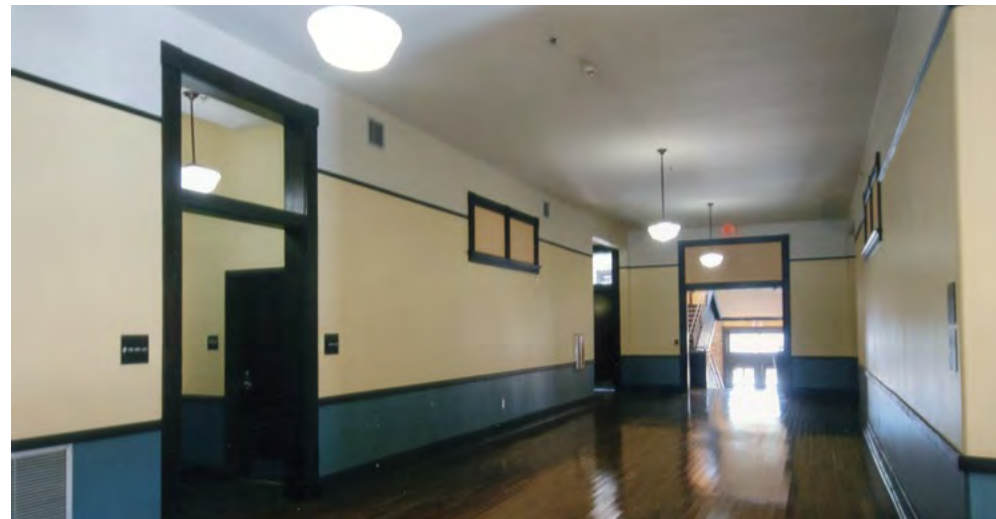
[35] (a) Although deteriorated, the historic school corridor, shown on the left, with its character-defining features, including doors and transoms, was retained and repaired as part of the rehabilitation project (b).

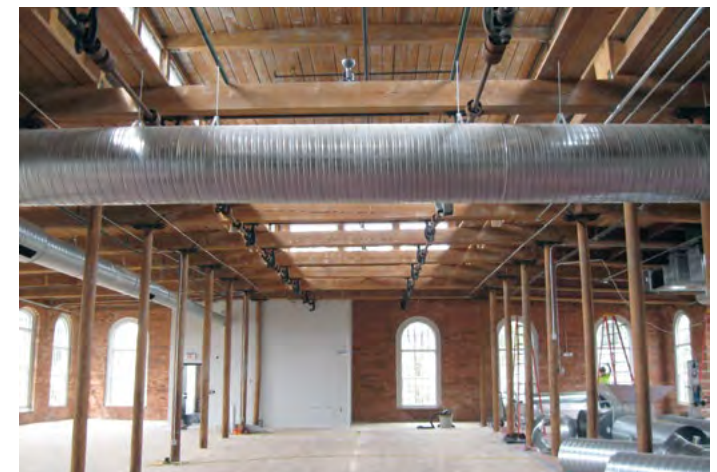
INTERIOR SPACES, FEATURES, AND FINISHES

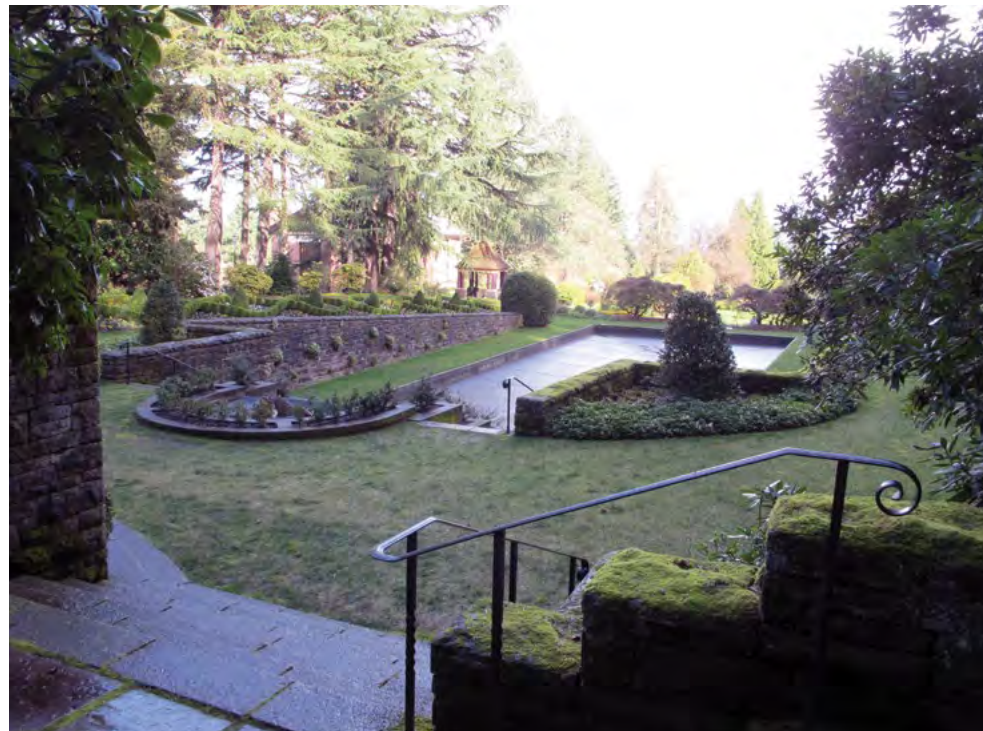
[42] This garden is an important character-defining landscape feature on this college campus.

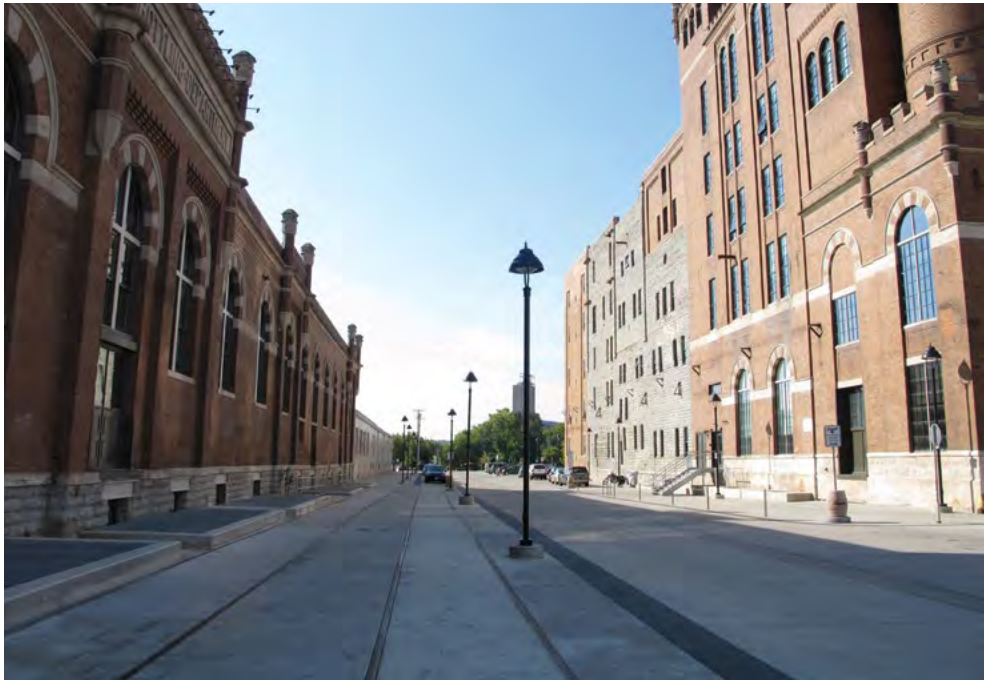
[43] The industrial character of the site was retained when this brewery complex was rehabilitated for residential use.

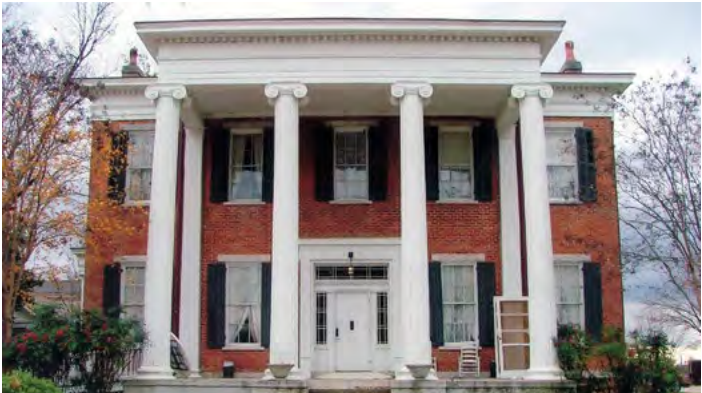
[44] **Not Recommended:** (a-b) The historic character of this plantation house (marked in blue on plan on opposite page) and its site was diminished and adversely impacted when multiple new buildings like this (#3 on plan) were constructed on the property (c).

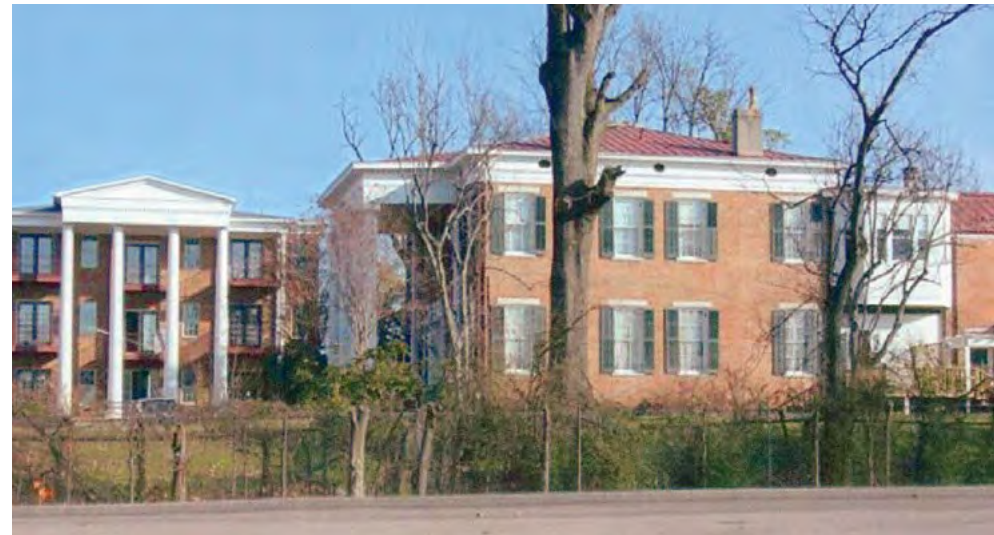
Adding conjectural landscape features to the site (such as period reproduction light fixtures, fences, fountains, or vegetation) that are historically inappropriate, thereby creating an inaccurate appearance of the site.

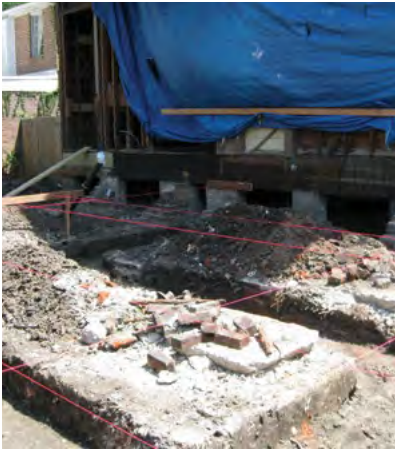
[45] Undertaking a survey to document archeological resources may be considered in some rehabilitation projects when a new exterior addition is planned.

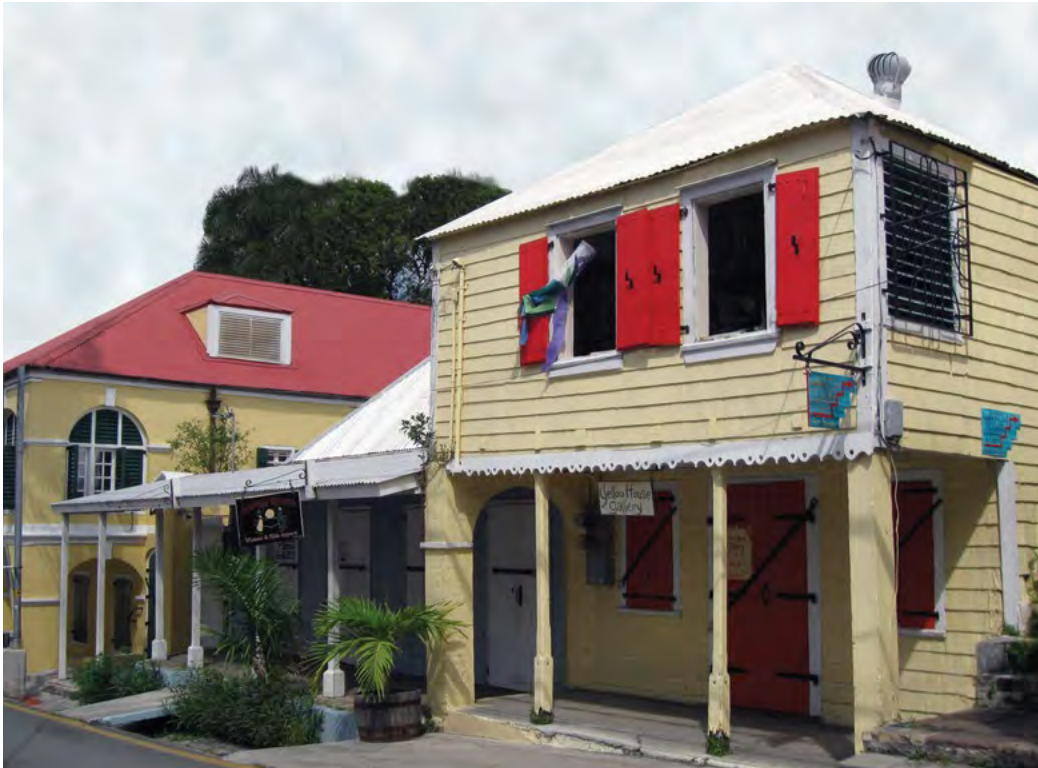
[46] The varied size, shapes, and architectural styles of these historic buildings are unique to this street in Christiansted, St. Croix, USVI, and should be retained in a rehabilitation project.

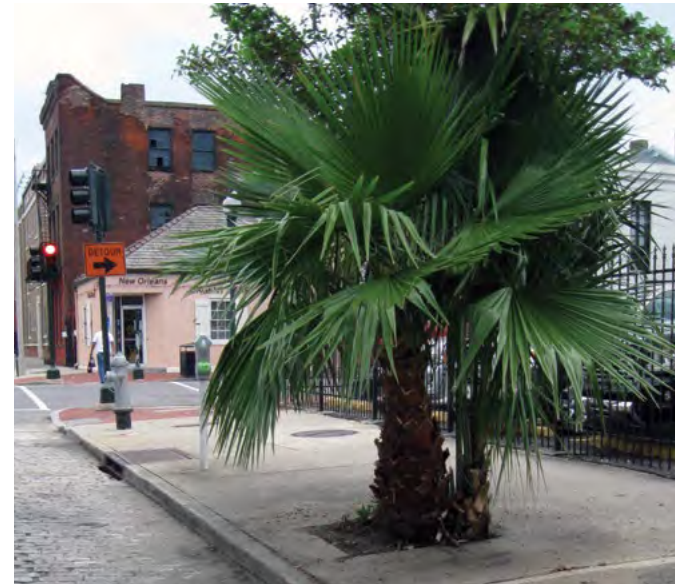
SETTING (DISTRICT / NEIGHBORHOOD)

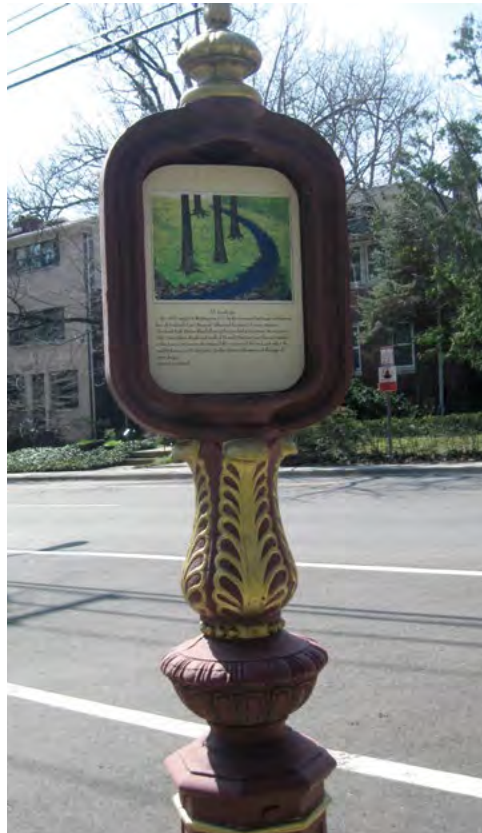
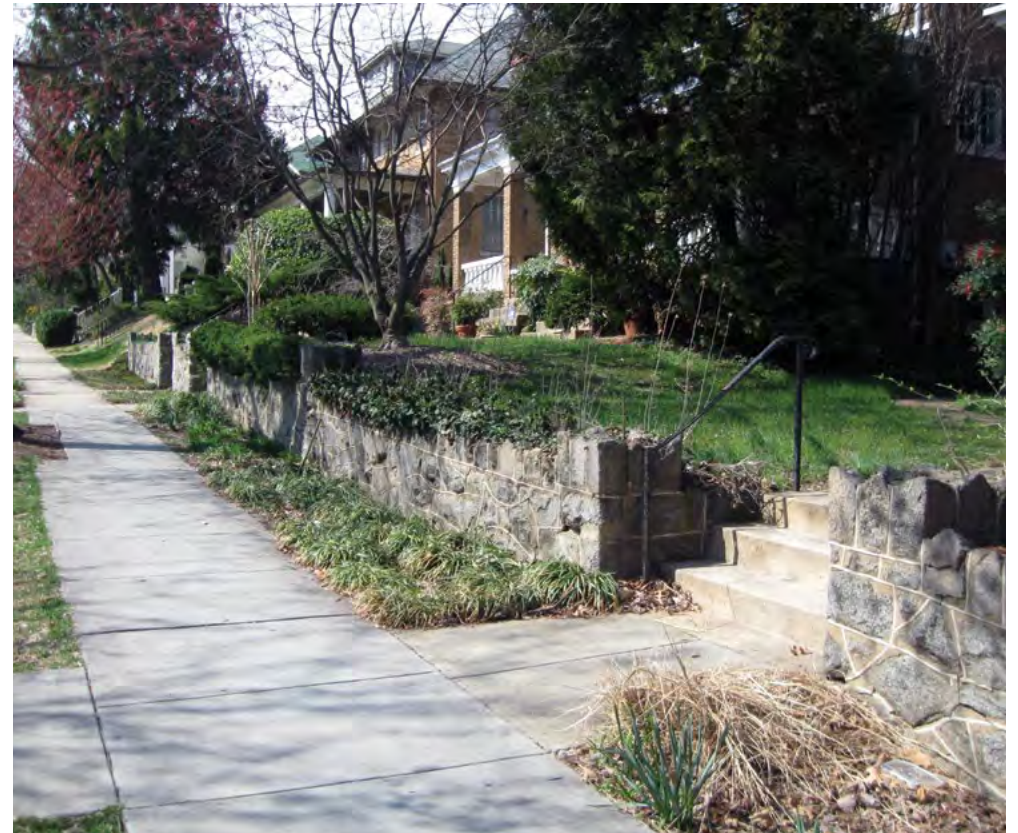
SETTING (DISTRICT / NEIGHBORHOOD)

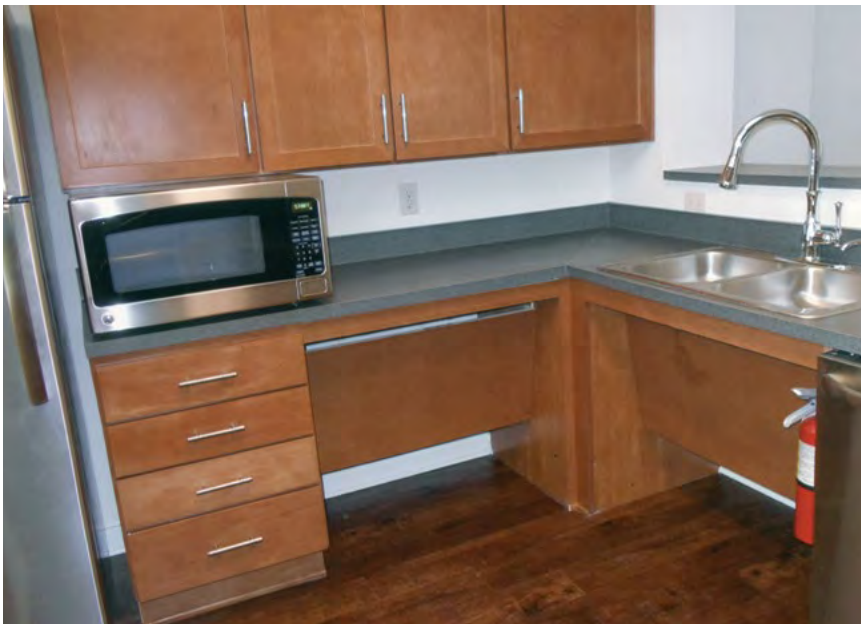
[51] A new interior access ramp with a simple metal railing is compatible with the character of this mid-century-modern building.

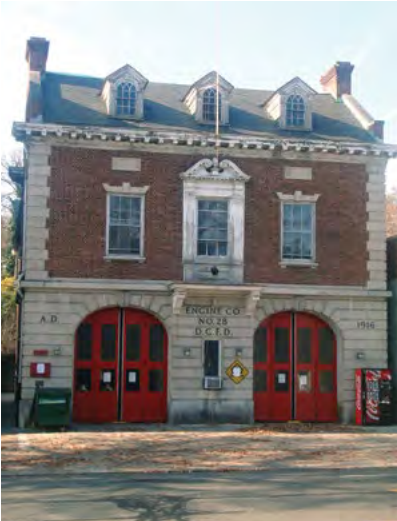
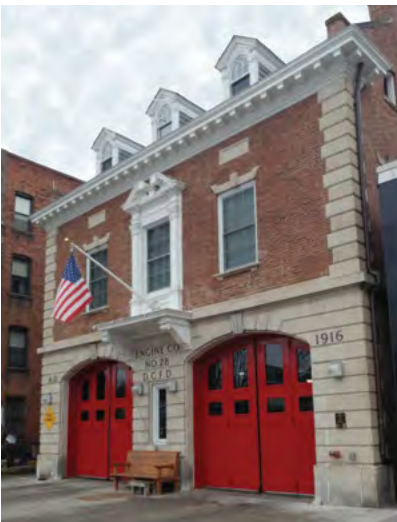
[56 a-b] In order to continue in its historic use, the door openings of this 1916 Colonial Revival-style fire station had to be widened to accommodate the larger size of modern fire trucks. Although this resulted in some change to the arched door surrounds, it is minimal and does not negatively impact the historic character of the building. (a) Above, before; Photo: Fire and Emergency Medical Services Department (FEMS), Washington, D.C.; below, after.

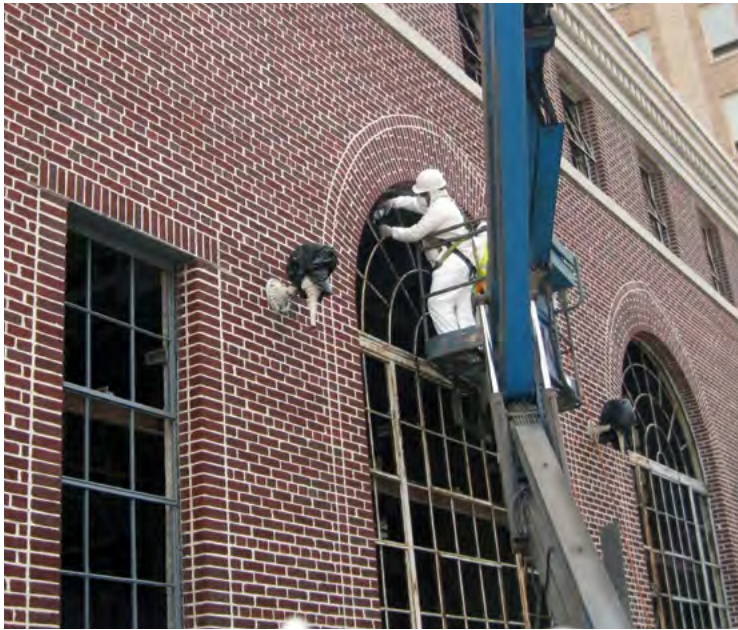
[57] Workers wear protective clothing while removing lead paint from metal features.

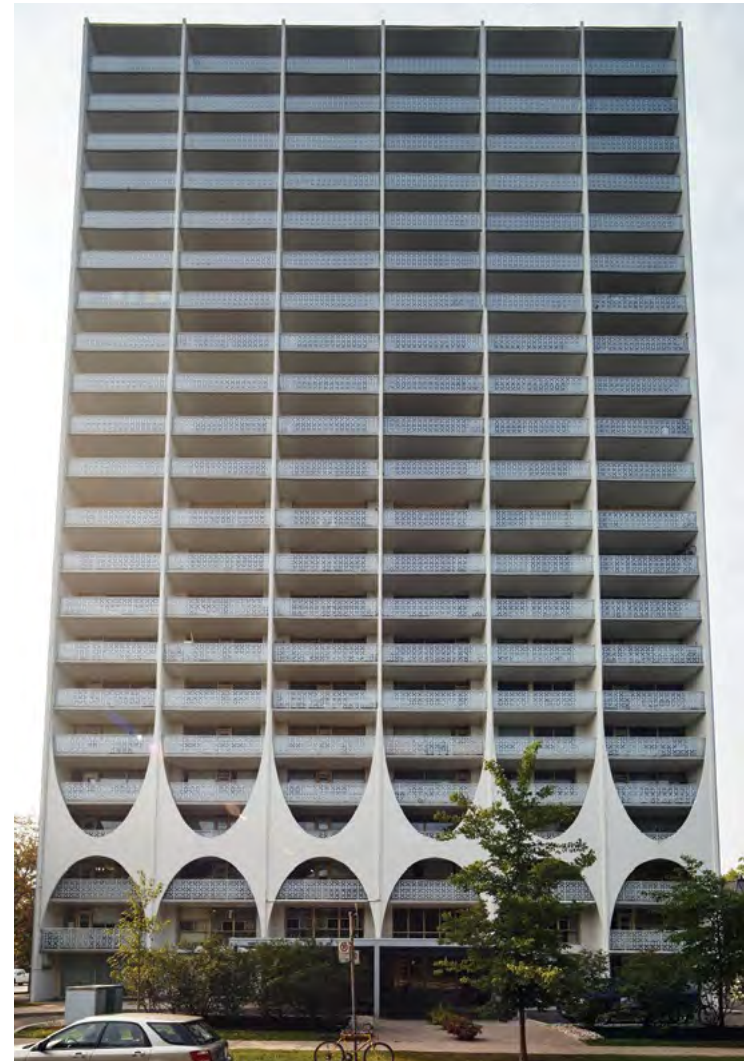
[59] (a-b) The decorative concrete balcony railings on this 1960s building did not meet life-safety code requirements. They were replaced with new glass railings with a fritted glass pattern matching the original design—a creative solution that satisfies codes, while preserving the historic appearance of the building when viewed from the street (c-d). Photos: (a, b, d) ERA Architects, Inc.; (c) Nathan Cyprys, photographer.

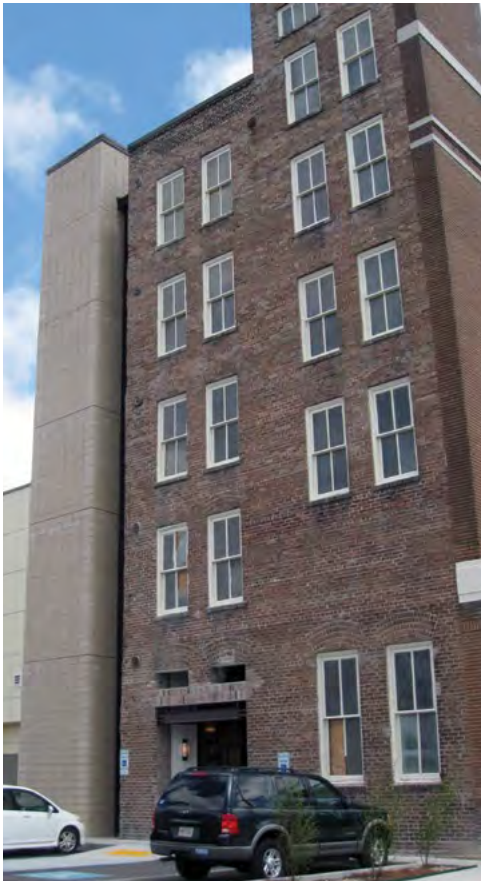
[62] The stair tower at the rear of this commercial building is a compatible new addition.

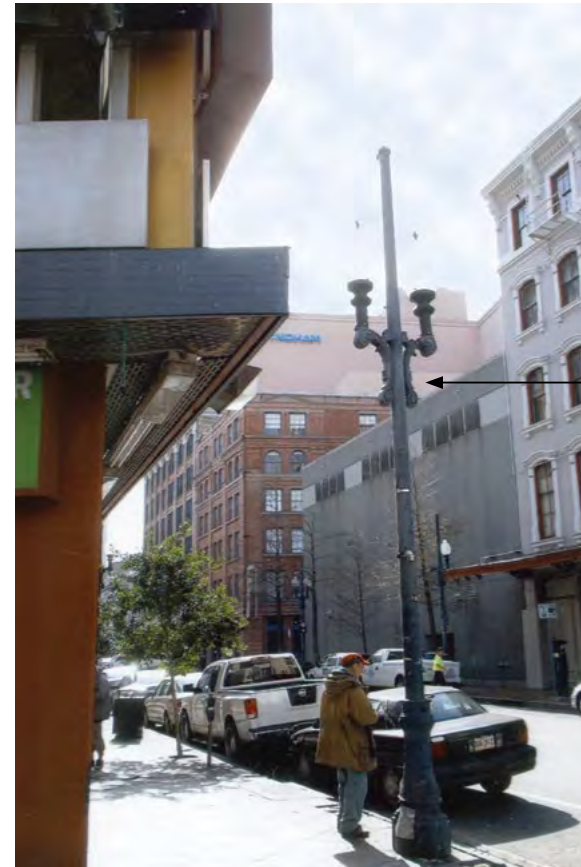
NEW EXTERIOR ADDITIONS TO HISTORIC BUILDINGS AND RELATED NEW CONSTRUCTION

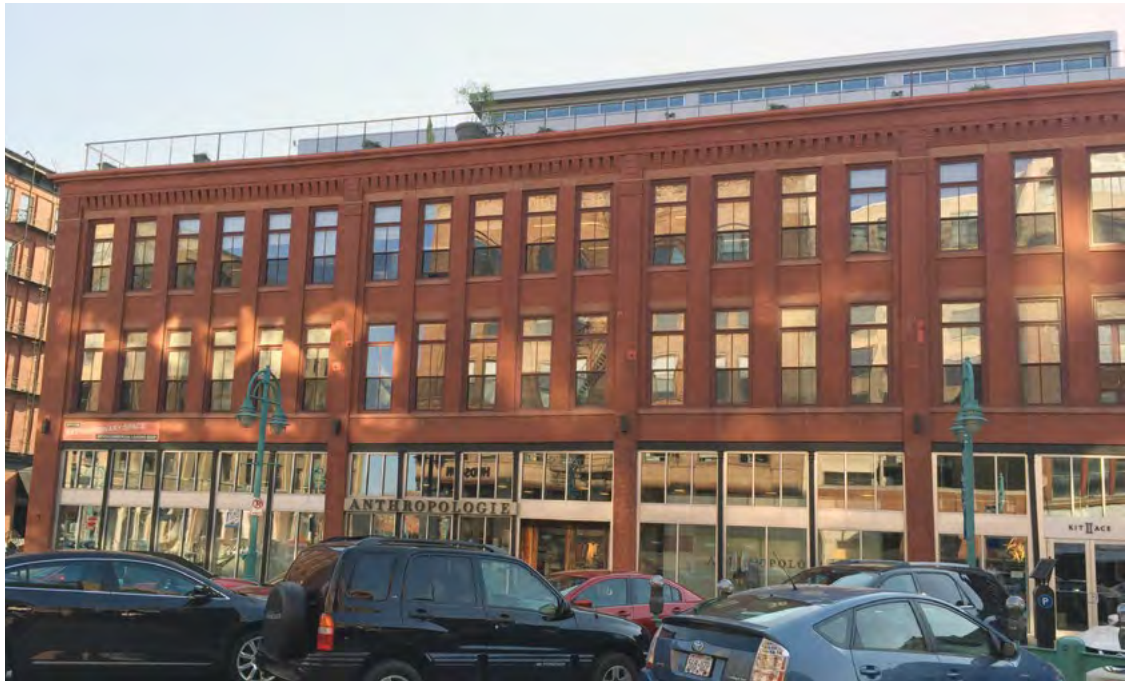
[64] Not Recommended:
It is generally not appropriate to construct a rooftop addition on a low-rise, two- to three-story building such as this, because it negatively affects its historic character.

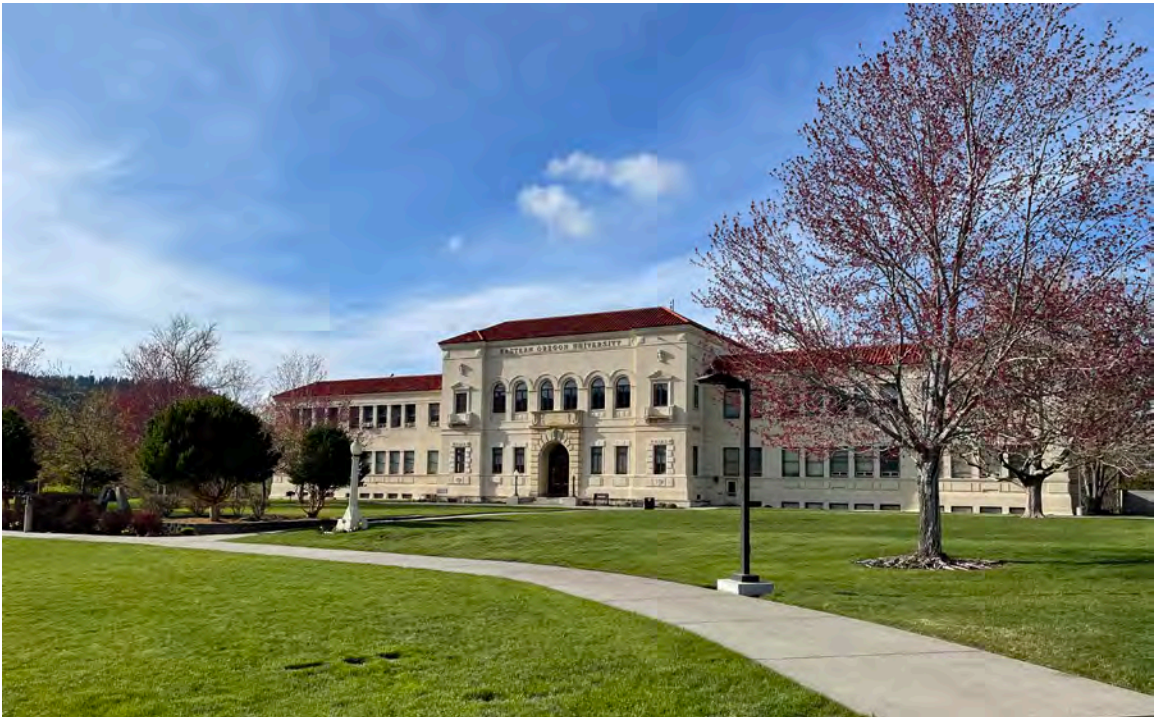
1. Inlow Hall south elevation, facing north. 04/12/2022.

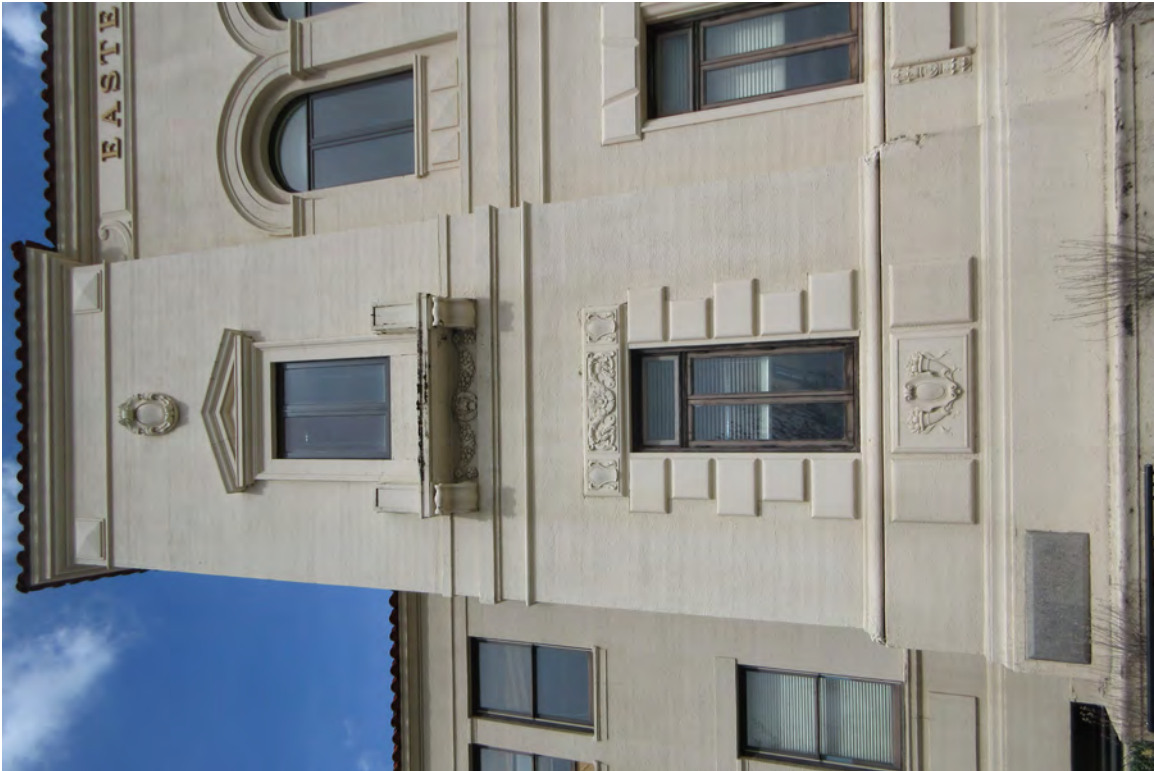
7. Inlow Hall south elevation, facing north. Notice damaged Juliet balcony. Juliet balconies are either damaged or missing on both north and south elevations. 04/19/2022.

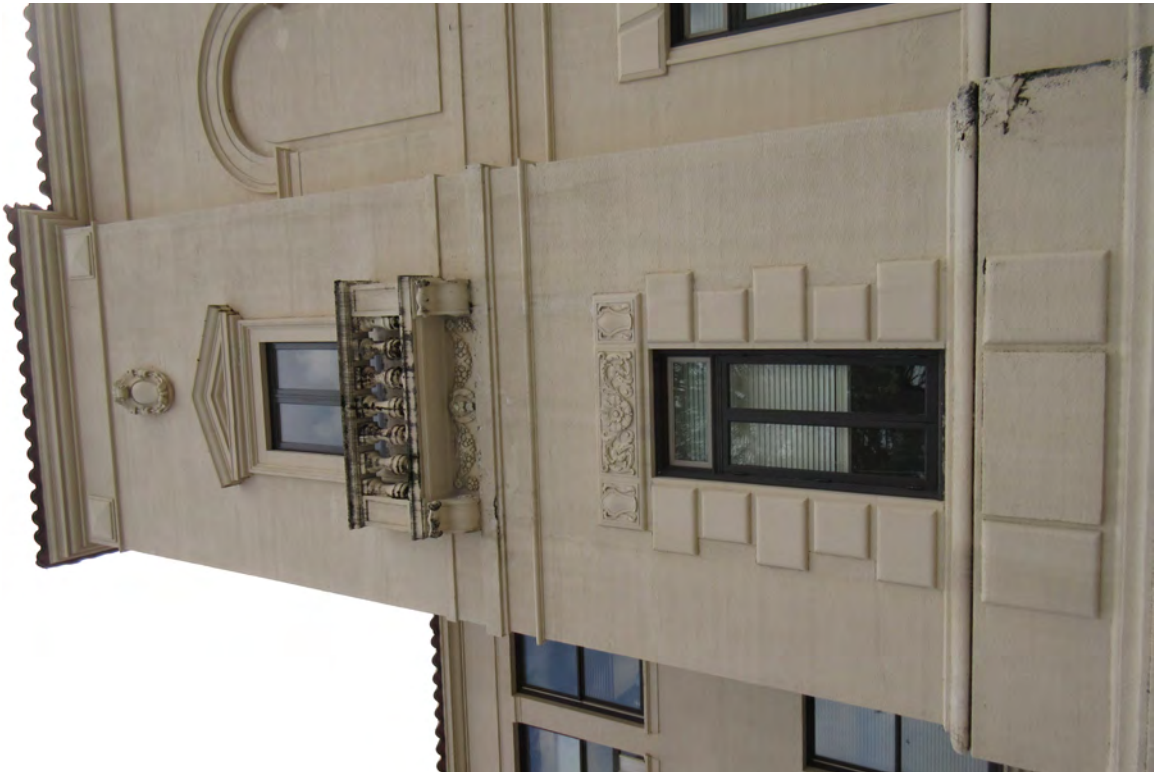
8. Inlow Hall north elevation, facing south. Notice deteriorating Juliet balcony. 04/19/2022.

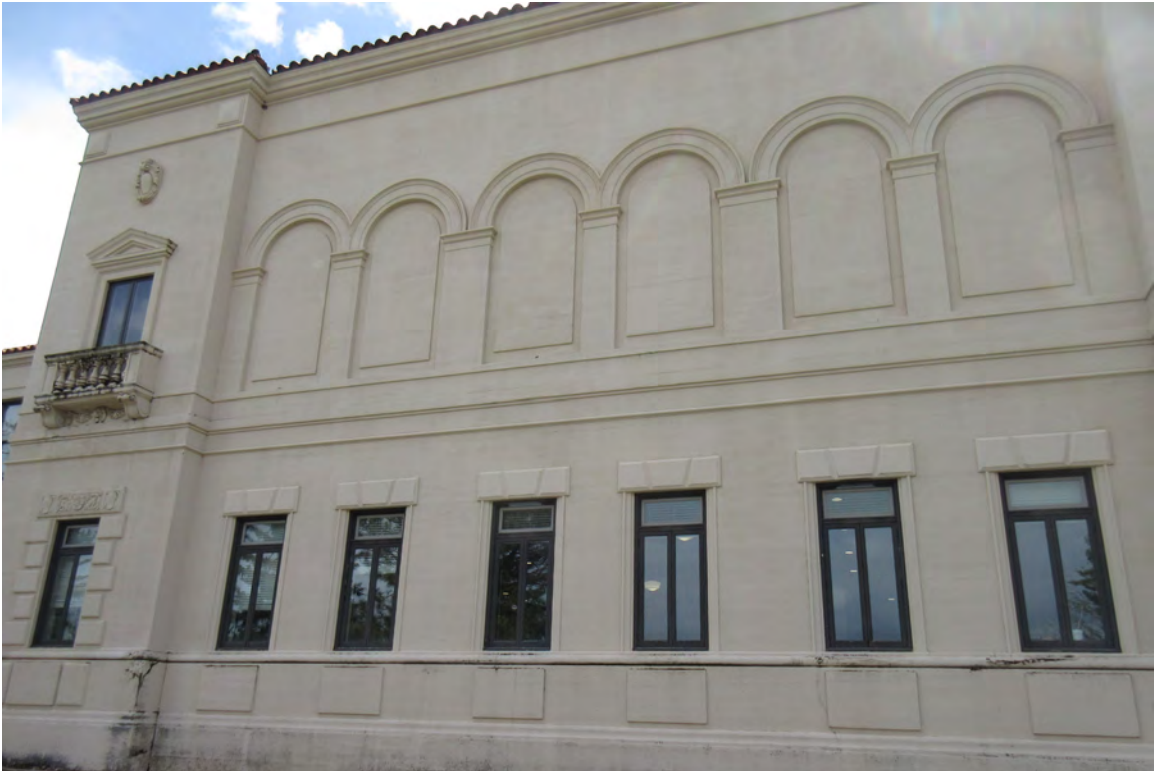
9. Central pavilion, north elevation. The concrete detailing in the archways will be replaced with windows that match the windows of the south elevation second floor, facing south. 04/19/2022.

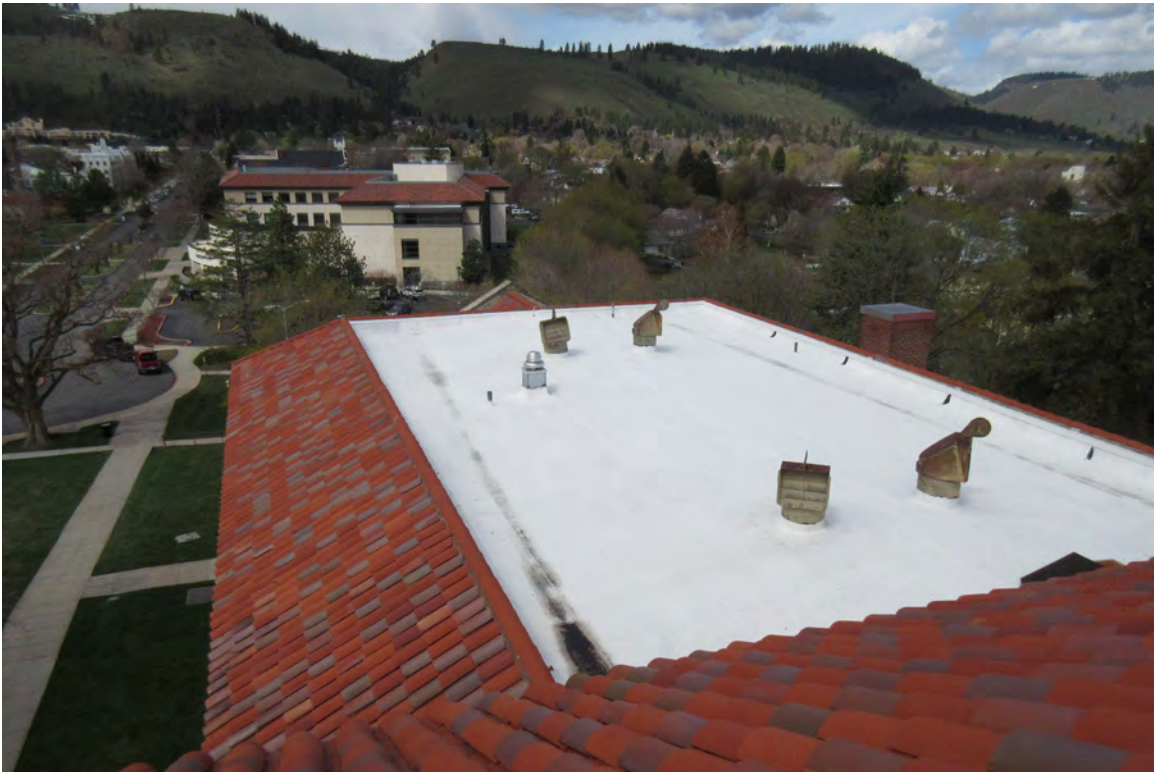
10. Inlow Hall's west wing roof. Terracotta tile and composite roof both to be replaced in kind. 04/19/2022..

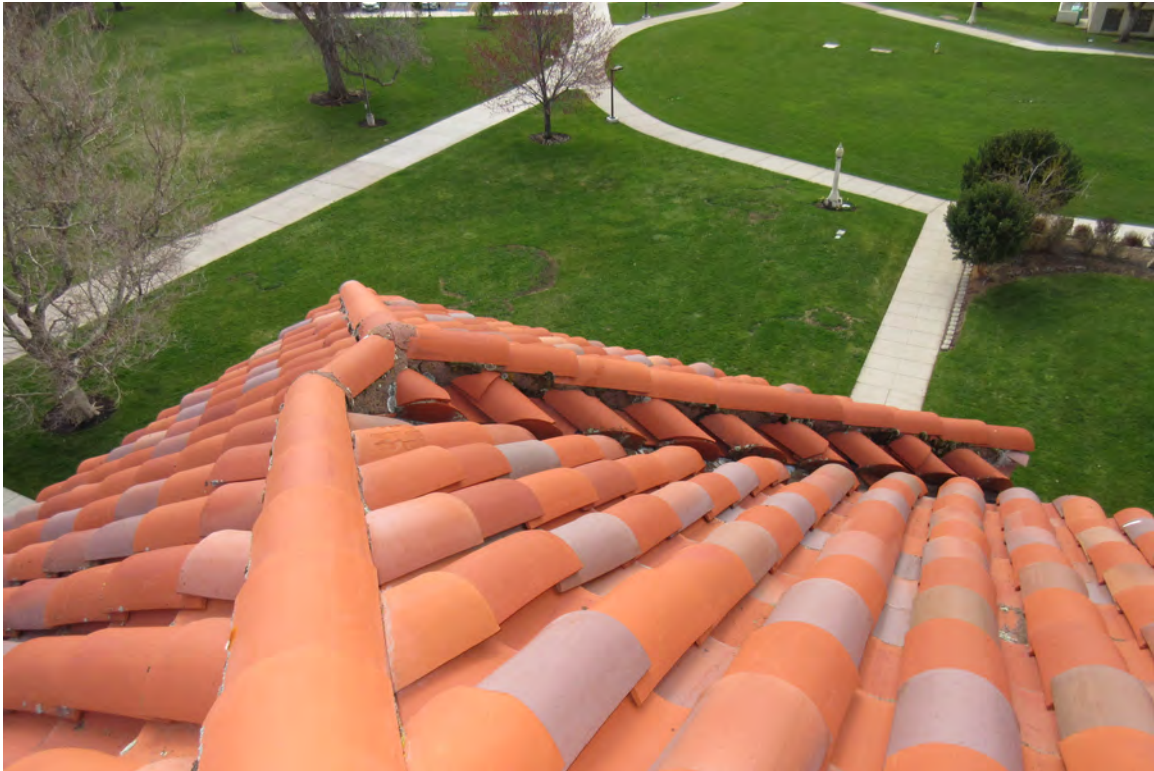
11. Example of terracotta roofing tile on southeastern corner of central pavilion roof, facing southeast. 04/19/2022.
