CITY OF LA GRANDE
Landmarks Commission Regular Session

Thursday, June 8, 2023
6:00 p.m.

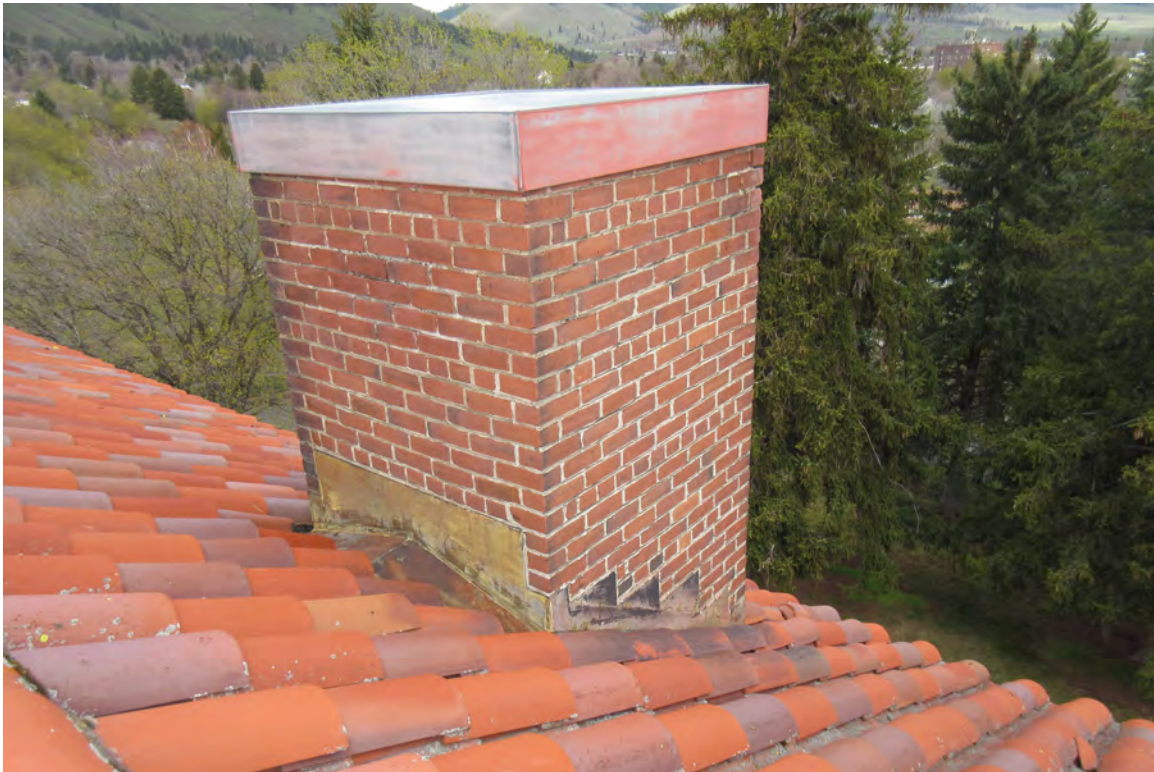
12. Inlow Hall's chimney to be removed and replaced with terracotta roof tiling on the north side of the west wing, facing northwest. 04/19/2022.

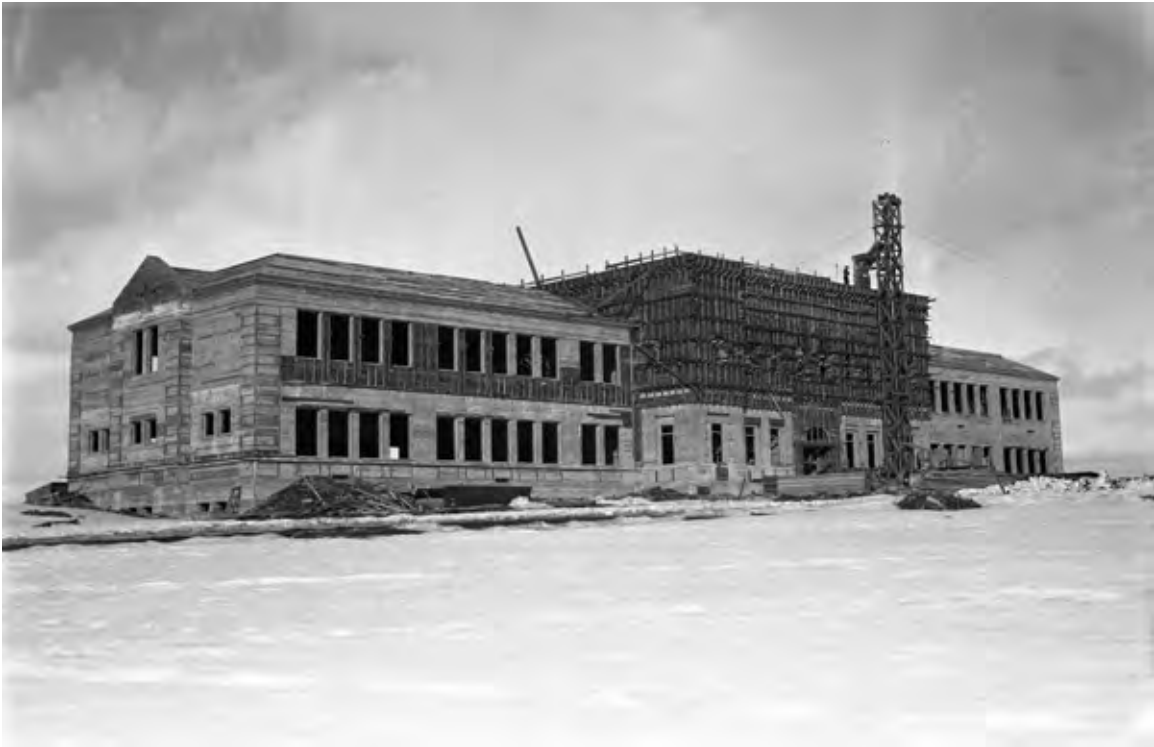
1. Inlow Hall under construction, 1927/1929. Southwest corner, facing northeast. Courtesy of Eastern Oregon University Digital Archives.

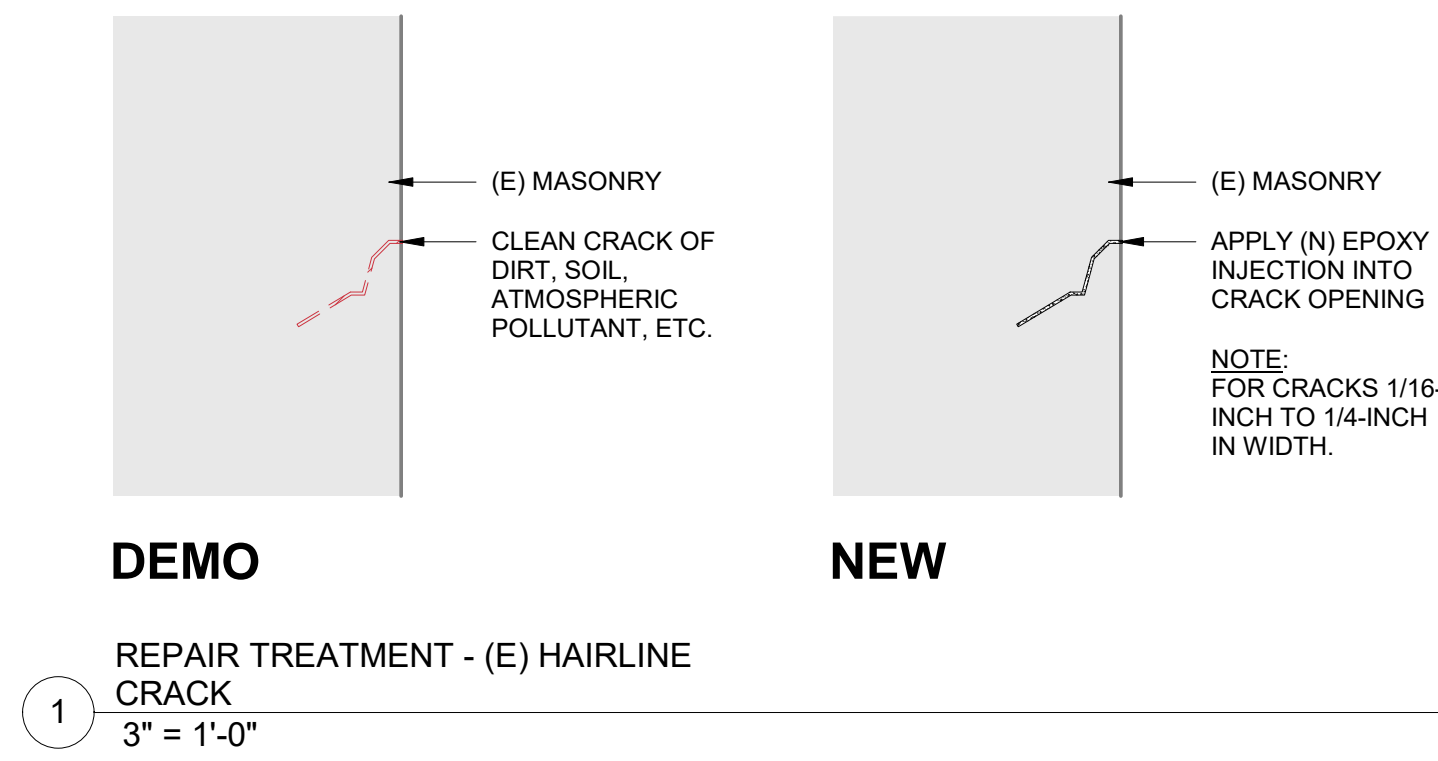
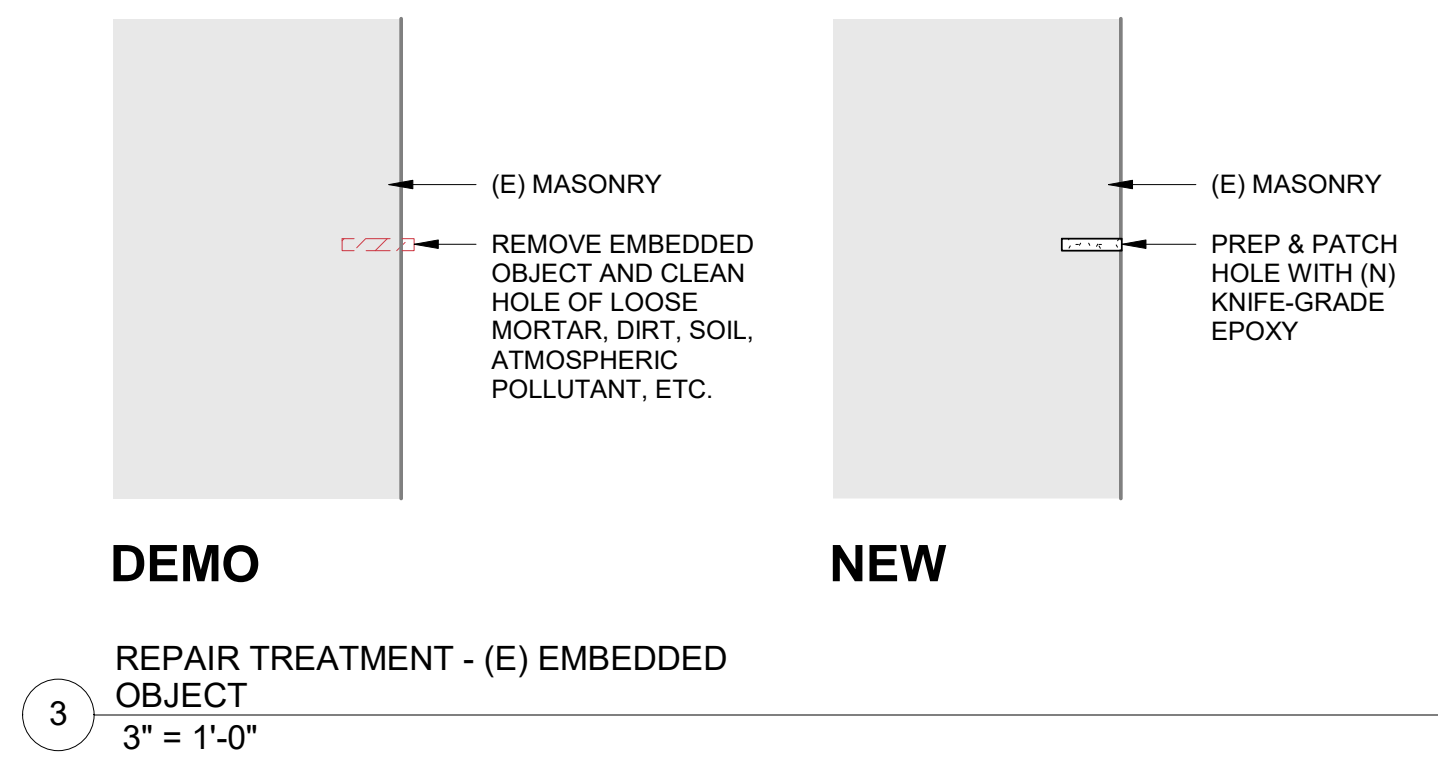
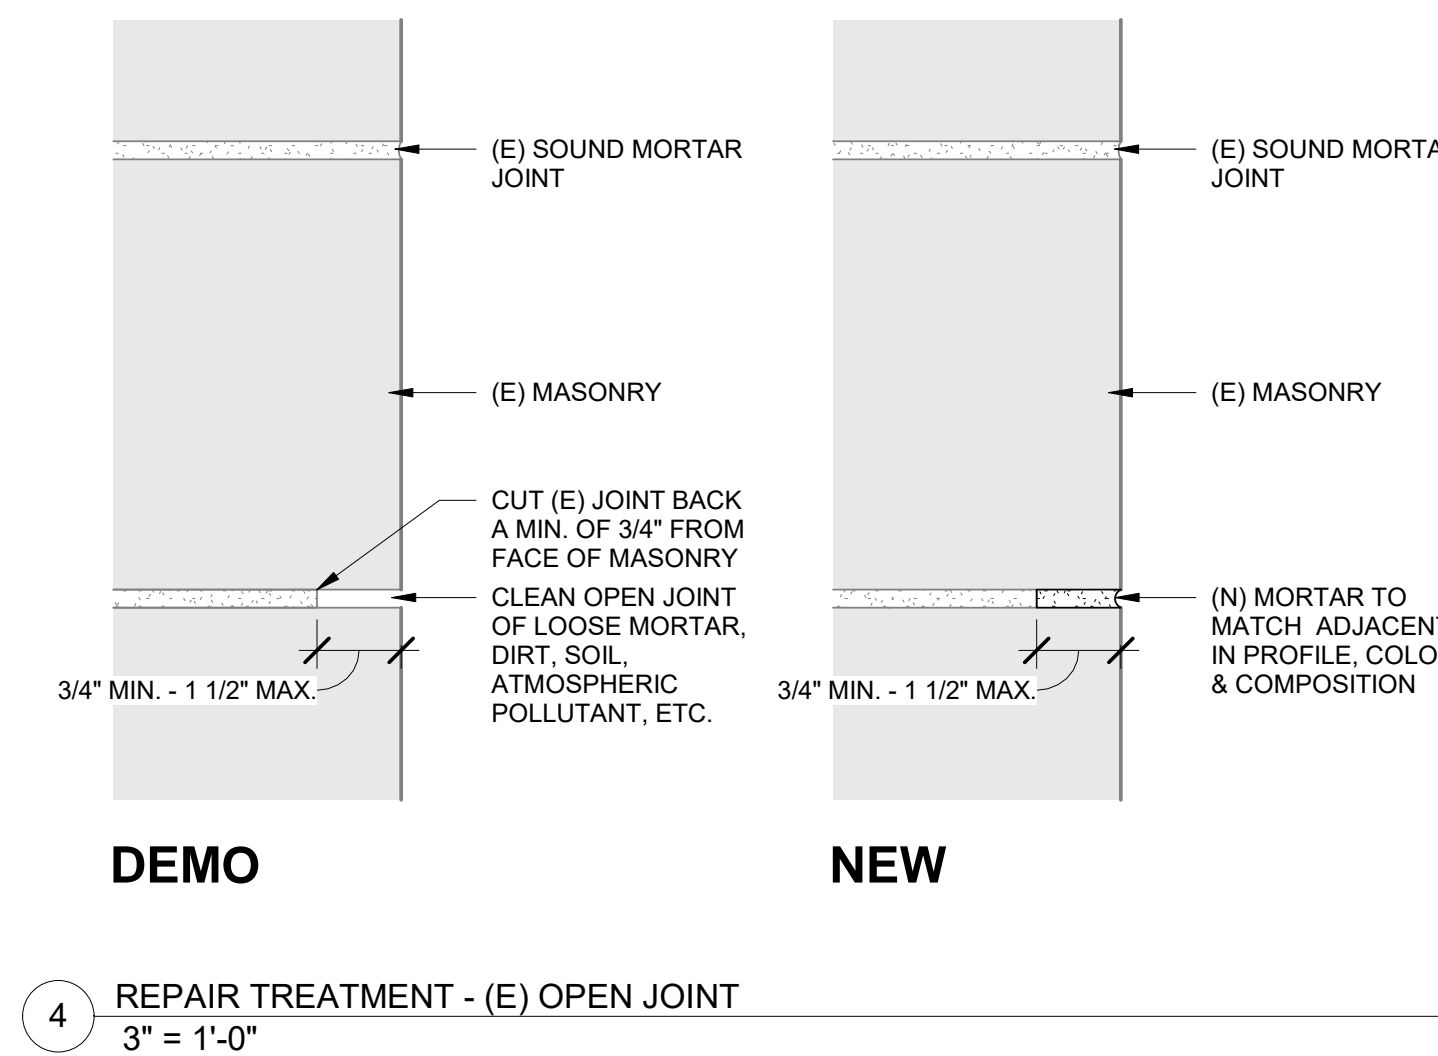
General Repair Notes
