STANDARDS AND GUIDELINES MANUAL FOR HISTORIC REHABILITATION AND PRESERVATION

The Standards and Guidelines Manual for Historic Rehabilitation and Preservation for La Grande, Oregon will provide rehabilitation parameters to owners of buildings in the National Register Commercial Historic District as well as establishing criteria for new construction within the District. Property owners can also use these standards to assist in developing viable applications to the City Landmarks Commission for major alterations and new construction within the District. These design standards will also provide assistance to the City as they review alteration, demolition, and new construction requests within the downtown Historic District. The design standards are meant to encourage owners of historic properties and La Grande residents to appreciate and preserve the local architecture and history which helps define the unique character of the community.

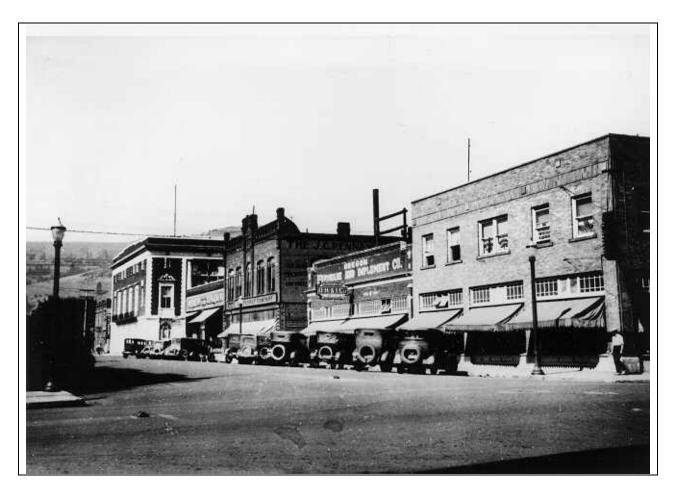
Depot Street, c. 1927, looking southwest from Adams Avenue. Observe the original lampposts and awnings. Contrast the changes in the building facades to the existing storefronts.

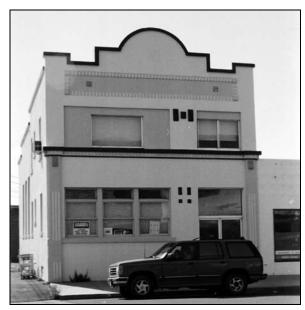
West Jacobson Building -20th Century

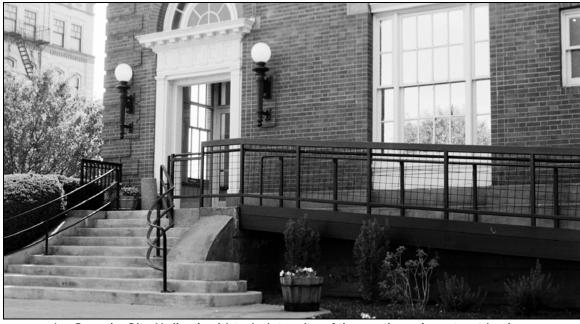
La Grande City Hall – the historic integrity of the north and west entries has been maintained. The ramp and railing have been added to the secondary elevation of the building at the southwest corner.
